March 8, 2010
W-P Project No. 12018A

Subject: Macallen Dam - Preliminary Report
Structural Analysis and Recommendations

Newmarket, NH
Macallen Dam Inspection
Project #12018A

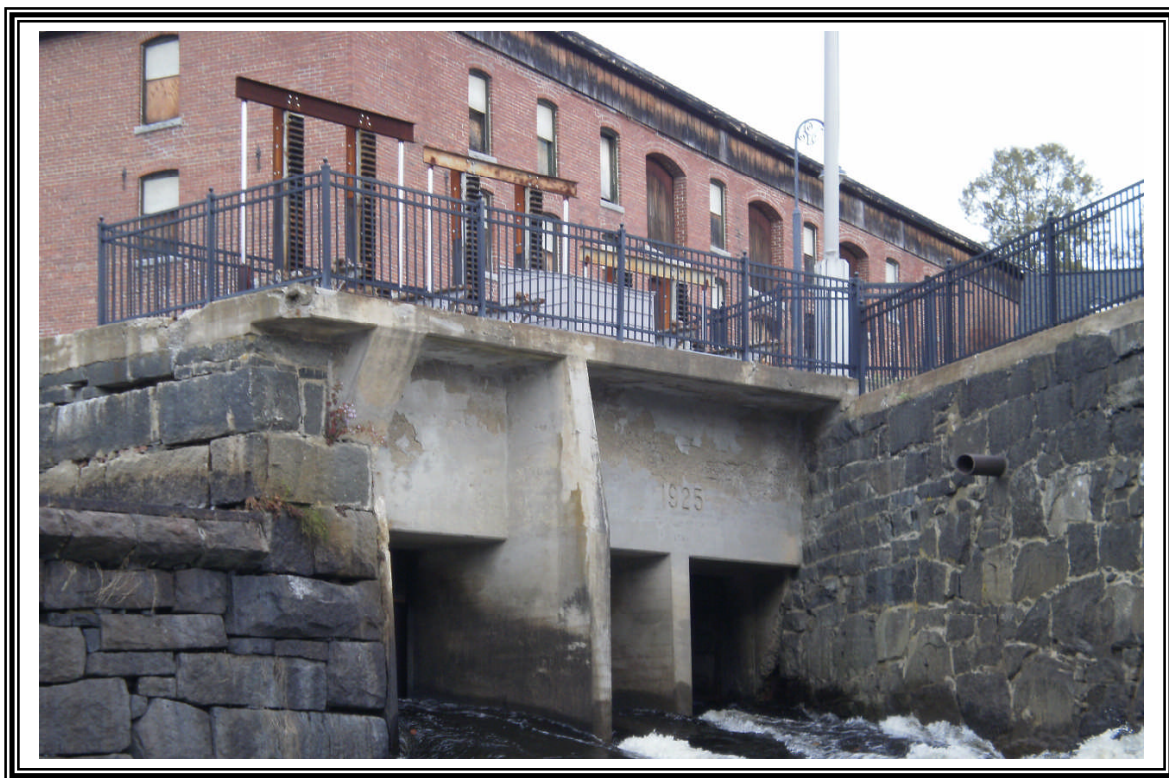
Photo 3

8. Thin layers of concrete are peeling off the south face of the structure where the construction date is etched. (Photo 3)
9. Water was observed leaking through the edge seals of the stop log gates when the gates were closed.

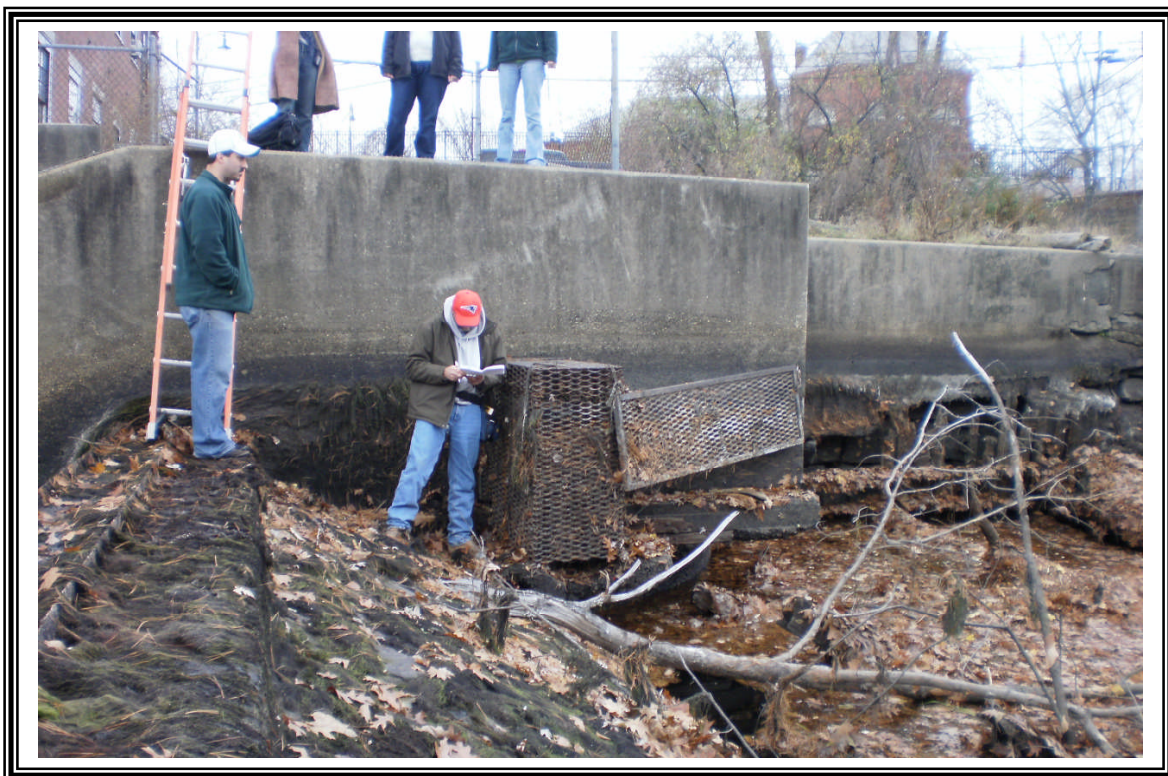
Photo 11

The spillway and exposed upstream (sloped) face were covered with thick layers of vegetation and mud so it was difficult to assess the condition of the dam structure. (Photo 11) It appeared the top four vertical feet of the face were faced with stone. We observed what appeared to be very deteriorated concrete with exposed aggregate just below the point where the stone terminated. The spillway consists of a 3 feet wide by 1 foot deep concrete cap. A severely corroded 15 inch steel channel section is bolted across the full width of the spillway crest. It is not apparent if this channel was used for attachment of flash boards or if it simply increases the storage capacity by several inches. It is our understanding that during normal hydraulic operation this channel section serves as the main spillway crest.

The upstream retaining wall on the west side and immediately north of the dam is comprised of stacked stone blocks with a concrete overlay wall (Photo 11). The retaining wall frames into the concrete fish passage inlet structure which bounds the west end of the spillway. There is a small impoundment area to the north of the retaining wall that is bound by a stacked stone and concrete retaining wall (running east-west) and the Route 108 stacked stone and concrete retaining wall (running north-south). (Photo 21)

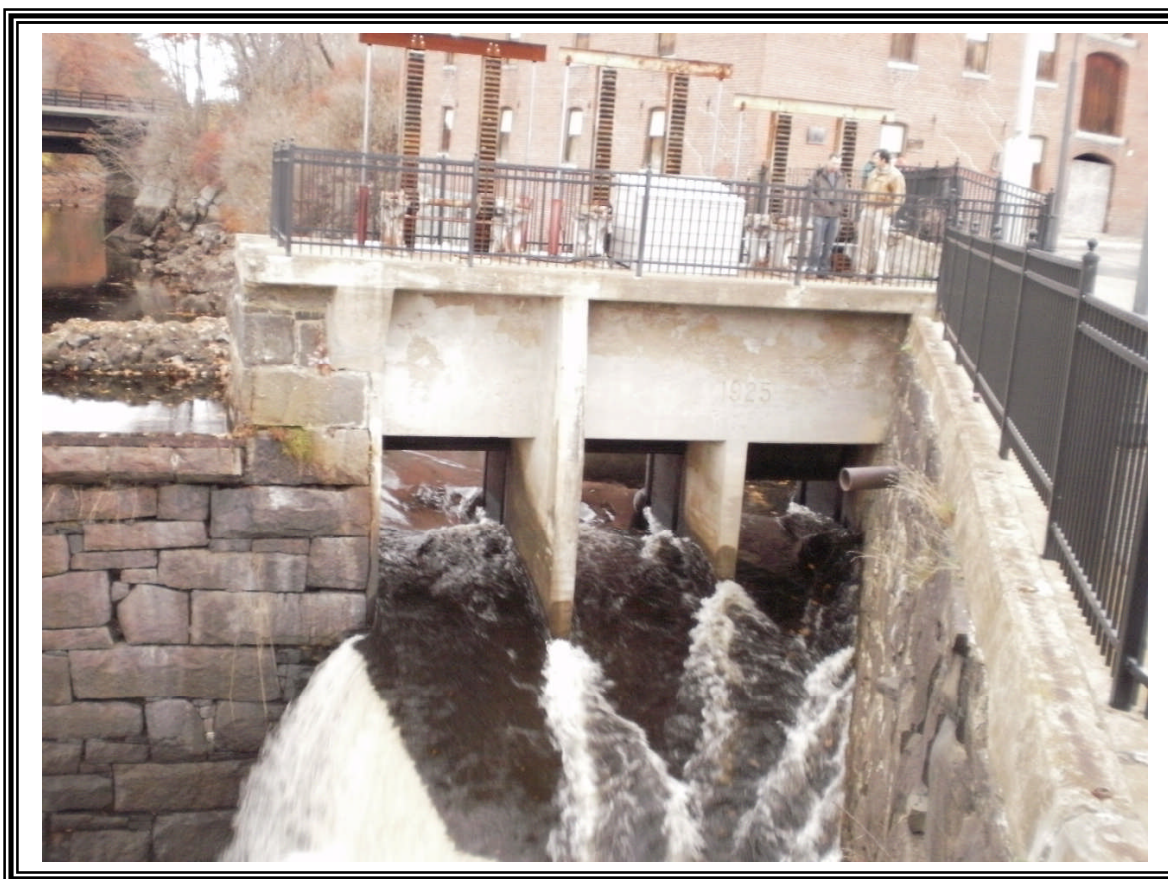
Photo 12

The gate structure consists of three reinforced concrete channels with a concrete operation platform above them (Photo 12). The inverts of the channels are about 8 feet below the crest of the dam. We were not able to observe the surface of the channel slab from a close proximity due to flows (Photo 13). It is likely that there would be deterioration of the concrete due to the age of the structure and erosion. The east side of the structure is built into the east side retaining wall (Photo 14) and the west side is built into a stacked stone wall abutting the spillway (Photo 15). The west side stone wall is ungrouted with vegetation growing through some of the joints. The structure appeared to be in fair condition with the following deficiencies noted:

6. The west platform steel fence is very loose. (Photo 12)
7. There are gaps in the west side stone wall where smaller stones were washed out during the May 2006 flood.

- B. Fill the hole in the southeast concrete channel wall where it frames into the stone retaining wall with reinforced concrete. Reinforcing steel dowels should be drilled into the existing concrete and adhered with epoxy resin. (Photo 12)

- D. The spalls in the edge of the concrete platform slab should be repaired with a structural concrete patching material. (Photo 13)
- E. The west platform steel guard posts should be stabilized by installing epoxy grout in the embedded post sleeves in the concrete. (Photo 12)

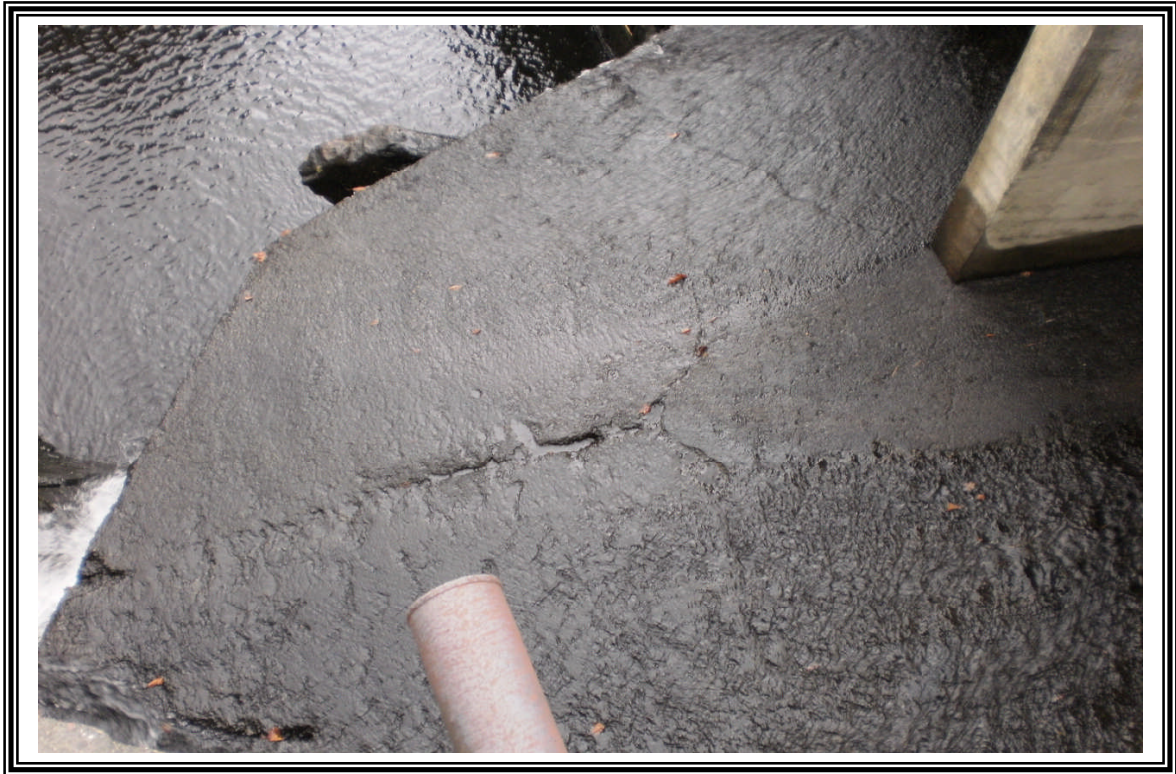
Photo 13

4. There are cracks and spalls in the southwest concrete channel wall that abuts the spillway. (Photo 15)
5. There are several spalls in the edge of the concrete platform slab. (Photo 13)

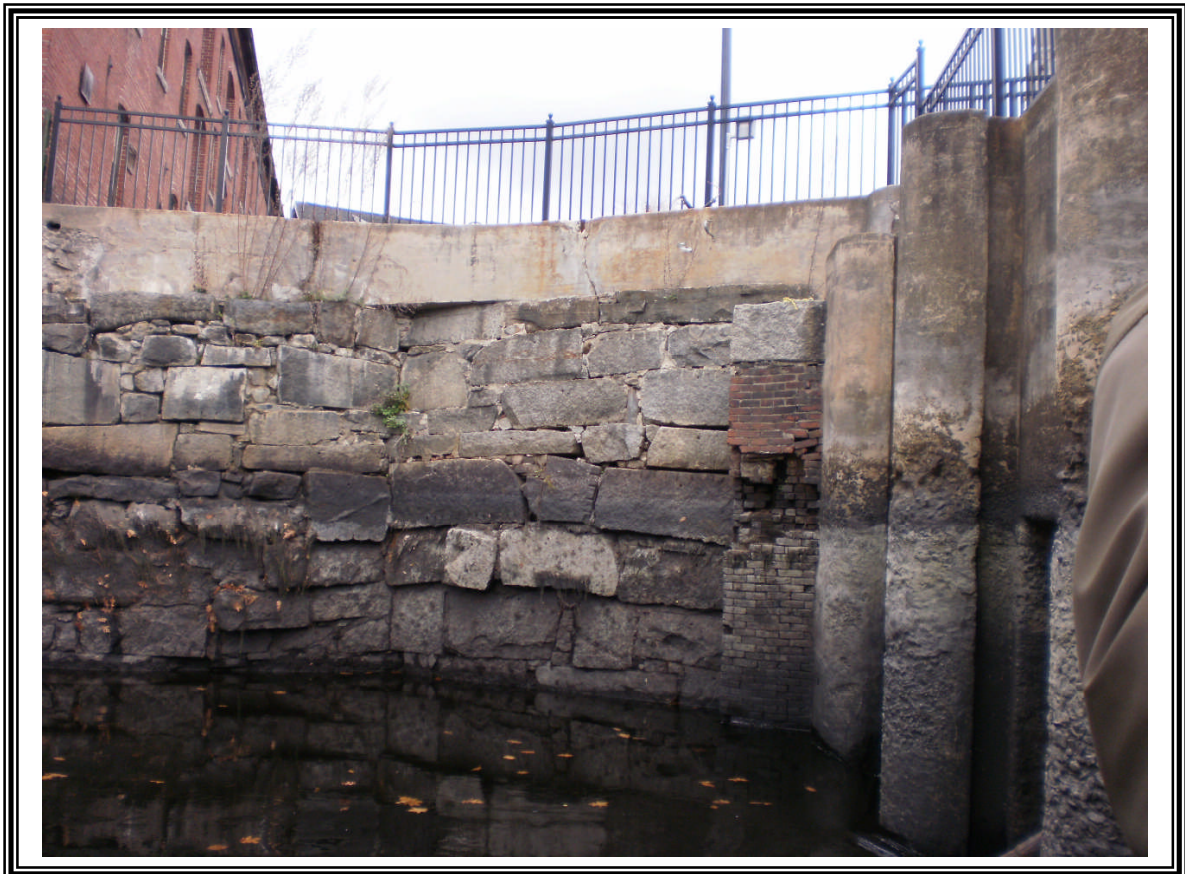
Photo 14

There is a brick pier structure at the northeast corner of the gate structure with a large portion of the bricks either damaged or missing. It is our understanding that this damage was caused by the flood in May 2006. It is not apparent what function the brick pier serves. (Photo 14)

- A. Repair the damaged brick pier by filling the gap with grout or mortared bricks. (Photo 14)
- B. Settlement of the parking lot should be monitored in the future. If sink holes continue to form, it is most likely a sign that water is getting in the subgrade either through the retaining wall or through the old penstock cavity below the Mill Building. (Photo 20)
- C. The Town should maintain dialogue with the Building Owner and coordinate how repairs to the Dam and/or Building will affect the other.

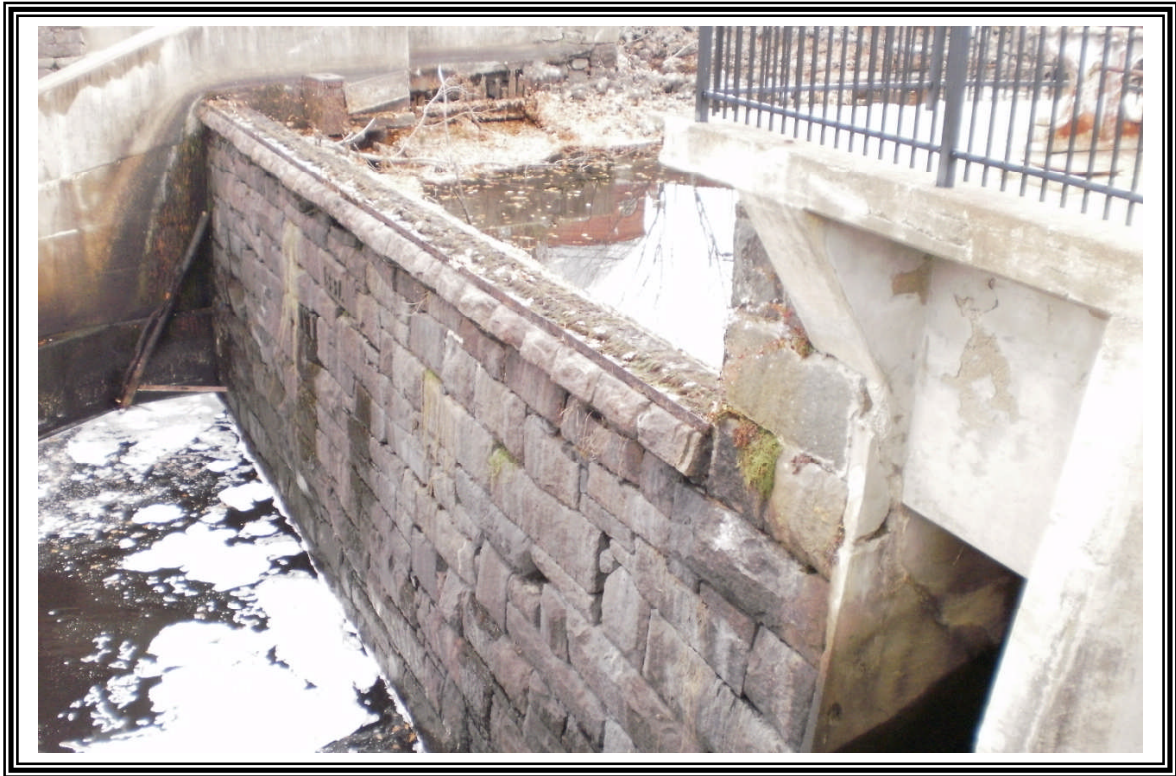
Photo 15

2. The surfaces of the slab supporting the west side stone wall are in poor condition exhibiting severe exposure of the aggregate. It appears that this slab was cast monolithically with the upstream face of the dam. (Photo 15)

- C. The cracks in the southwest concrete channel wall that abuts the spillway should be filled with an epoxy resin. The spalls in the wall should be repaired with a structural concrete patching material. Larger areas of spalling can be addressed by removing portions and replacing them with new reinforced concrete. (Photo 15)

- F. The gaps in the west side stone wall should be filled with stone or grout.
- G. The thin layers of concrete that are peeling off the south face of the structure where the construction date is etched do not present a serious structural problem at this time. Thus, no repairs are required at this time. (Photo 15)

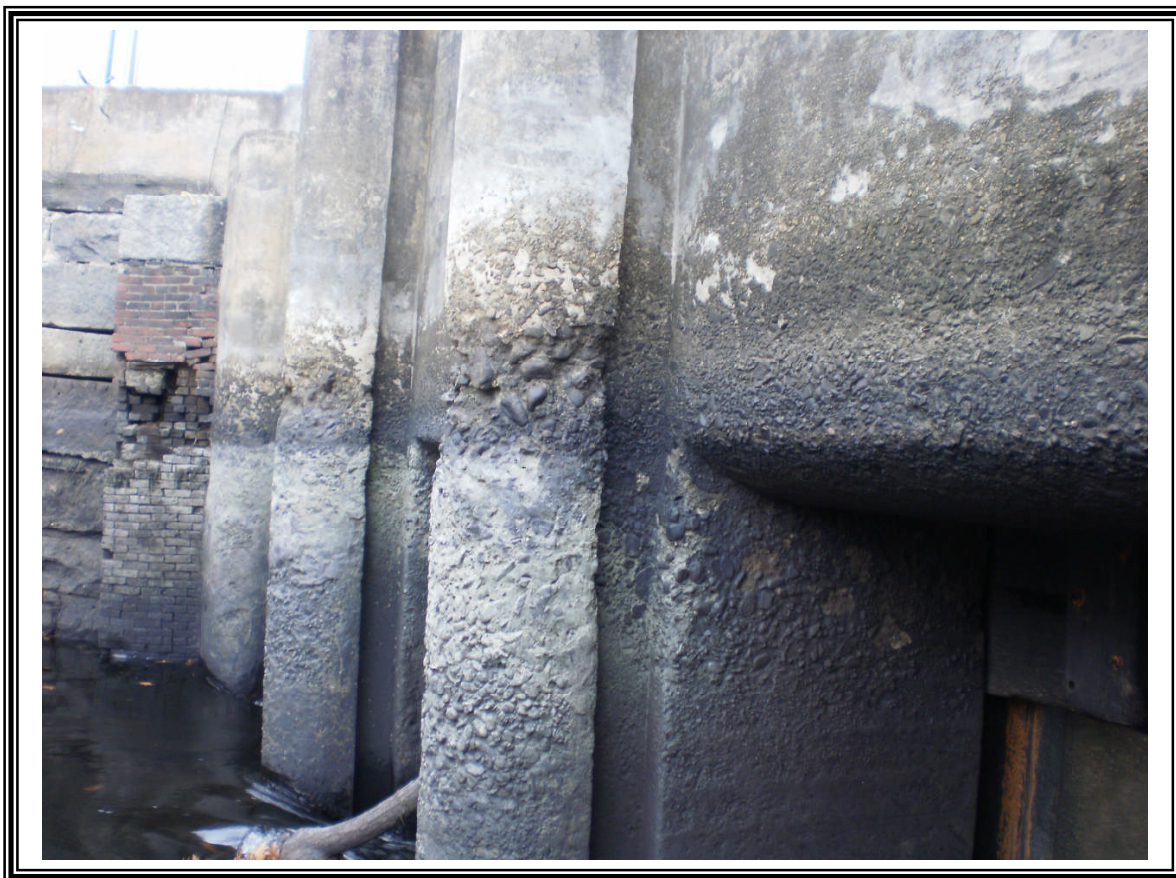
Photo 16

1. The upstream surfaces of the concrete channels at and below the normal water level (especially the rounded edges of the channel walls) are in poor condition exhibiting severe exposure of the aggregate. (Photo 16 & 17)

- A. Resurface the upstream surfaces of the concrete channels at and below the normal water level with a cementitious overlay. The upstream noses of the channel should be lined with stainless steel wear plates. (Photo 16)

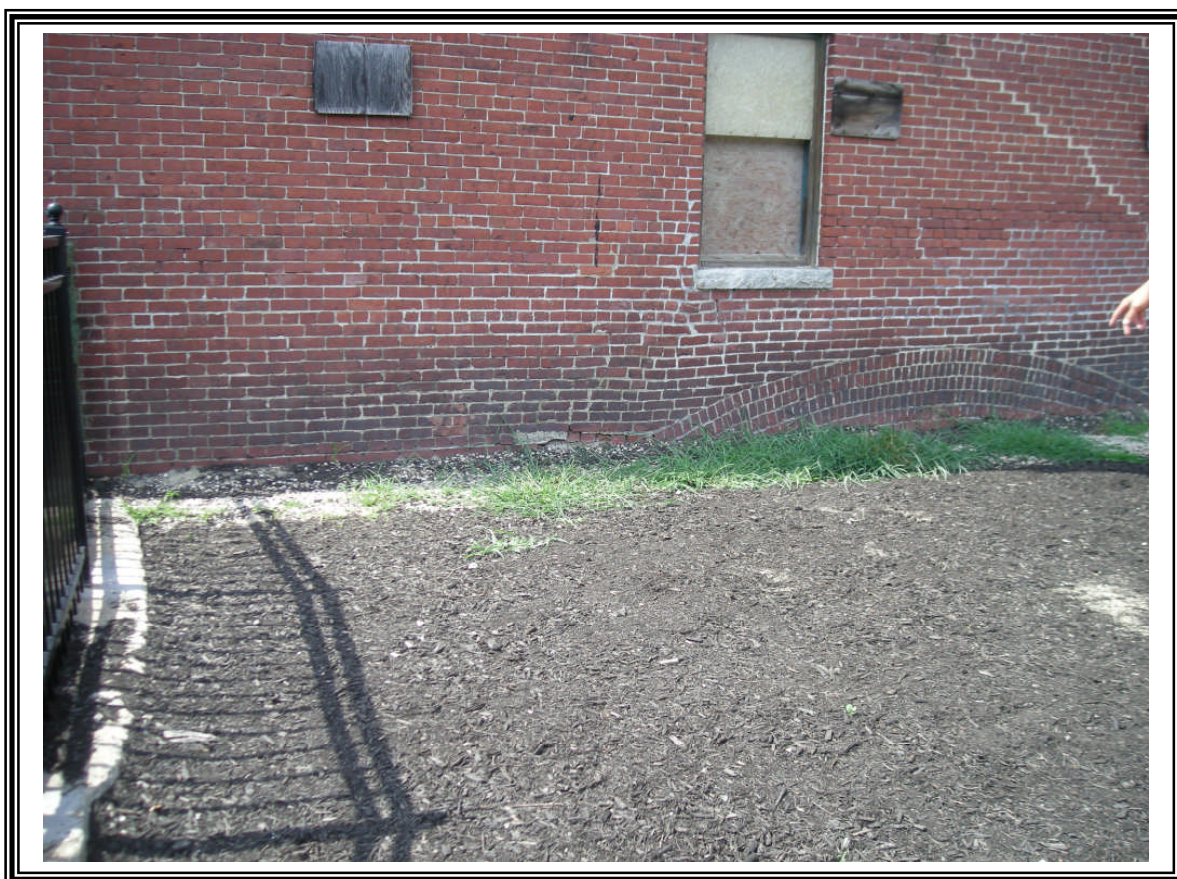
Photo 20

It is our understanding that sink holes have formed in the parking lot on the other side of the wall which may be an indication that water is getting behind the retaining wall either through the stone wall or through the old penstock cavity. (Photo 20)

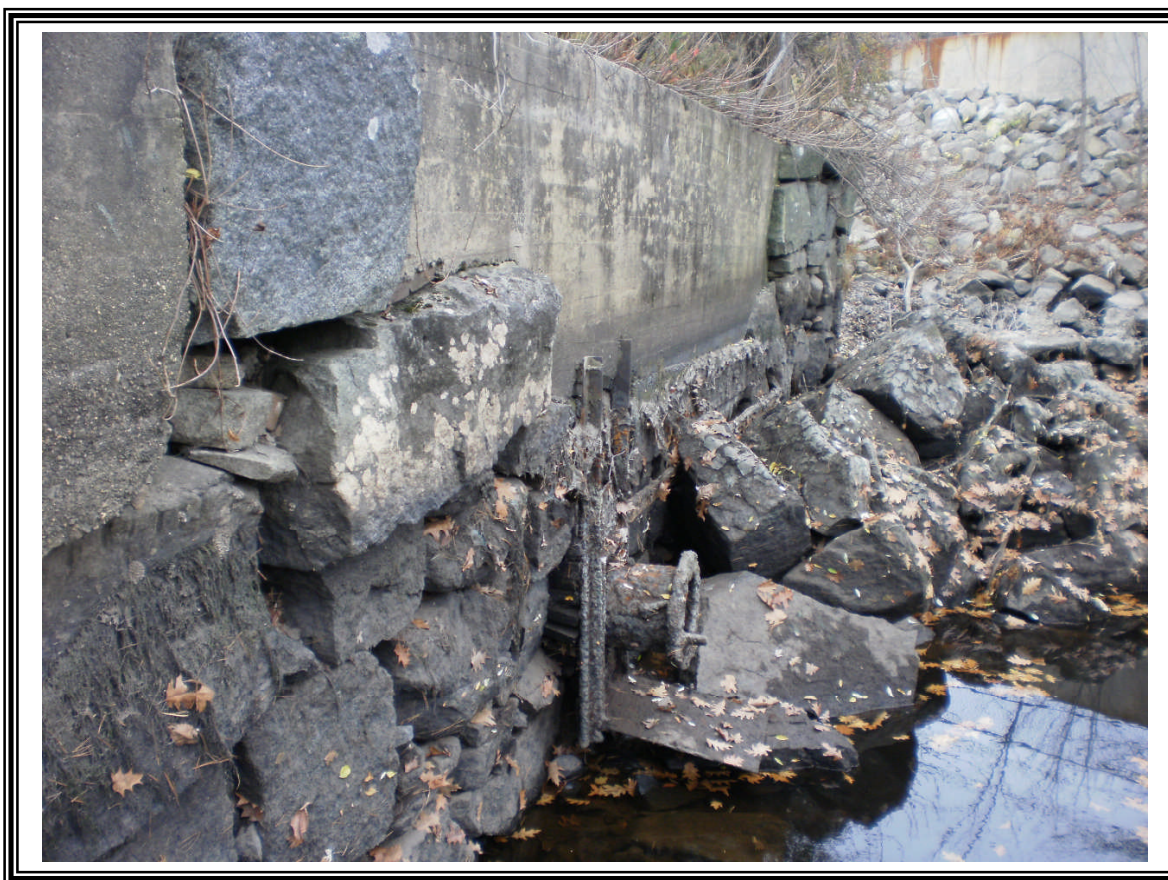
Photo 22

The concrete overlay wall appears to be about 12 inches thick and only partially covers the stone wall. The wall forms from a wall cap at the top and terminates unevenly between 3 and 5 feet above the drawn down water line (Photo 22). The stone wall is visible behind the concrete wall where it terminates. The bottom of the wall is submerged at the normal water level (Photo 23). All of the walls appear to be in fair condition. Spalls are present in the concrete at the north end of the wall where the concrete was placed around several stone blocks. There is some remaining wood cribbing in front of the wall (Photo 24). In addition, there was an exposed pile of riprap and debris in front of this wall that is submerged at the normal water level (Photo 25). There is a corroded pipe near the bottom of the exposed wall running in the east-west direction. It is not apparent what function the pipe serves.

- A. The spalling concrete at the north end of the wall where the concrete was placed around several stone blocks should be removed and repaired with a structural concrete patching material. (Photos 22 & 24)
- B. The existing construction drawings for the concrete fish passage structure should be reviewed by a Structural Engineer to confirm that the structure is adequate to cantilever over the slab. (Photo 28)
- C. The concrete overlay wall does not appear to be distressed. However, this wall should be monitored for future movement or cracking.

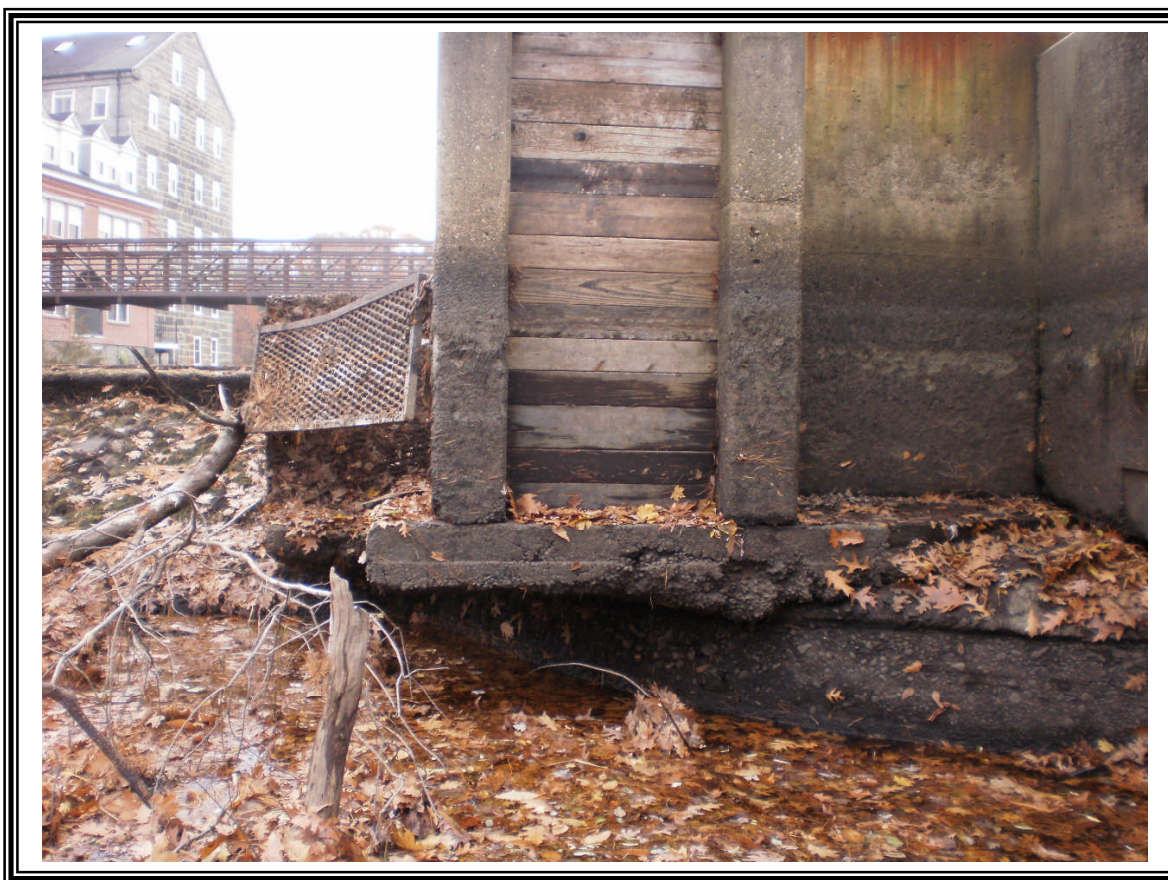
Photo 26

The concrete fish passage structure appears to be in fair condition. The base slab of the structure was exposed during the drawdown and revealed that the structure overhangs a larger base slab by several feet. It is not clear when the base slab was constructed and what specific purpose it serves (it has a curved edge and doesn't line up evenly with any other structure). (Photo 26)

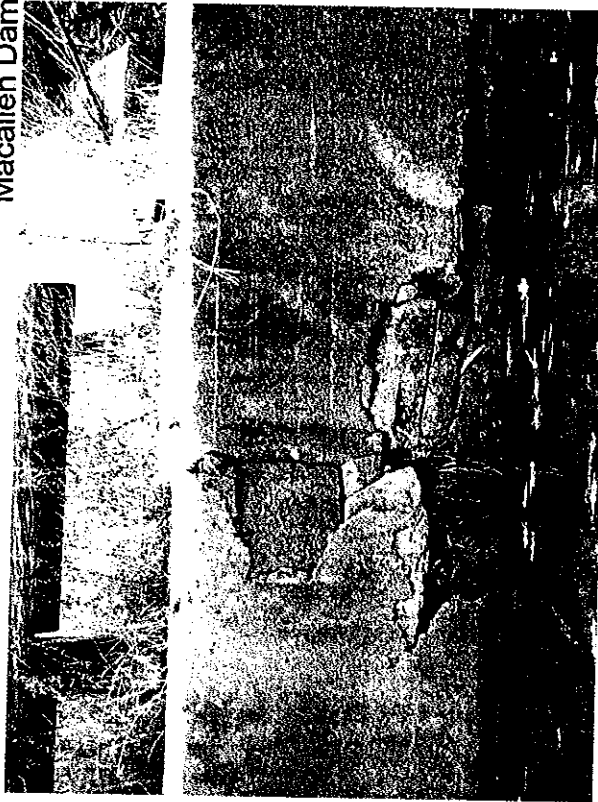
1. Concrete deterioration on upstream right abutment wall

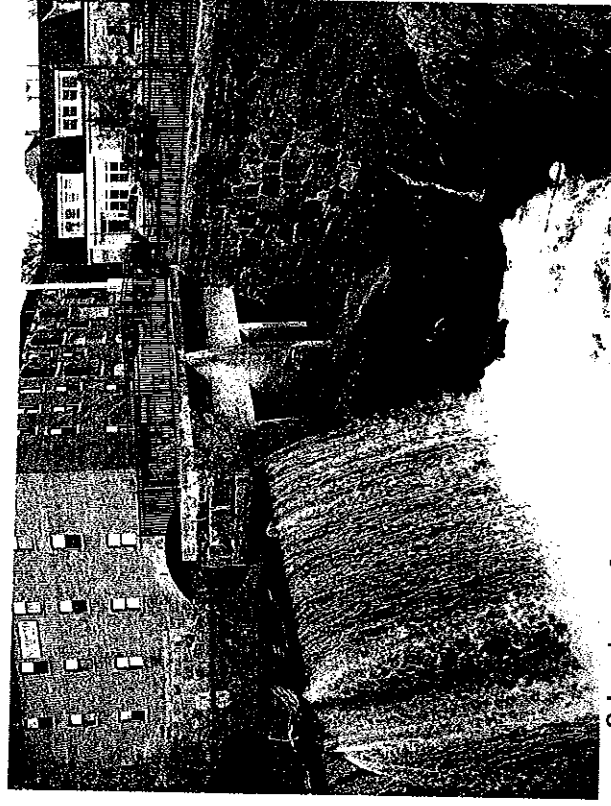
8. Leakage from left abutment wall, d/s of gate

4. Remove the brush growing from the stonework in the left abutment;
5. Investigate and repair, if necessary, leakage from left abutment wall, d/s of gate, Photo 8 – 9; and

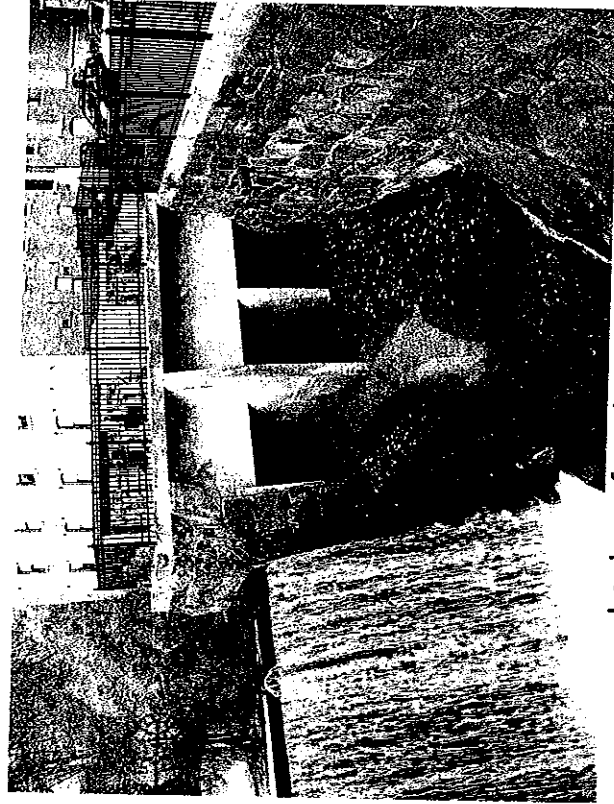
Leakage from low level gates
