FINAL REPORT - VOLUME 1

# Town of Newmarket

Facilities Master Plan

09.01.2023

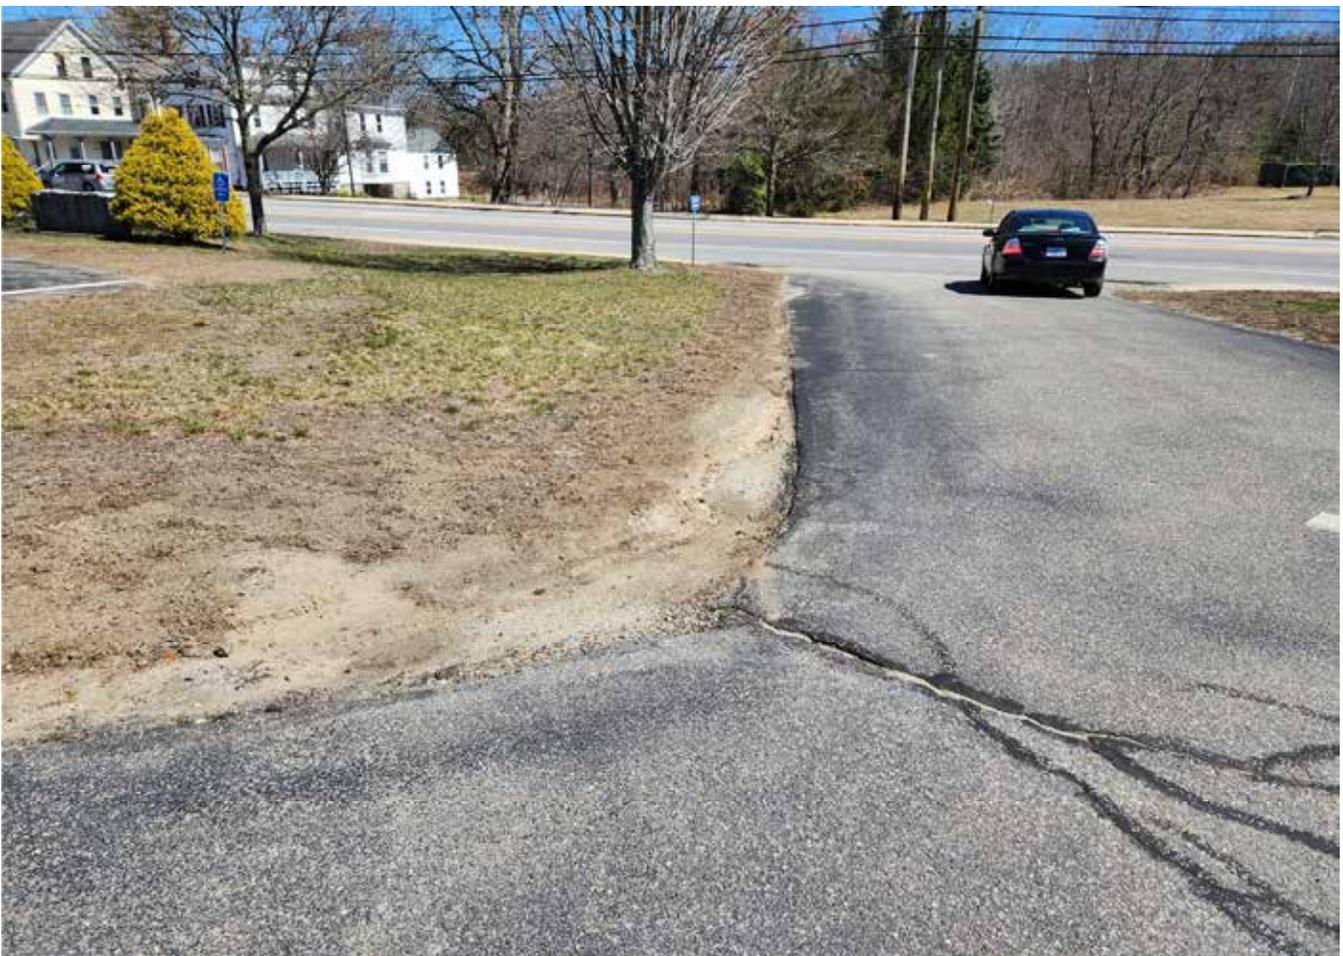
Erosion at the Main Street Driveway

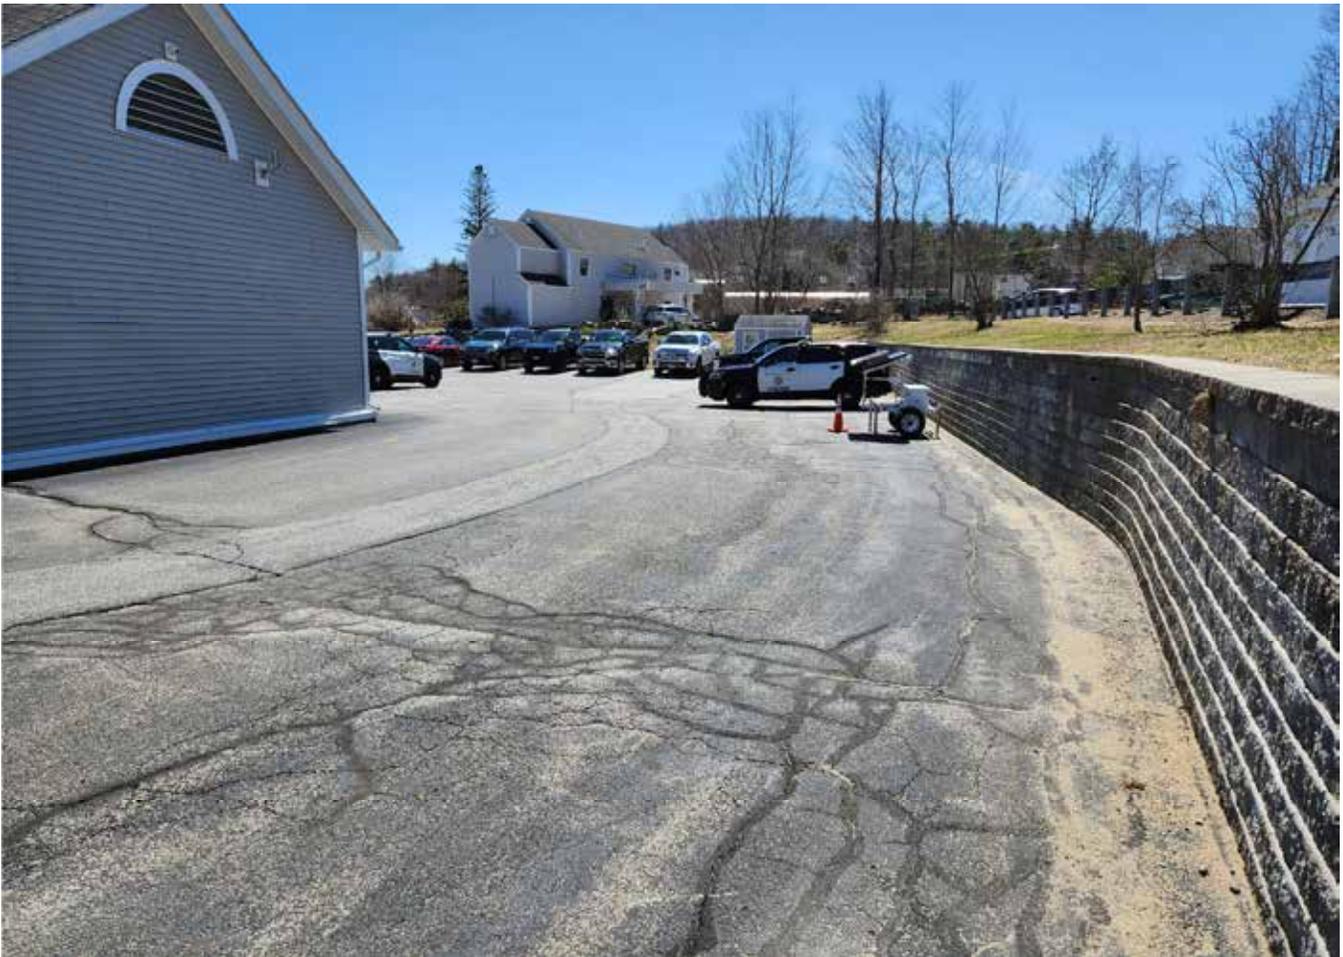
Erosion at the Main Street Driveway and Crack Pavement

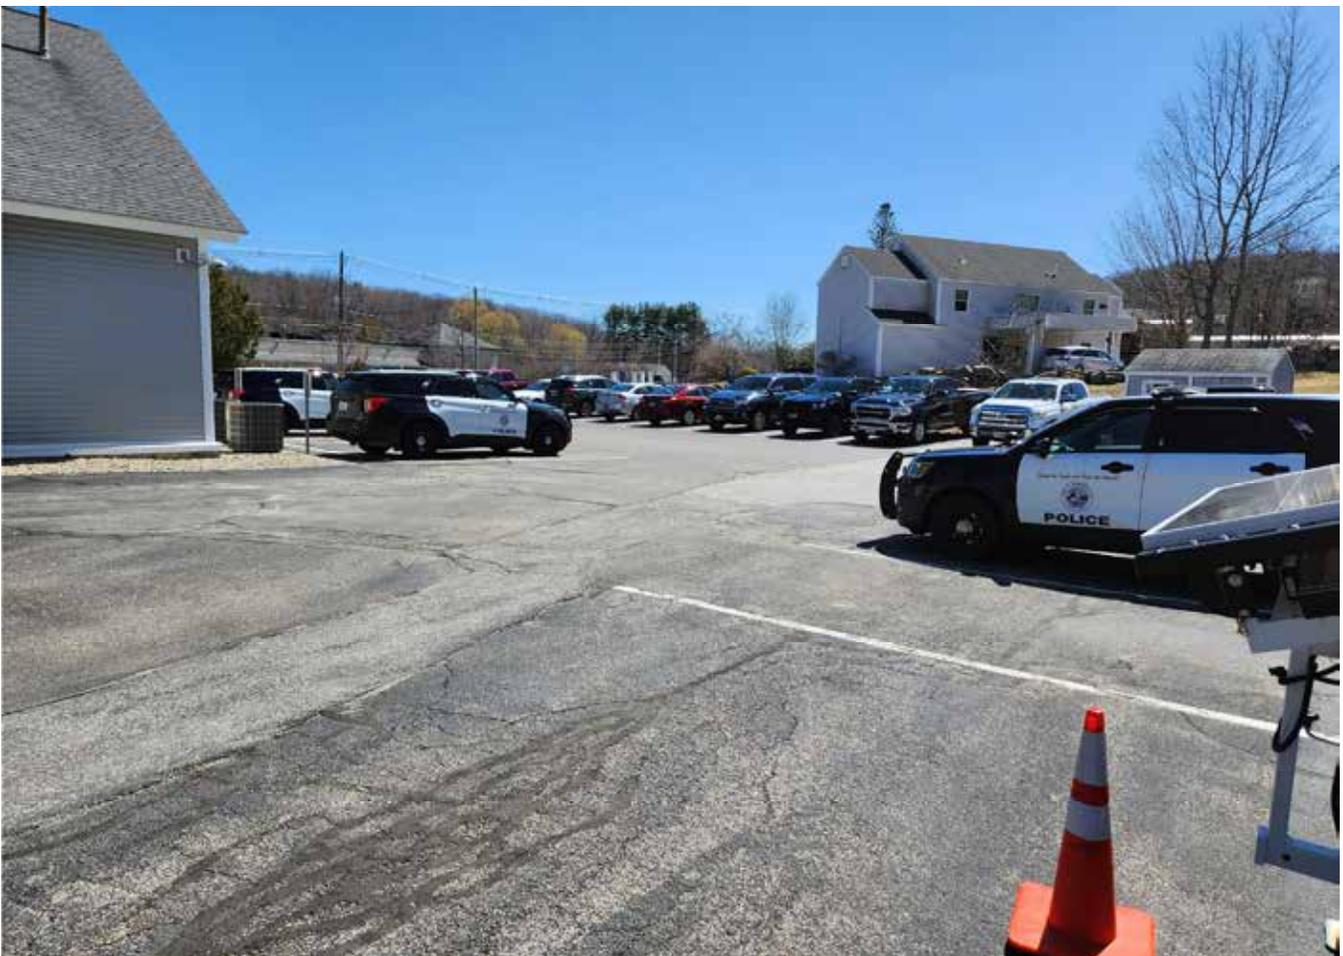
Failed Pavement-Pathed Pavement-Retaining Wall

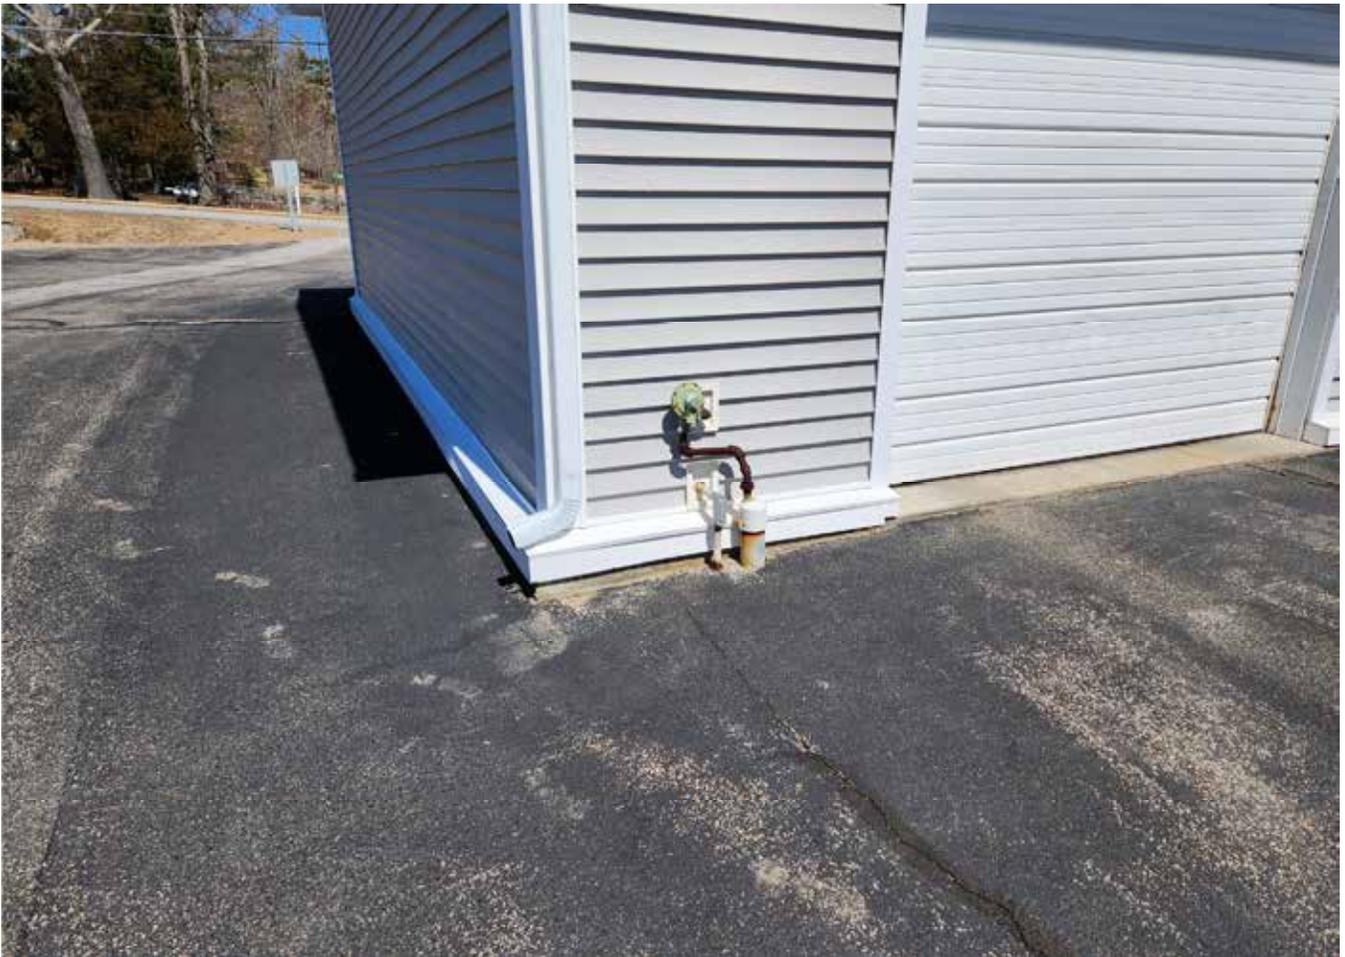
Failed and Patched Pavement

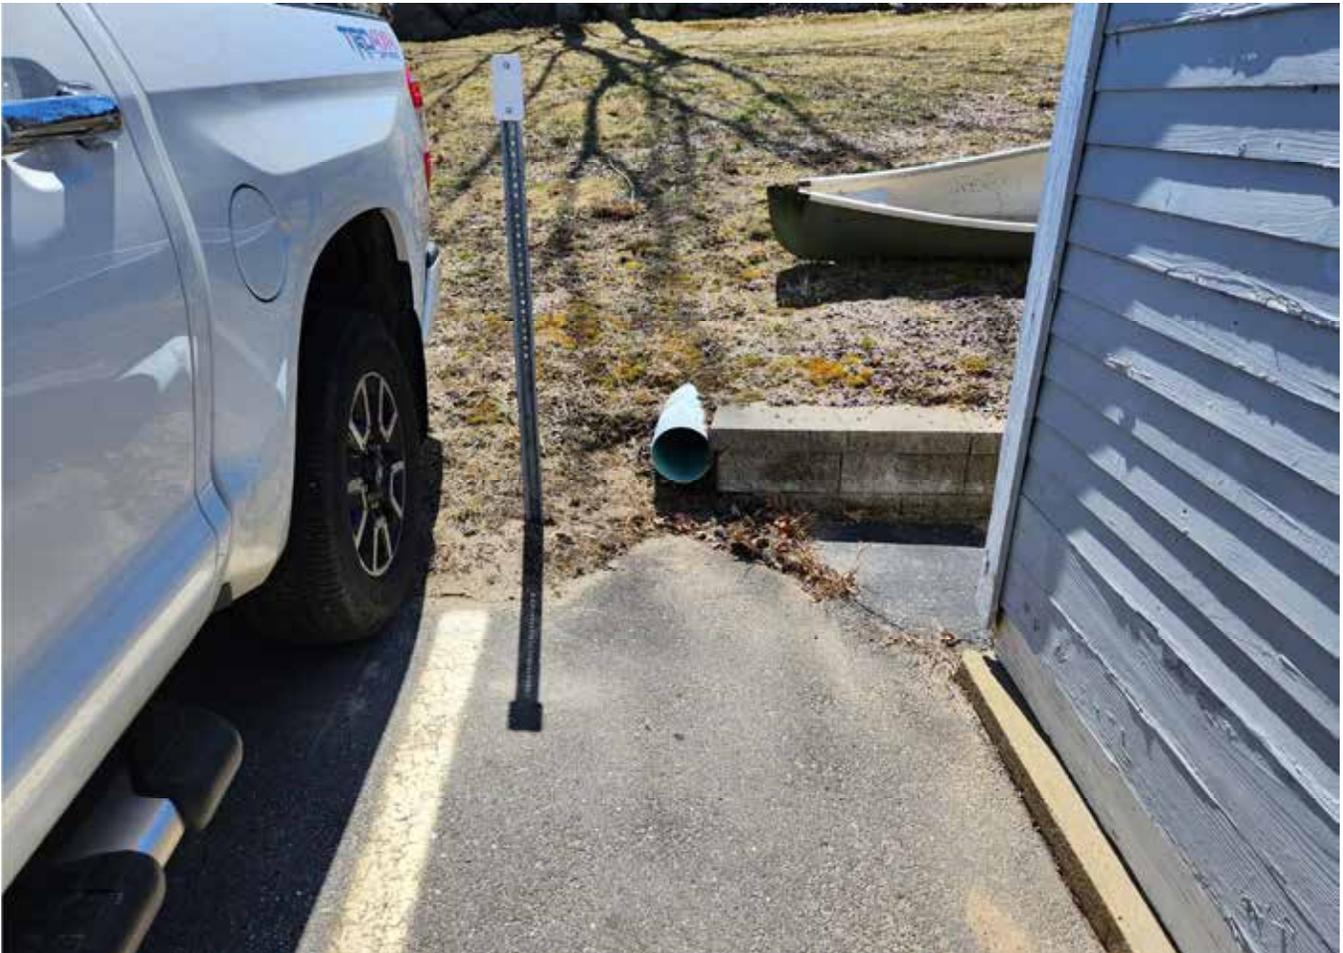
Failed Concrete Retaining Wall Block

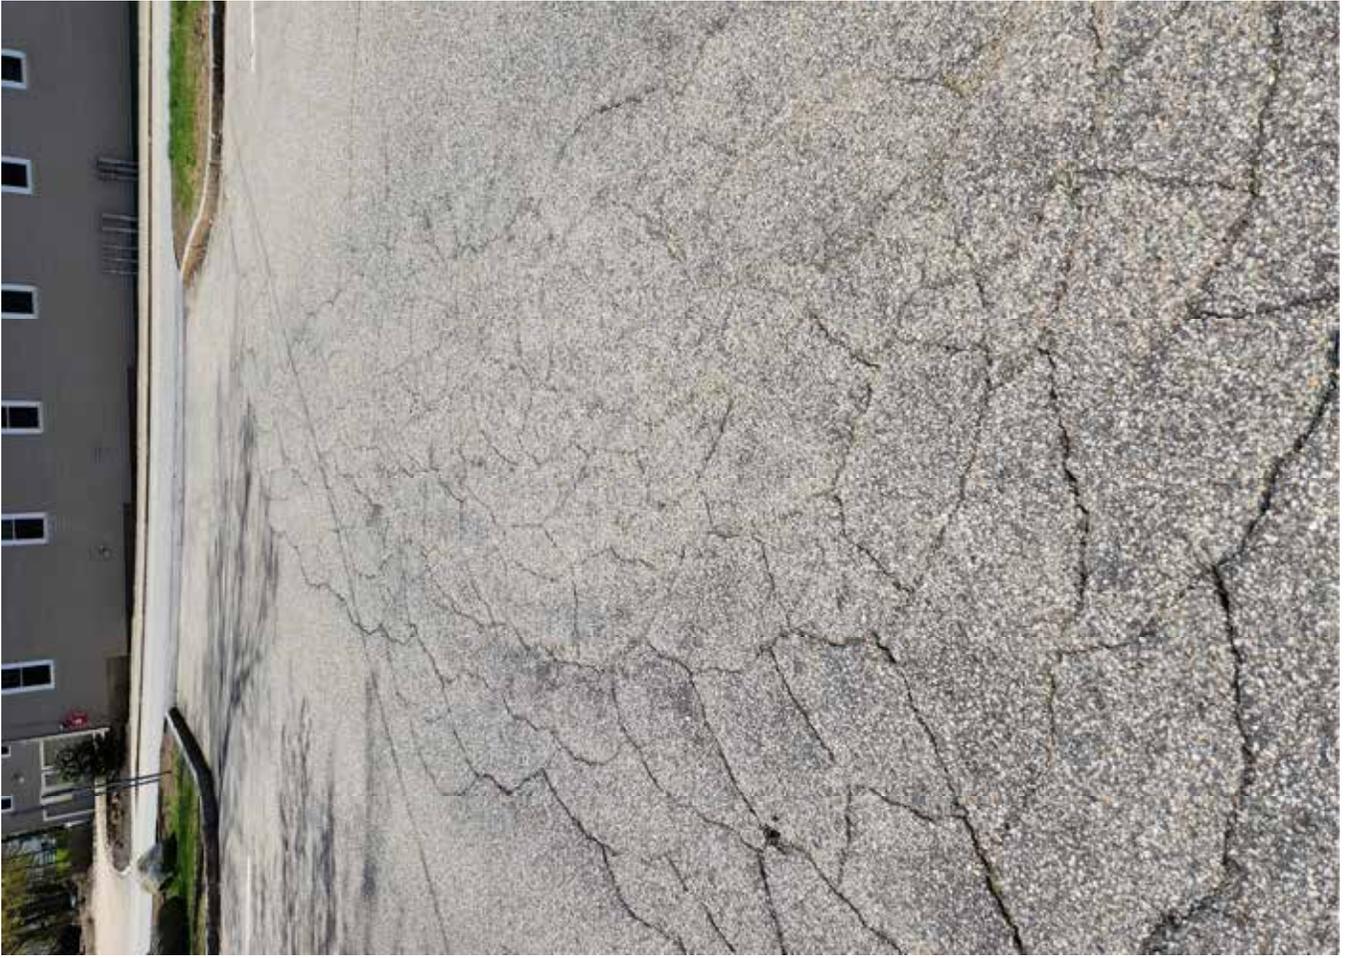
Failed Pavement

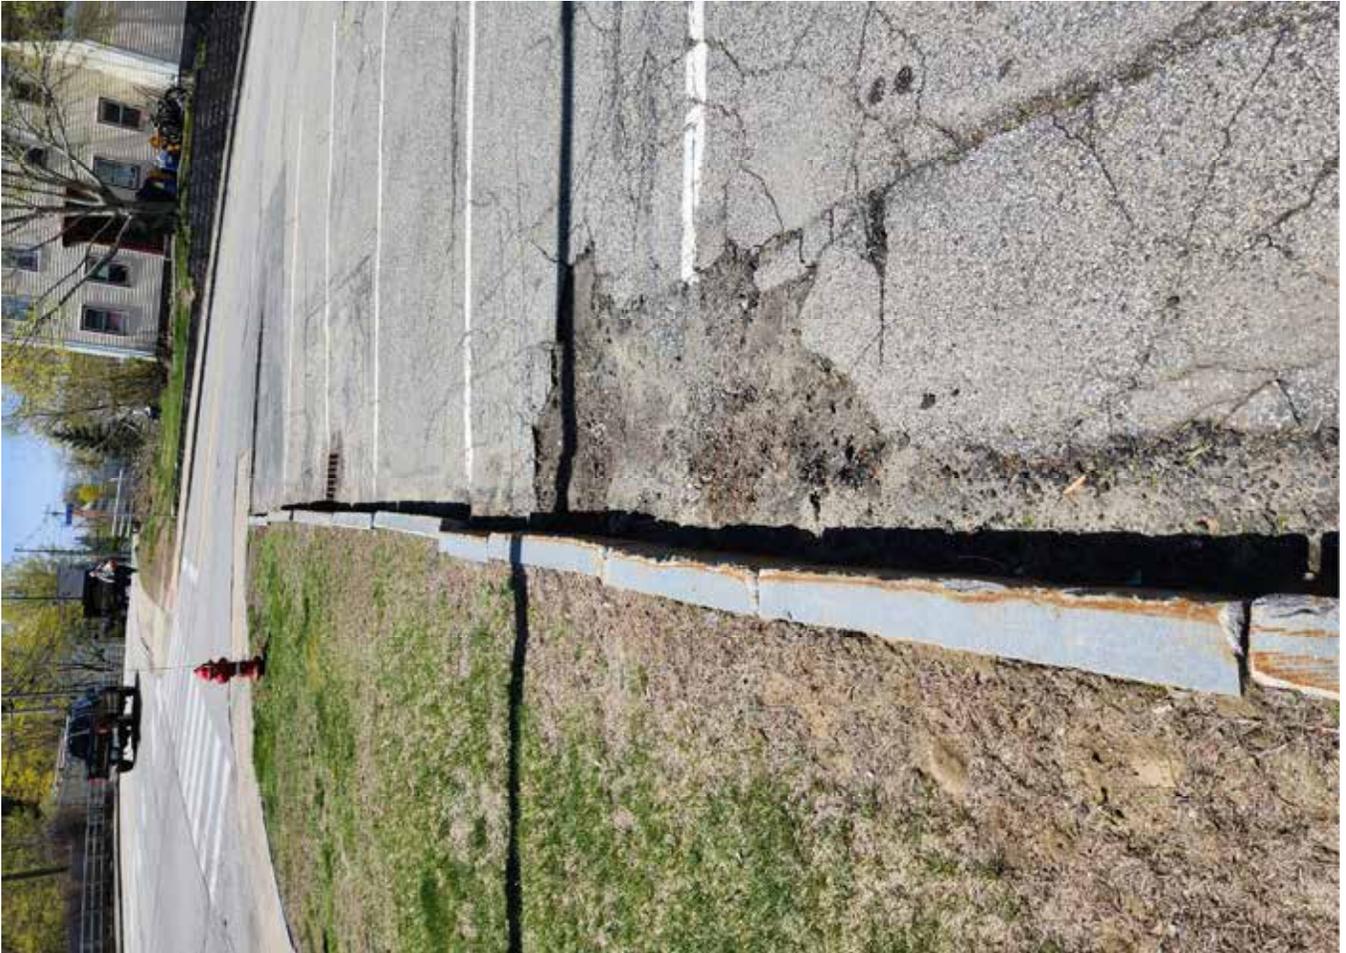
Loose Curb-Failed Pavement-Delaminated Pavement

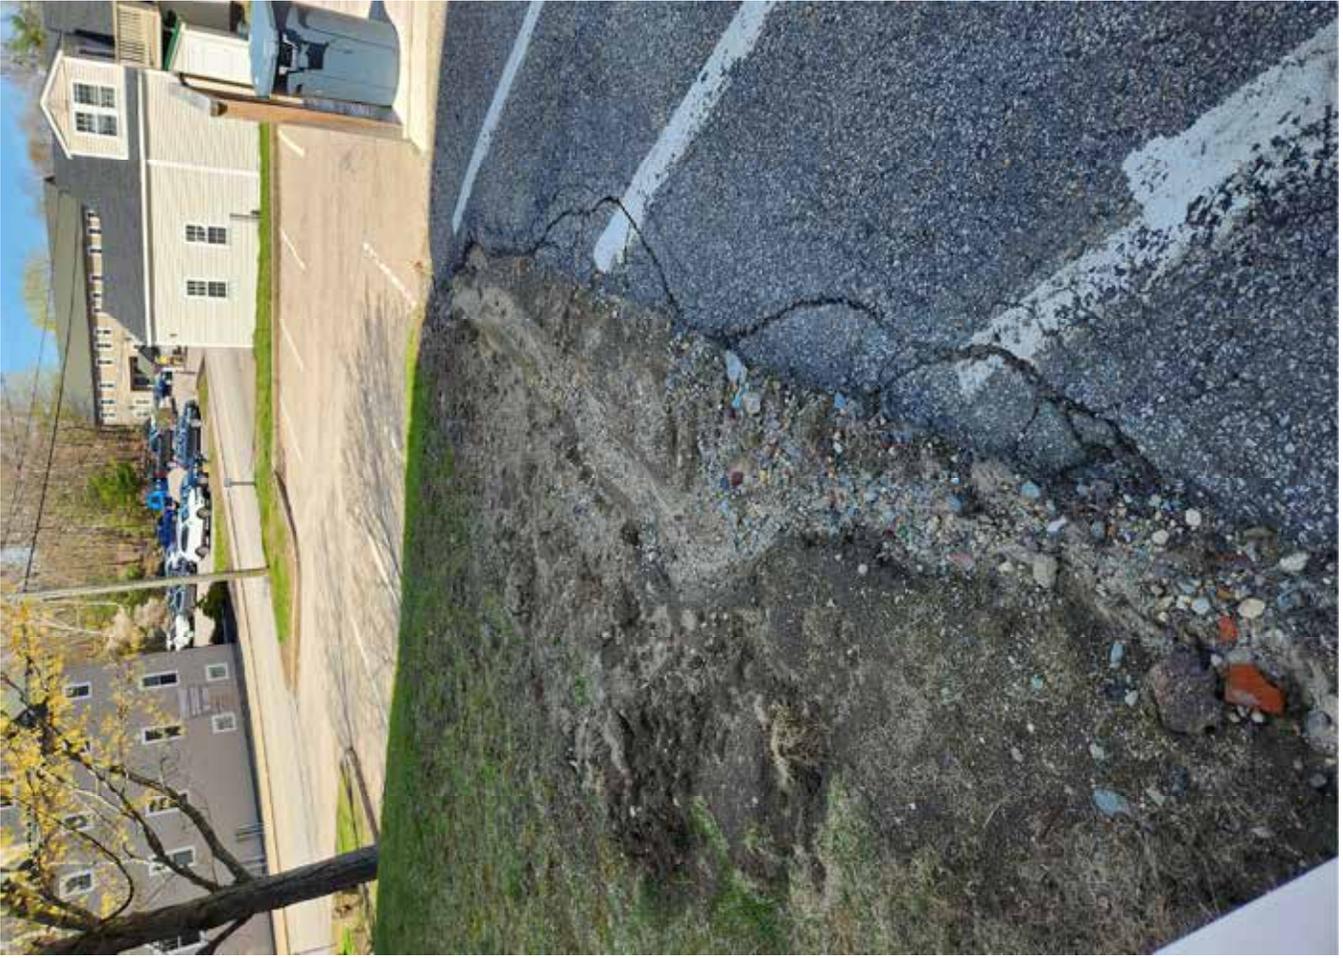
Erosion behind Town Hall

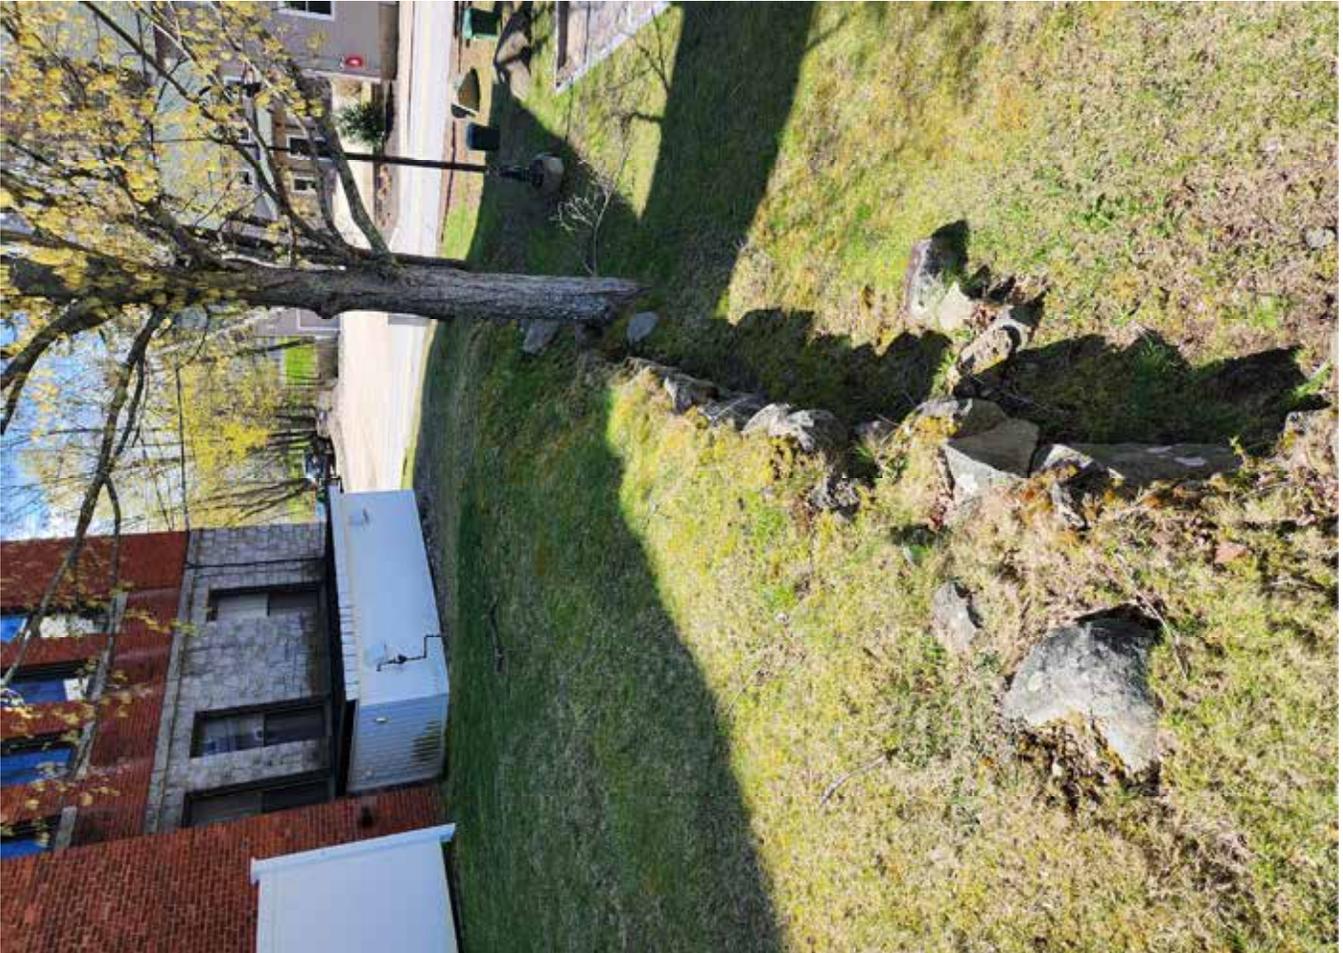
Failed Retaining Wall

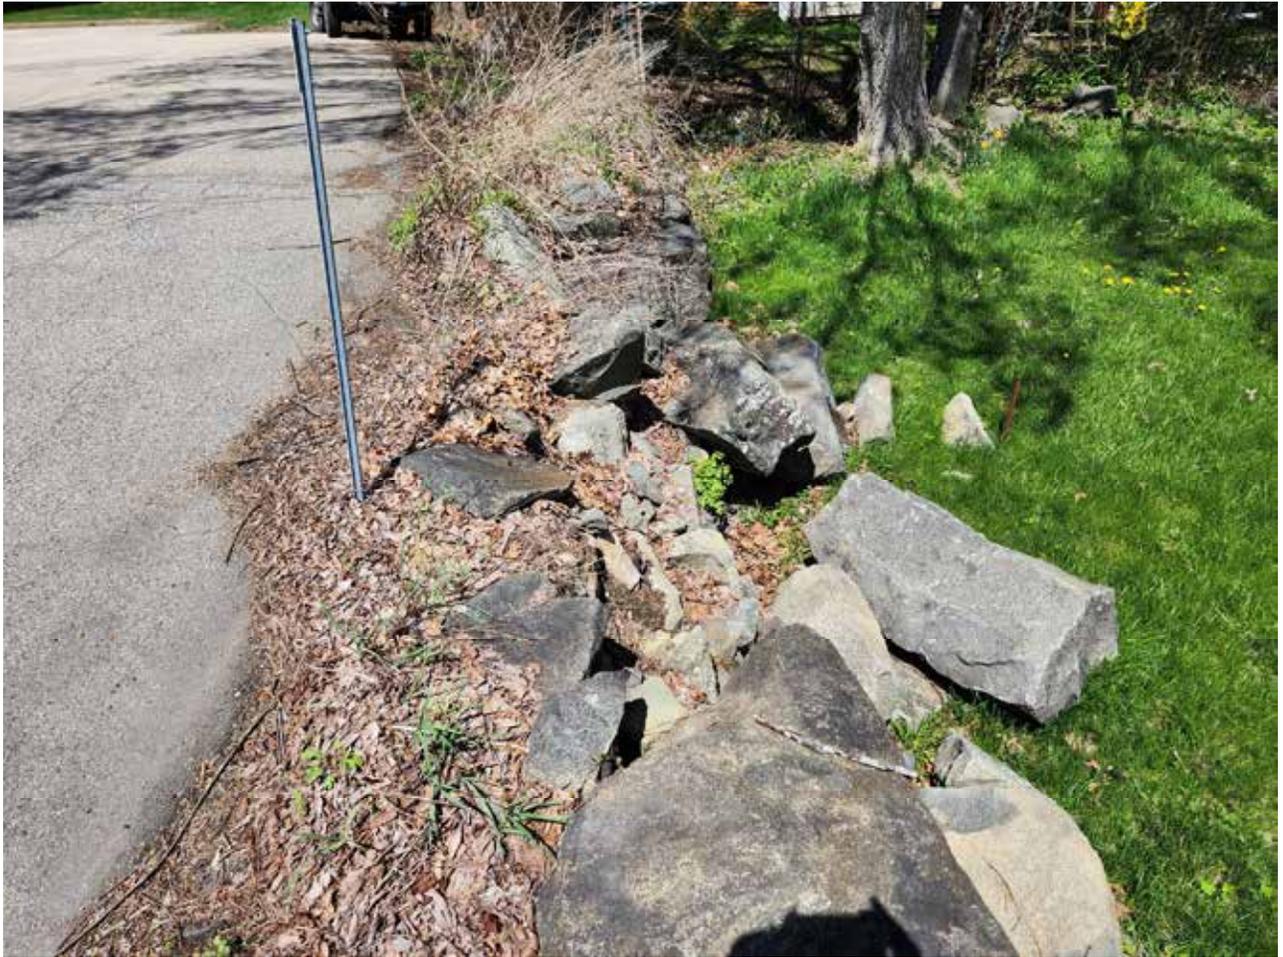
Failed Retaining Wall

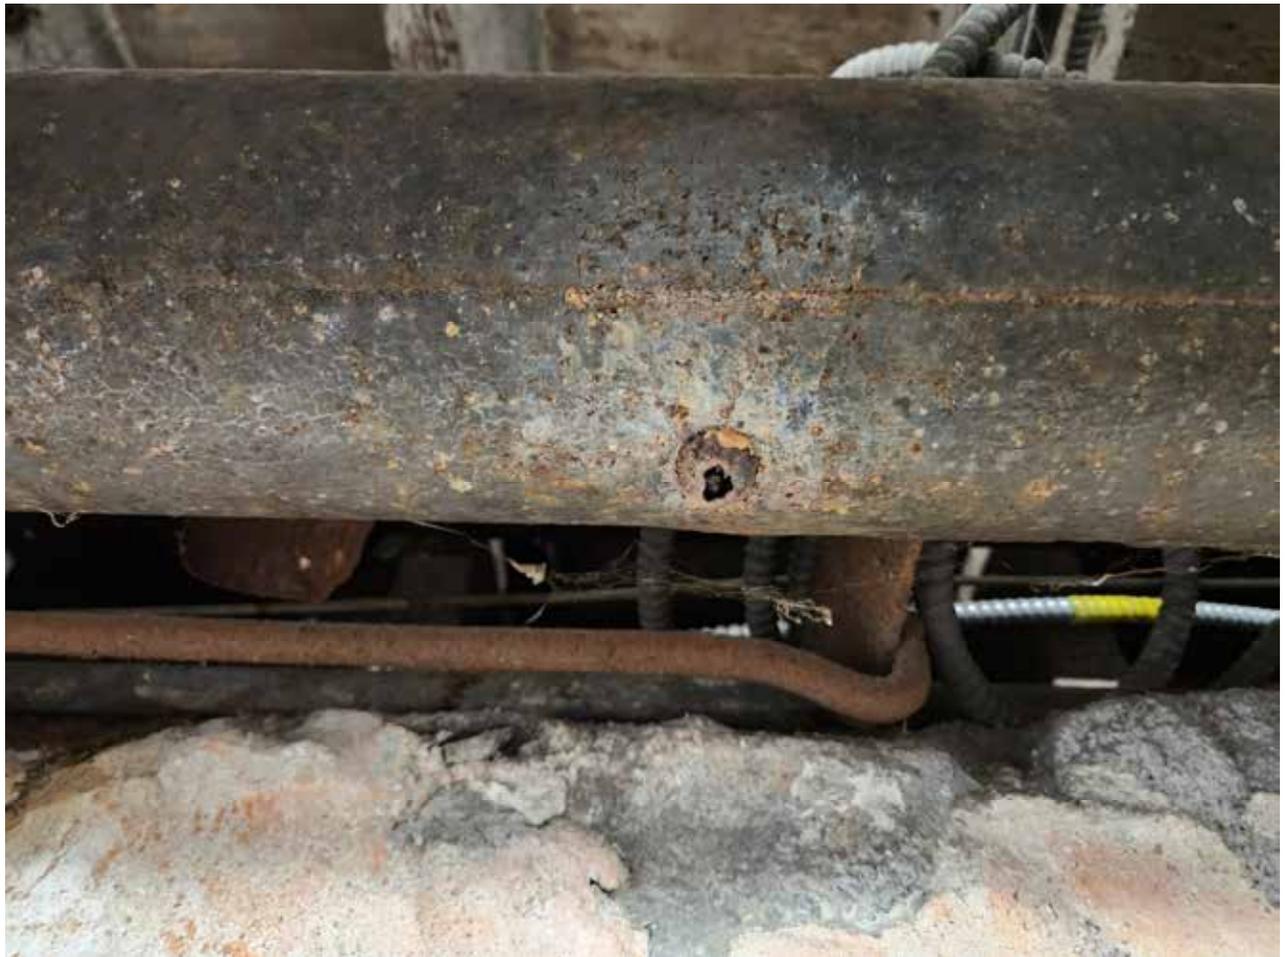
Rusted Sewer Pipe

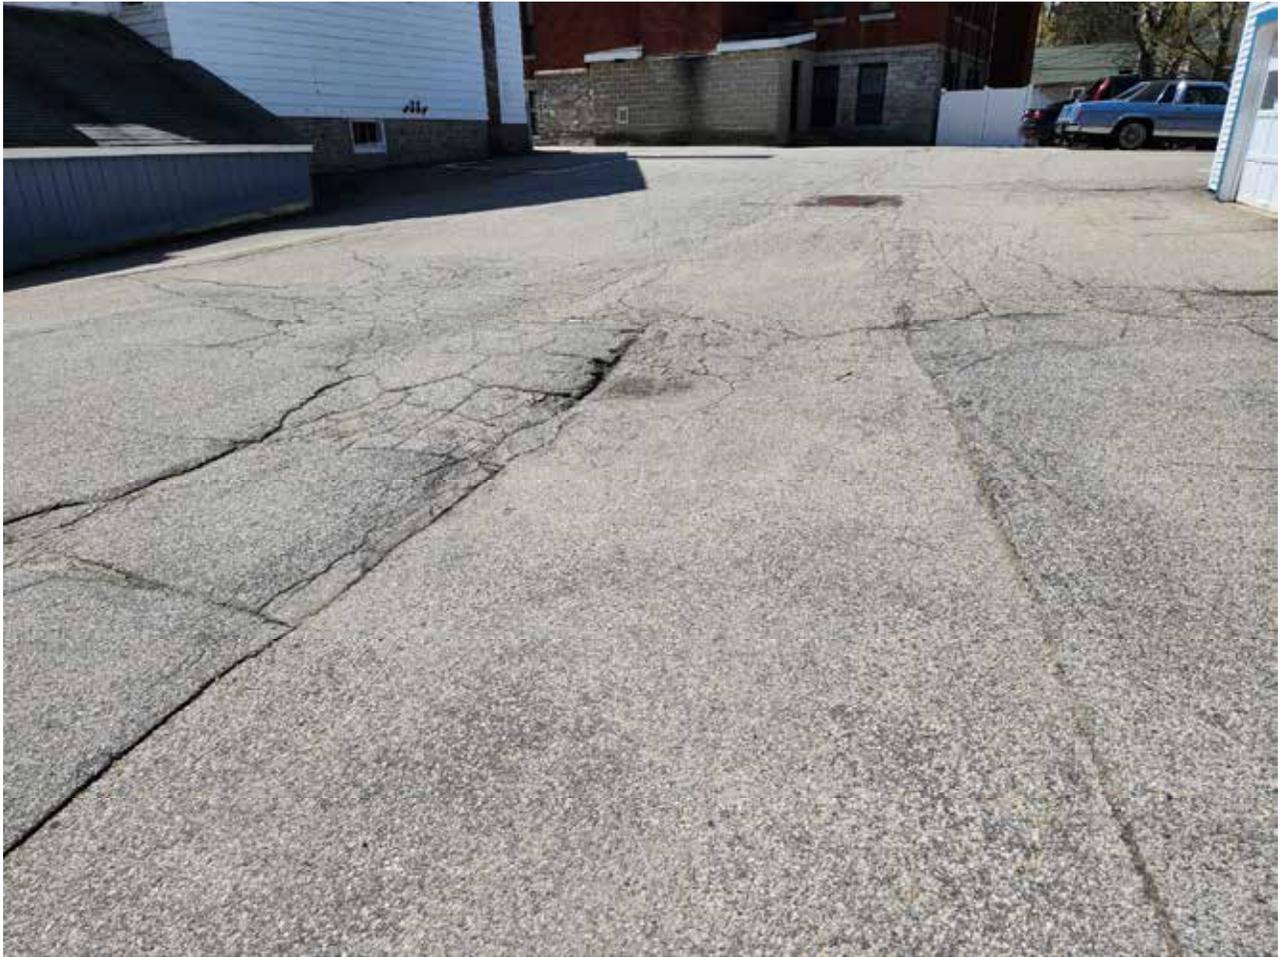
Failed Pavement Behind Church

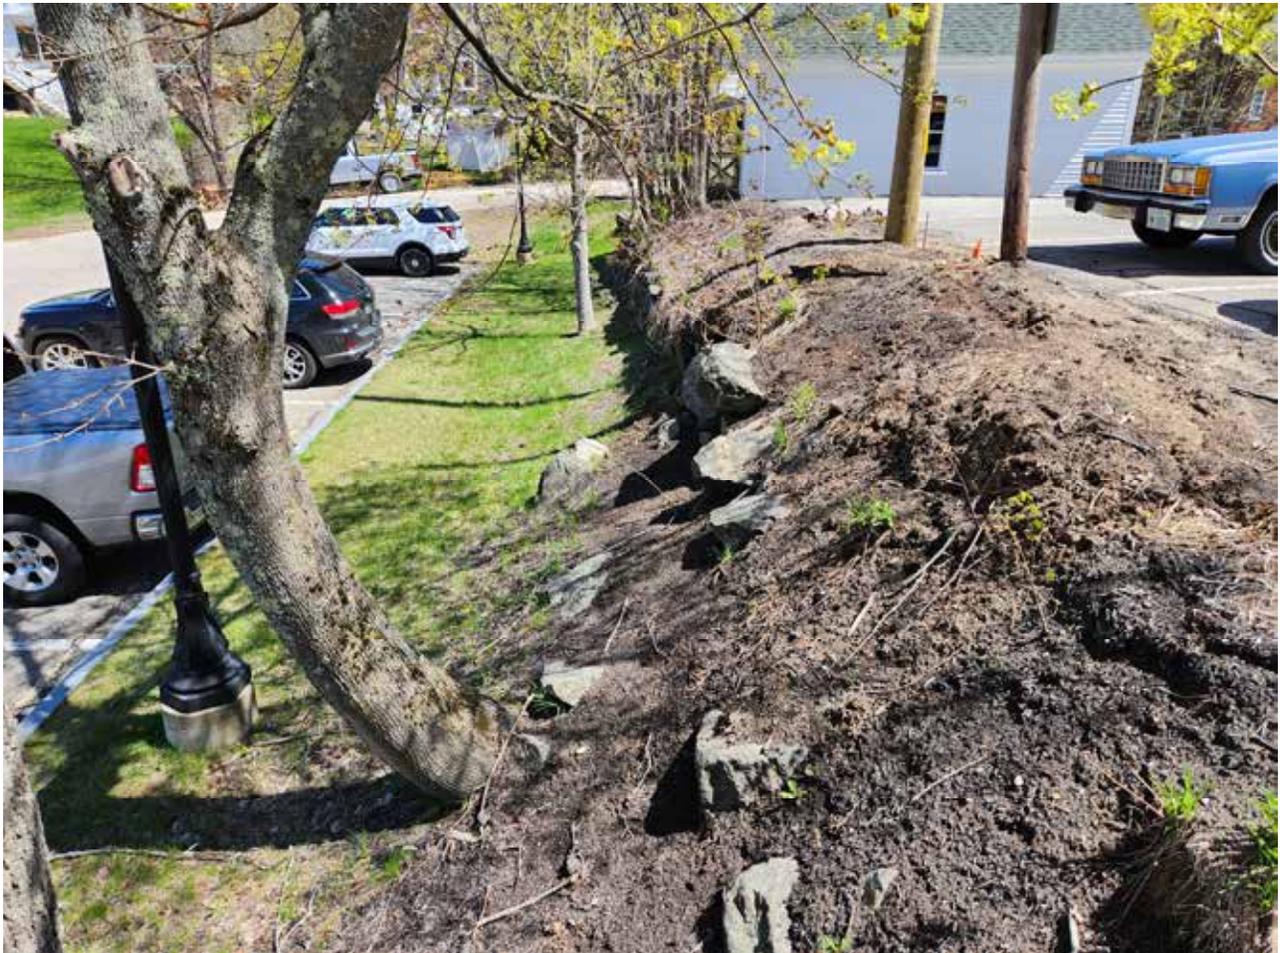
Failed Retaining Wall Behind Town Hall

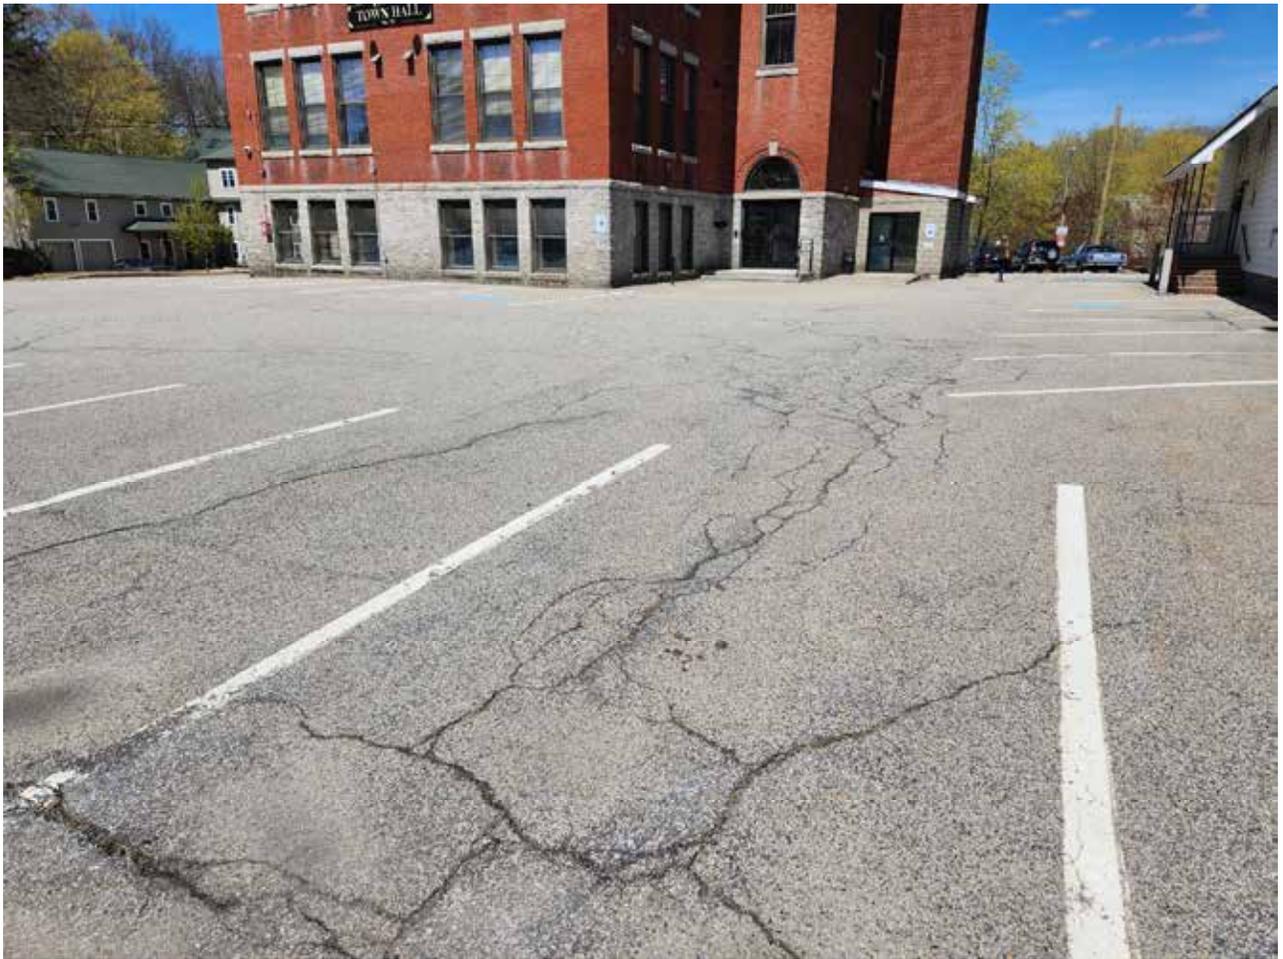
Failed Pavement

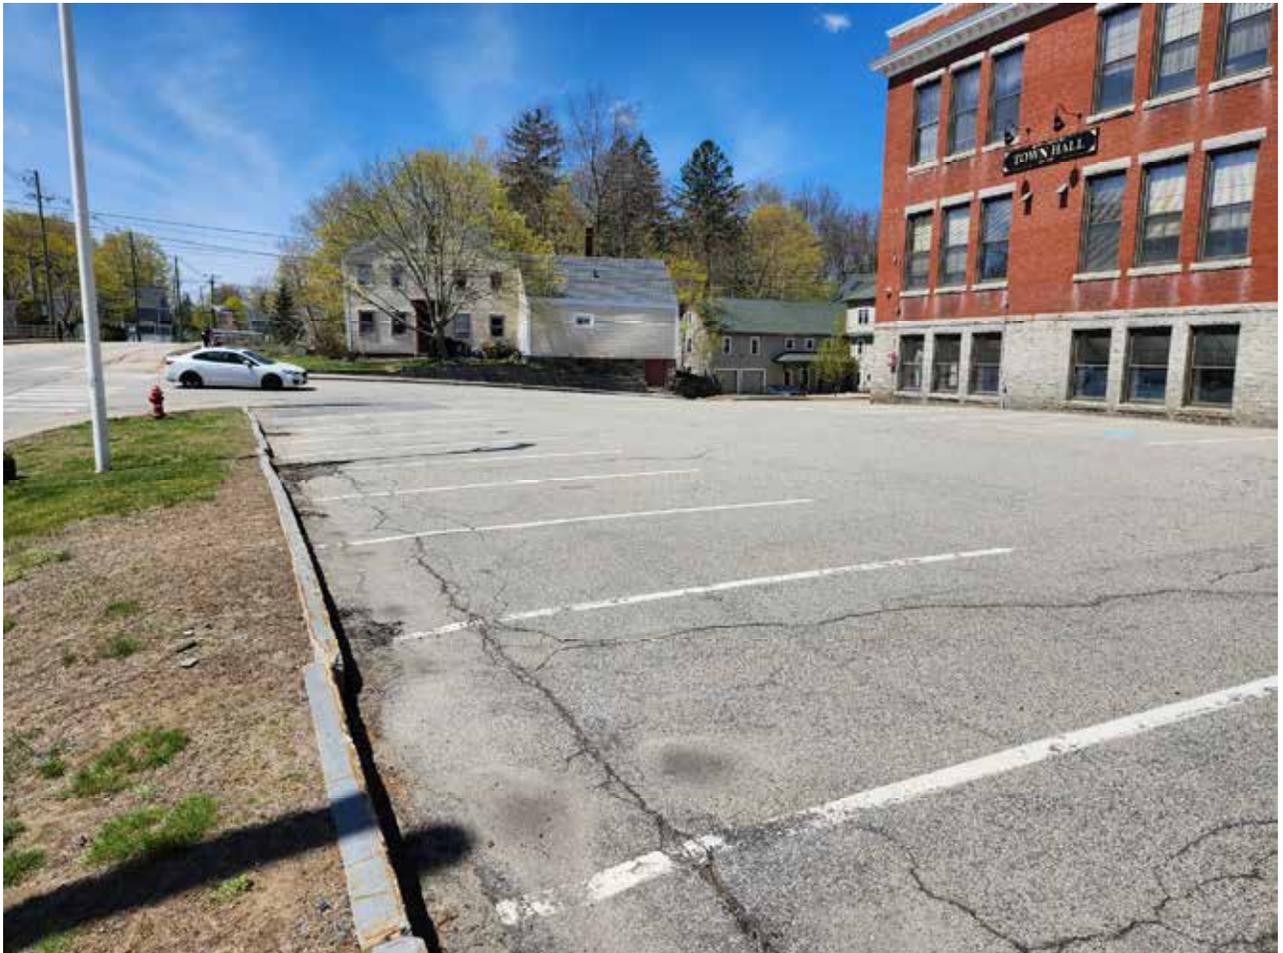
Loose Curb and Failed Pavement

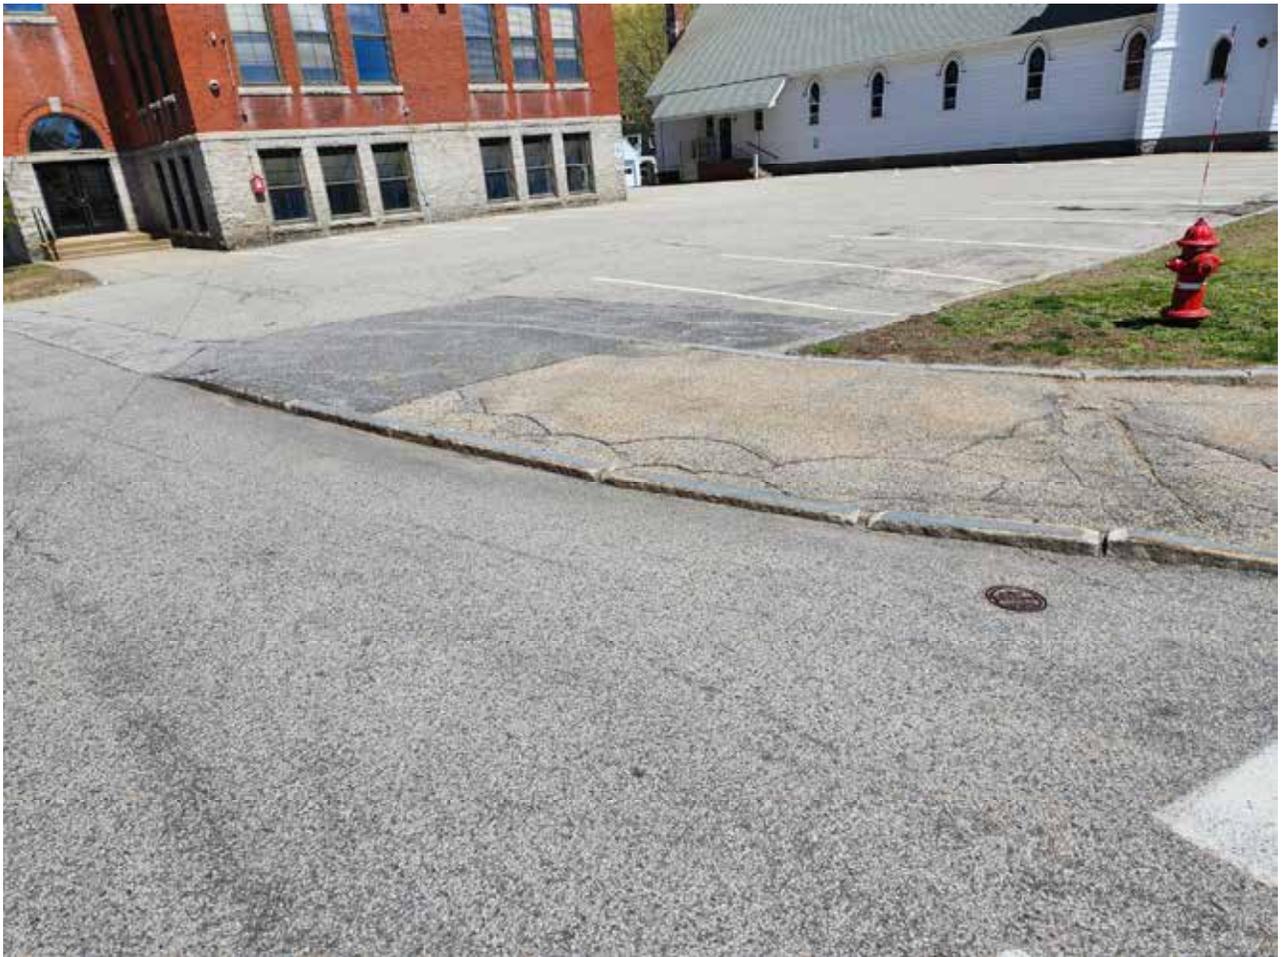
No Curb Protection for Pedestrians

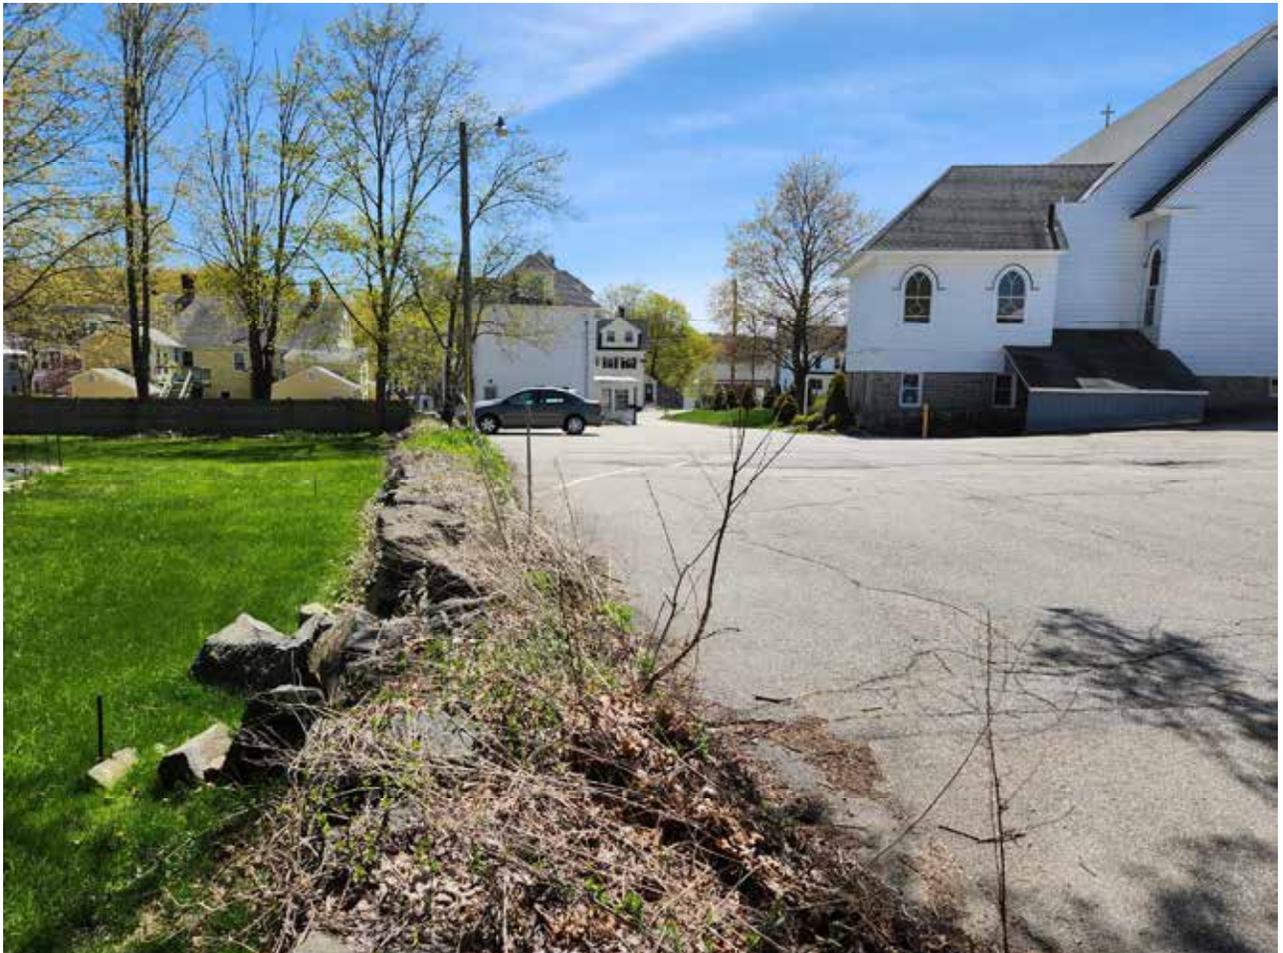
Failed Retaining Wall

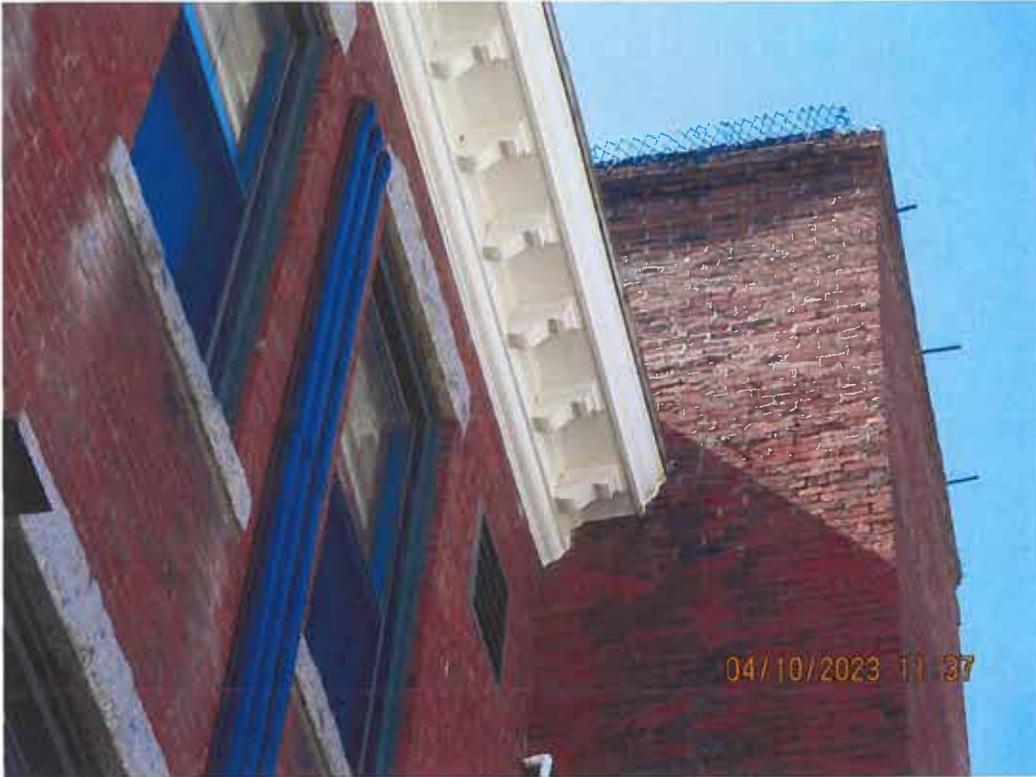
**Chimney top suspect to deterioration**

The existing brick chimney is showing signs of deterioration above the roof level, including staining and deterioration of clay masonry units, and excessive weathering of mortar joints. The chimney is screened at the top to prevent animal ingress, but rain and snow freely enter, which may be partially causing deterioration at the top and (likely) the bottom. Recommend masonry repairs above the roof level and capping the chimney with a cap suitable to prevent bulk water from entering.

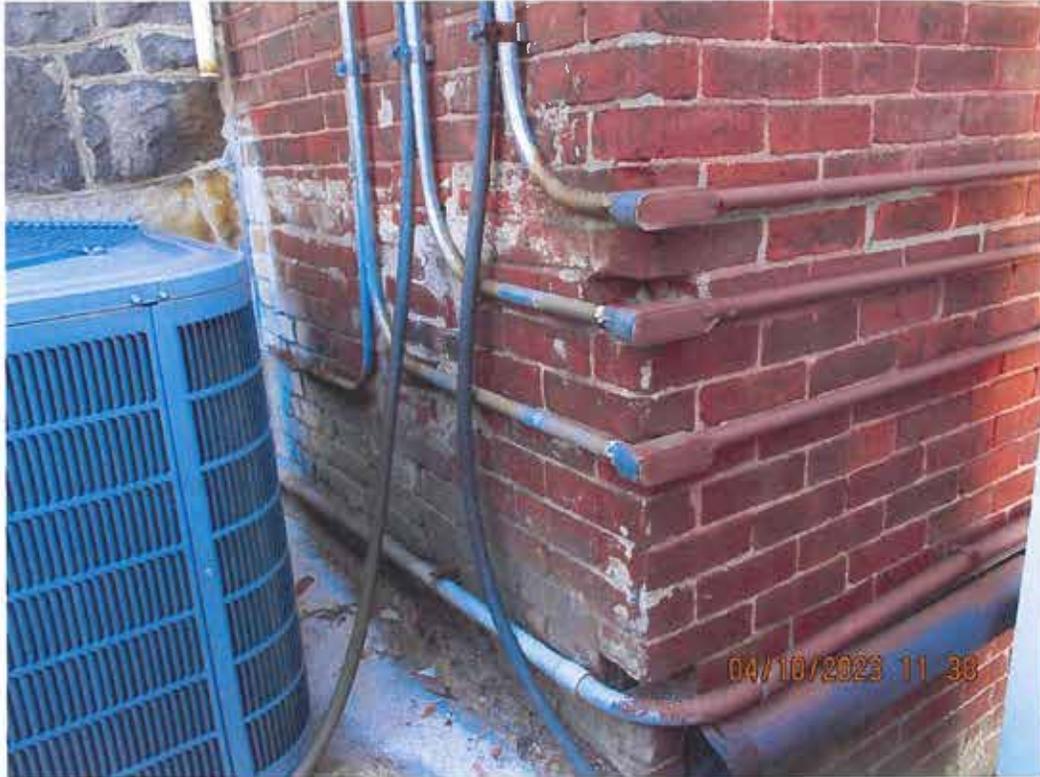
**Chimney base in good condition except where brick was chiseled out for conduit bends**
