FINAL REPORT - VOLUME 1

# Town of Newmarket

Facilities Master Plan

09.01.2023

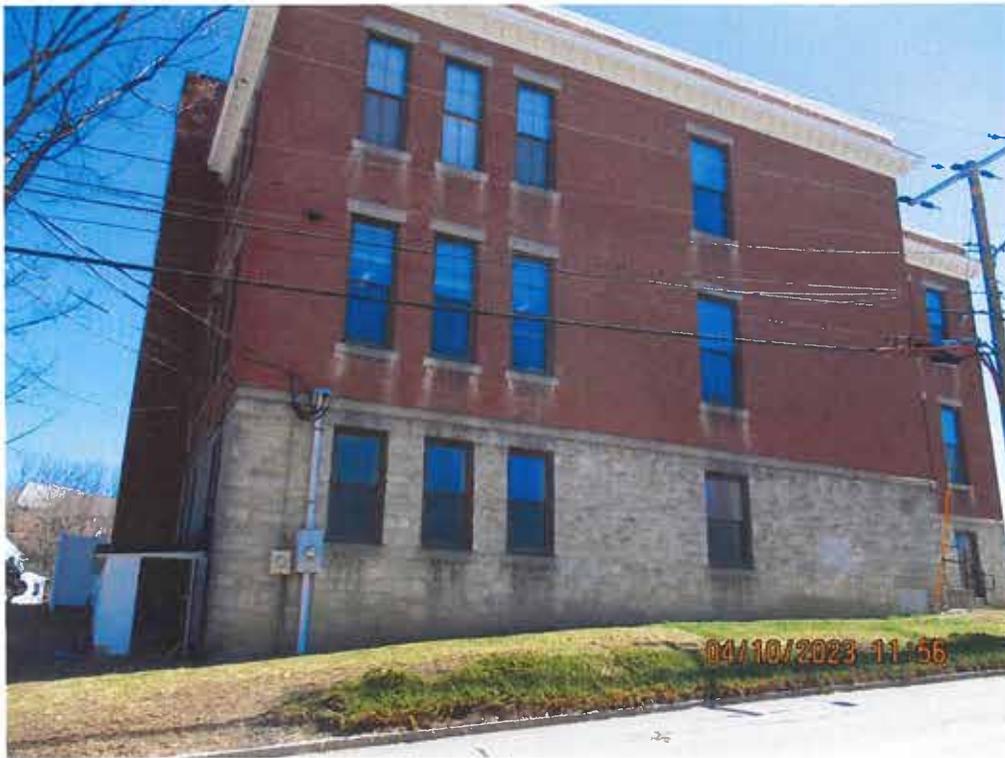
**White stain on brick is paint from previous windows**

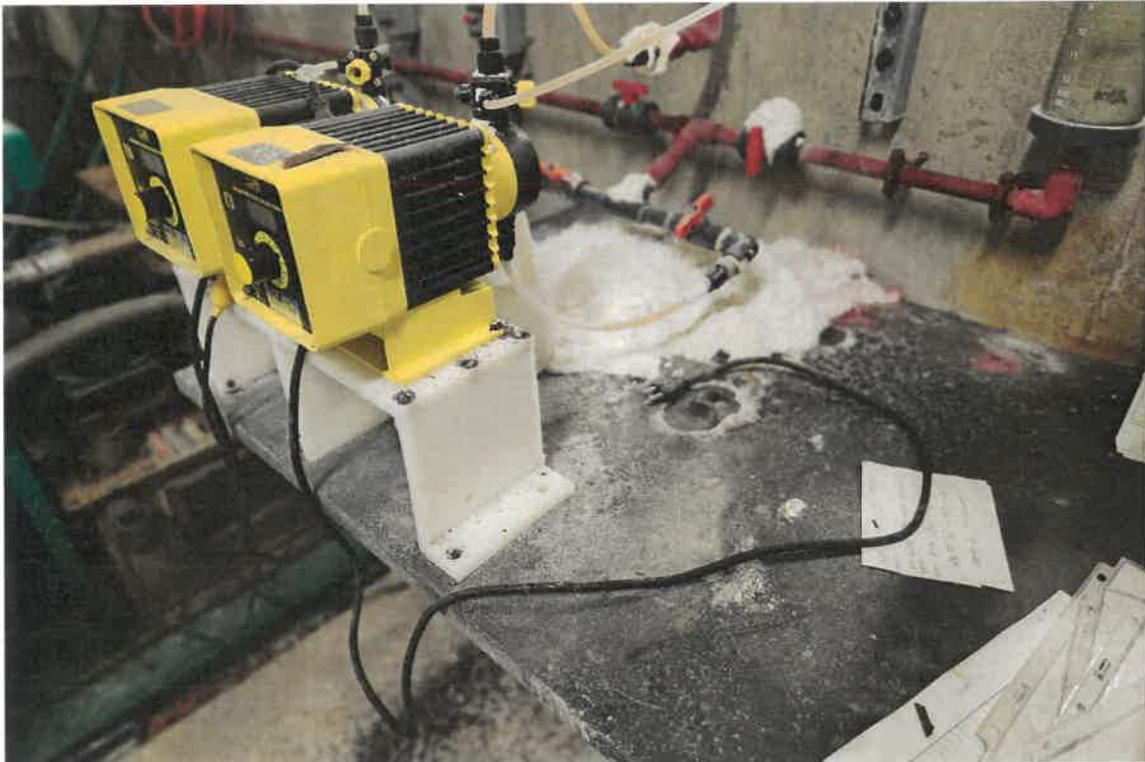
Pump and pipes in the chemical storage area and corrosion from the piping/fittings.

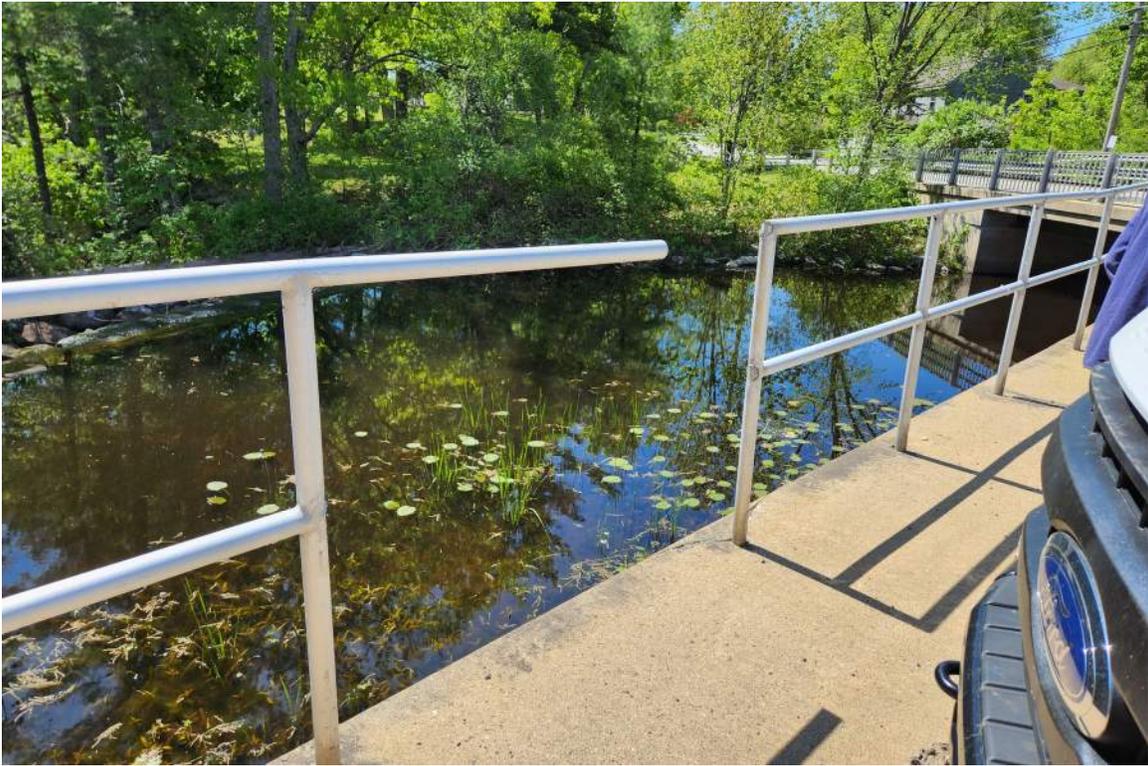
Handrail is missing and there is no car guardrail.

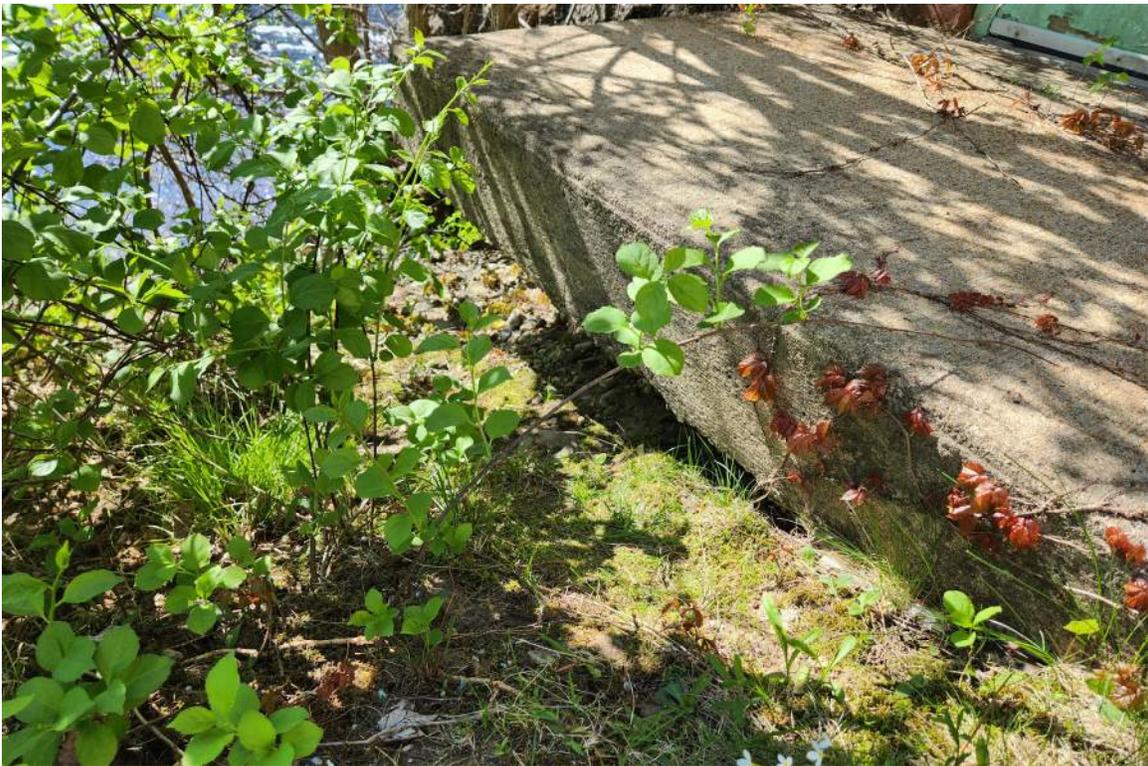
Erosion under slab out the rear of the building.

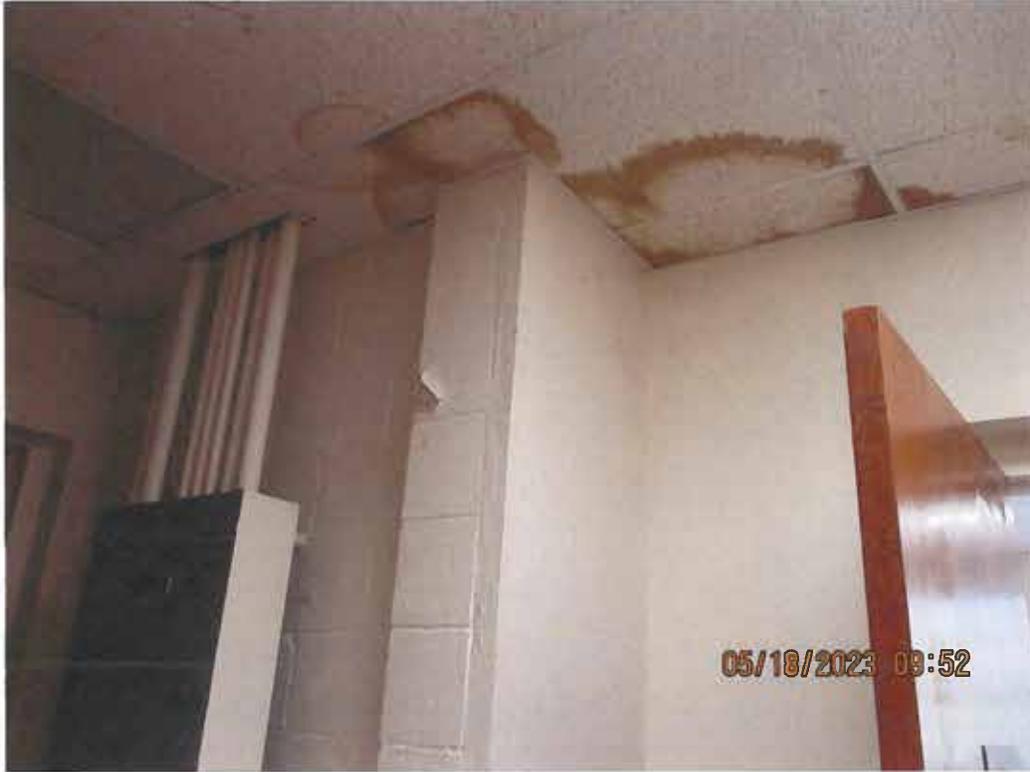
First floor lobby – water damage, old meet new

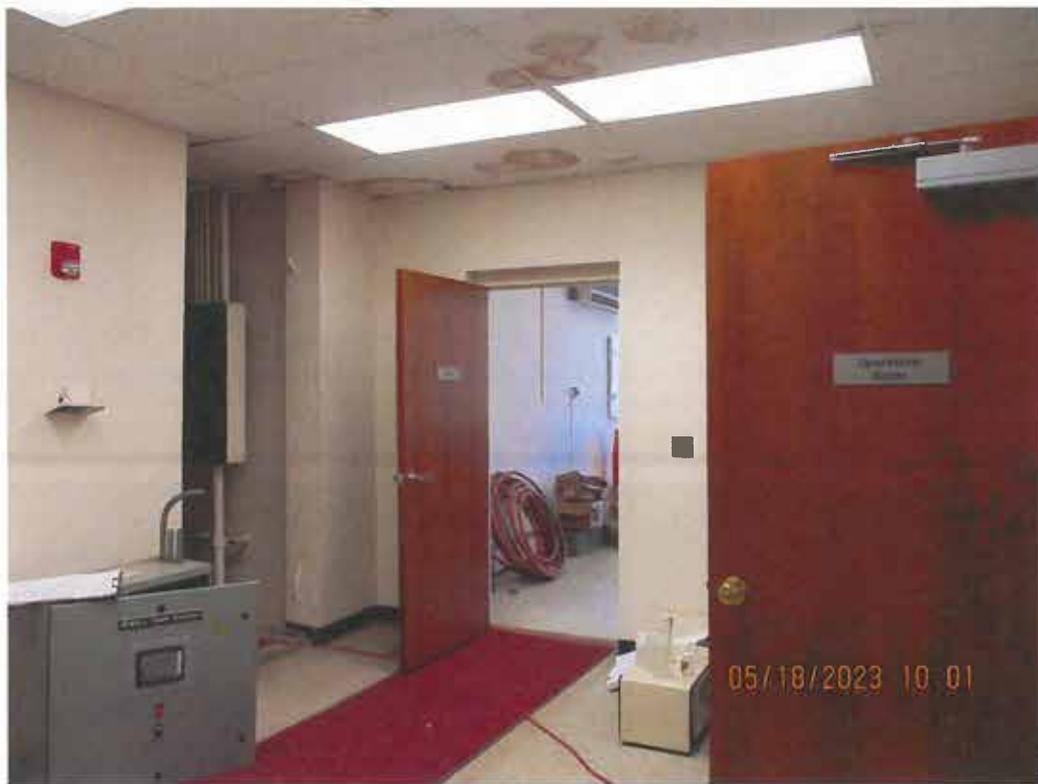
**Water damage where 1894 meets 1990**

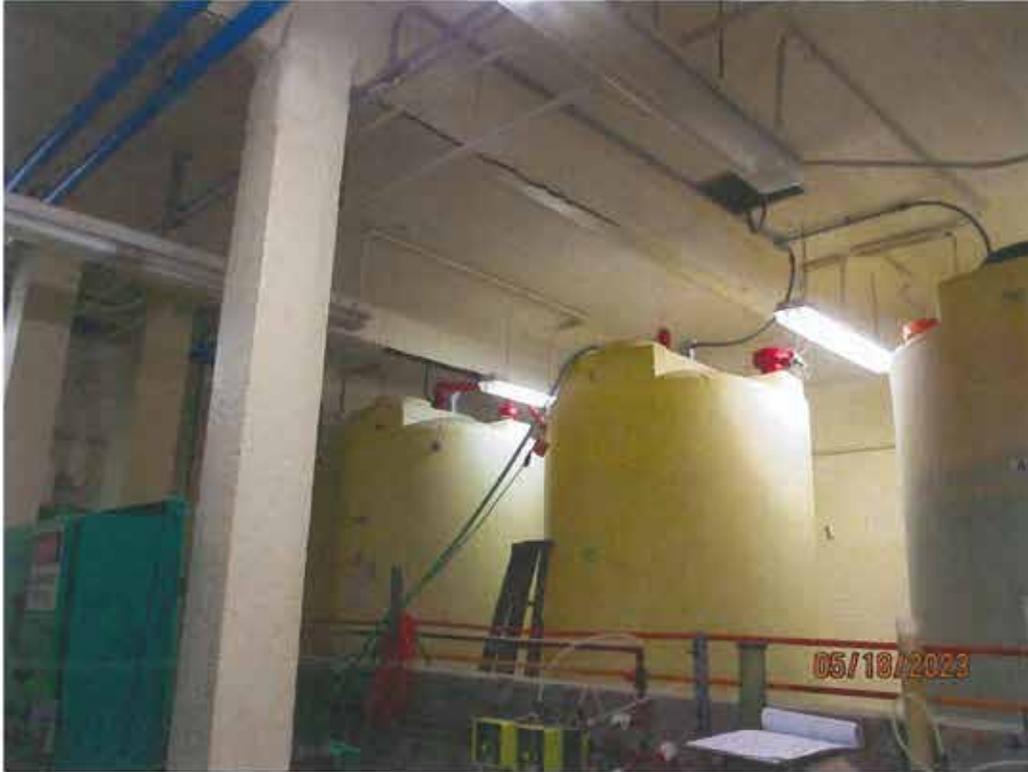
**Chemical storage room, steel corrosion causing coating to fail**

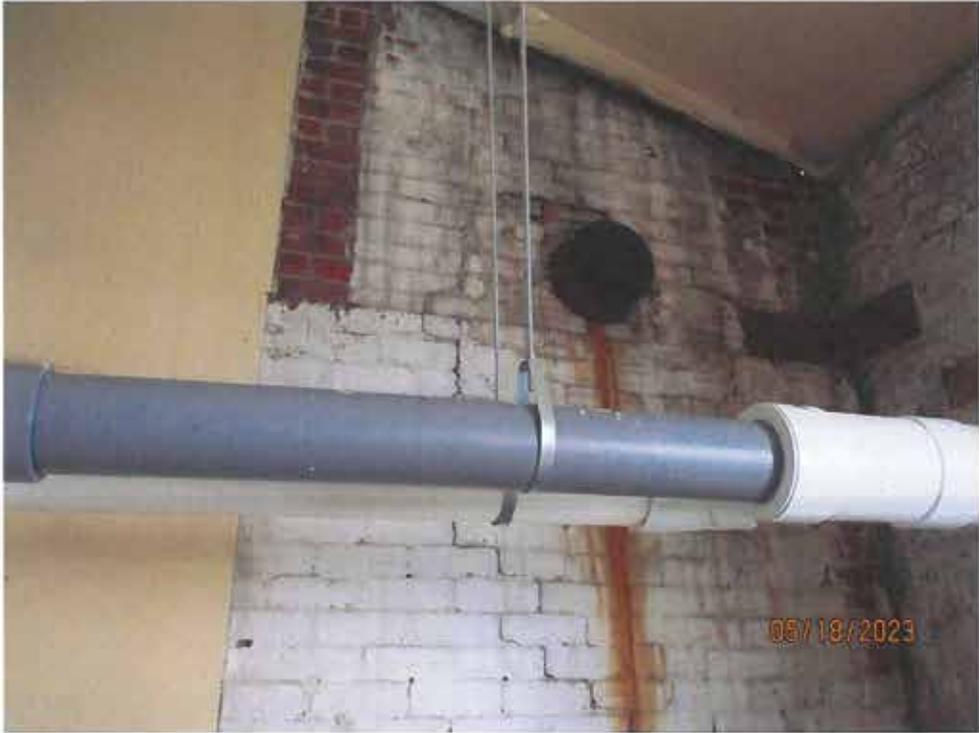
**Masonry cracks near chimney base due to settlement or wind**

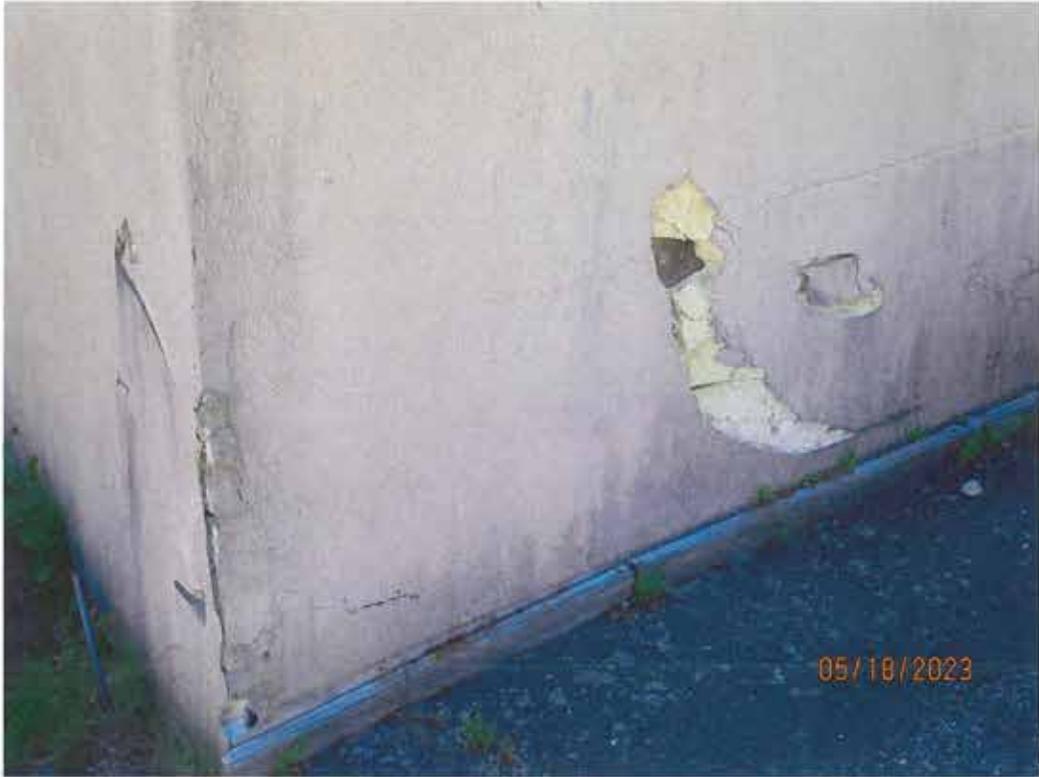
Damage to EIFS in the form of punctures, cracks, wear, & tear
