**Macallen Dam Abutments and Outlet Structure Rehabilitation Project**  
**Newmarket, NH**  
**ADDENDUM NO. 2**

Re: **Addendum No. 2**

Date: April 5, 2019

# Dam Inspection Form

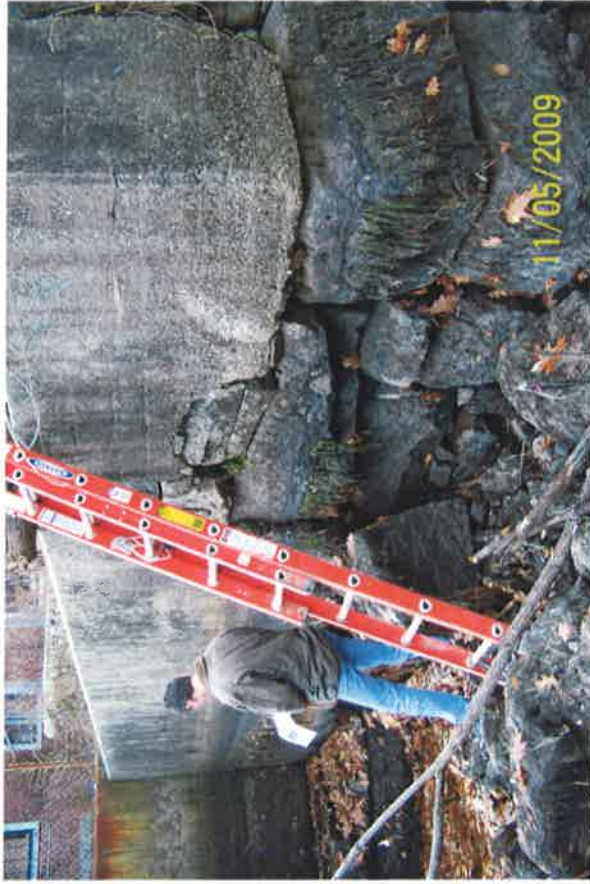
Photo A, Crack behind ladder

1. Seepage from downstream left side stone training wall, located at base of gate structure apron.
2. Concrete cracks and spalling on
  - a. Upstream right side training wall vertical crack. See photo A.
  - b. Downstream right side of gate structure housing. See photo B.
  - c. Concrete piers on the upstream face of the of the gate structure housing. See photo C.

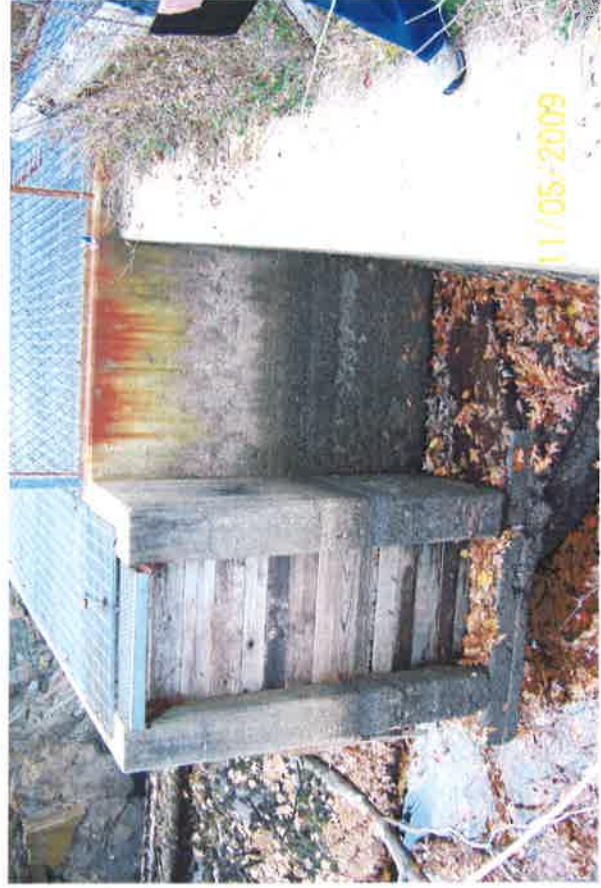
Photo K, Fishladder upstream slab

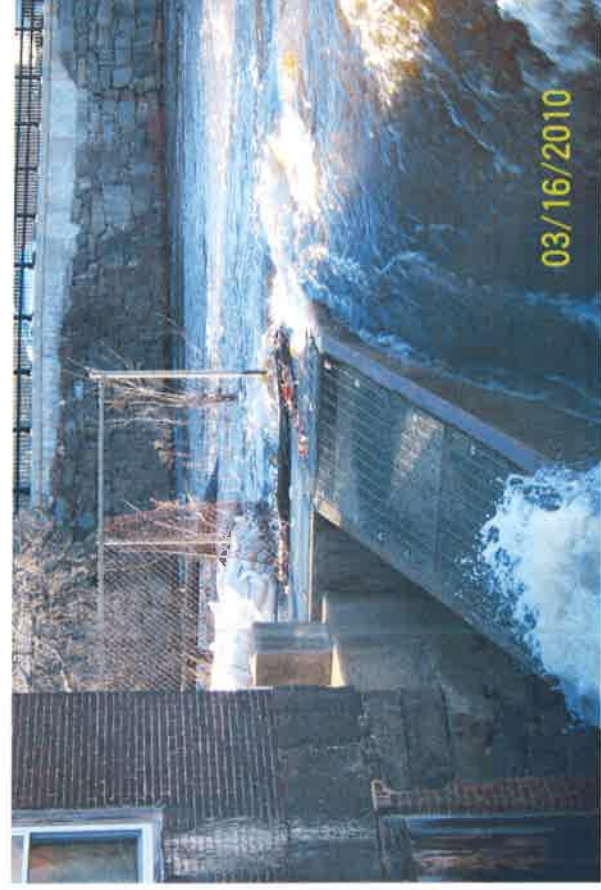
Photo L, Taken March 2010
