Figure G-1: Macallen Dam during the May 2006 flood, provided by NHDES. Photograph taken morning of May 16, 2006. Photograph used to estimate WSE at Macallen Dam and on downstream side of Veteran's Bridge.

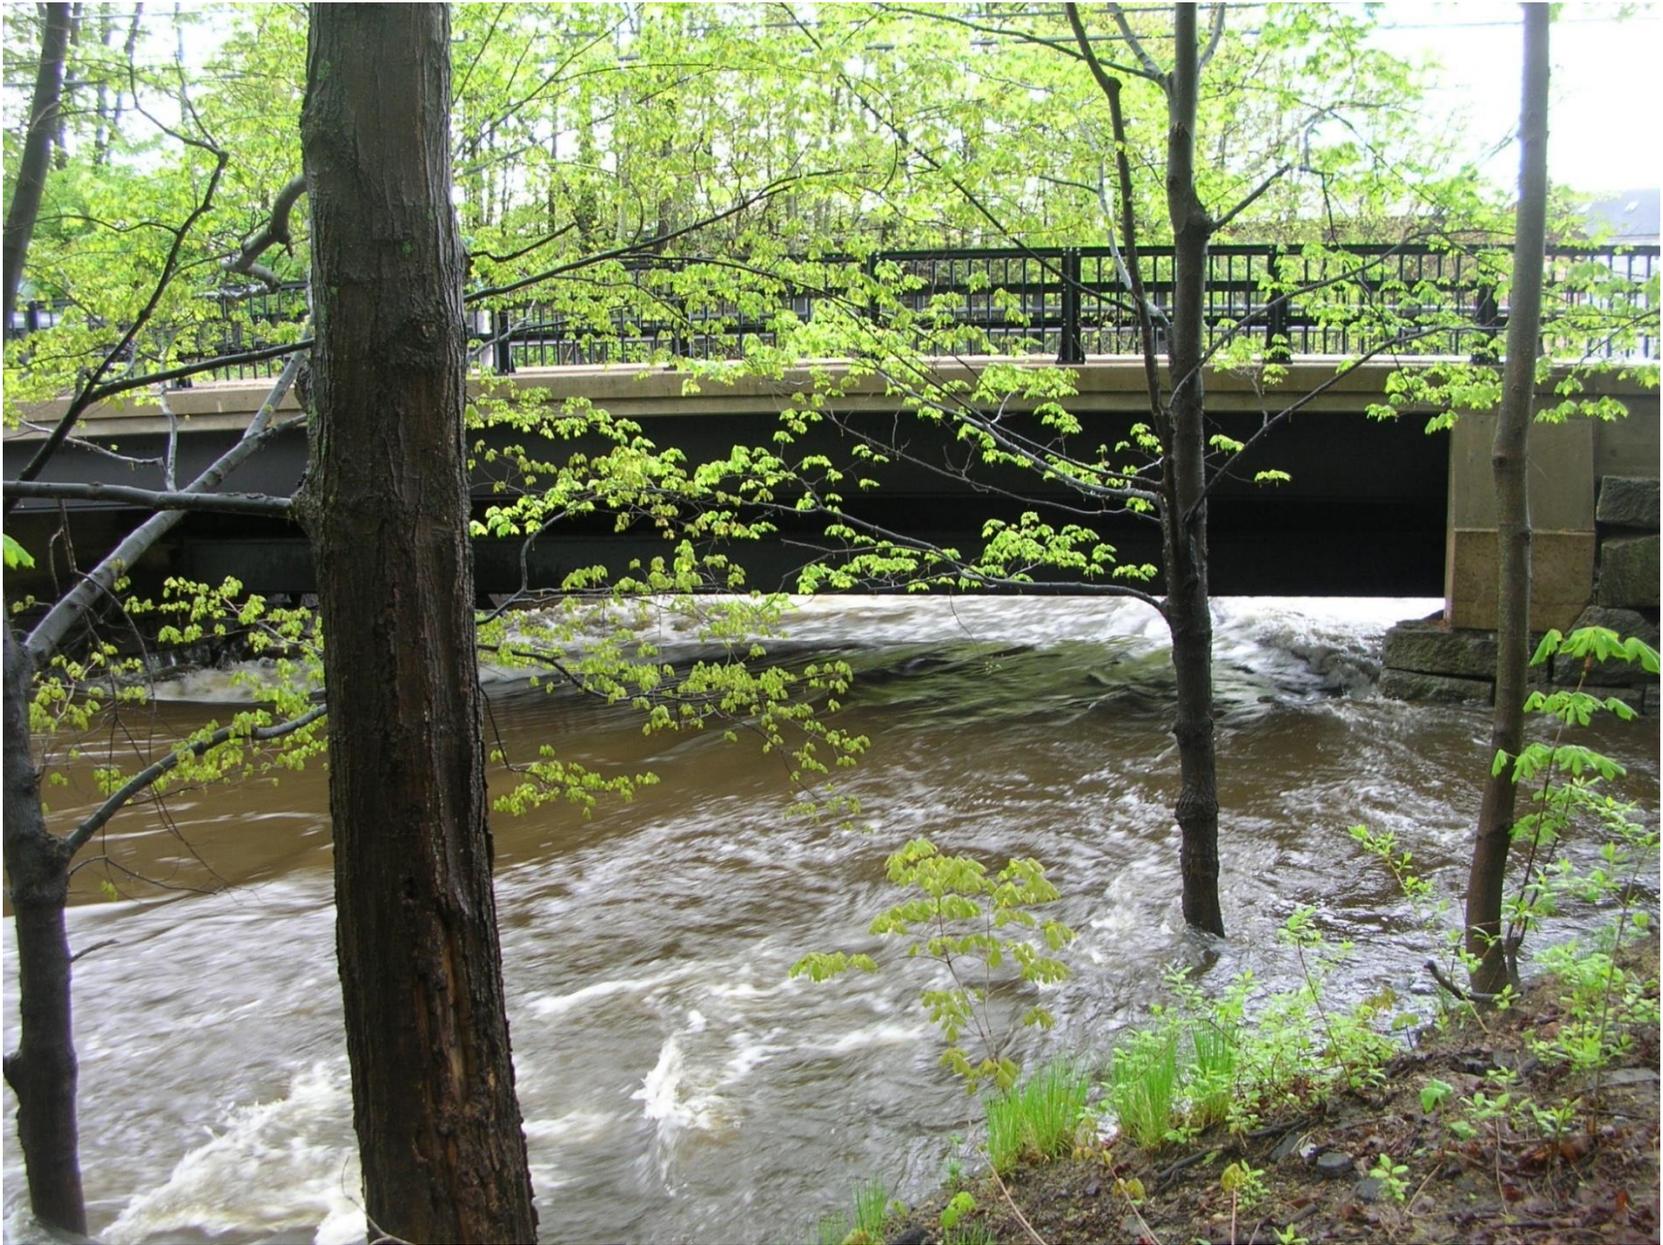
Figure G-2: Macallen Dam during the May 2006 flood, provided by NHDES. Photograph taken morning of May 16, 2006. Photograph used to estimate WSE at upstream side of Veteran's Bridge.

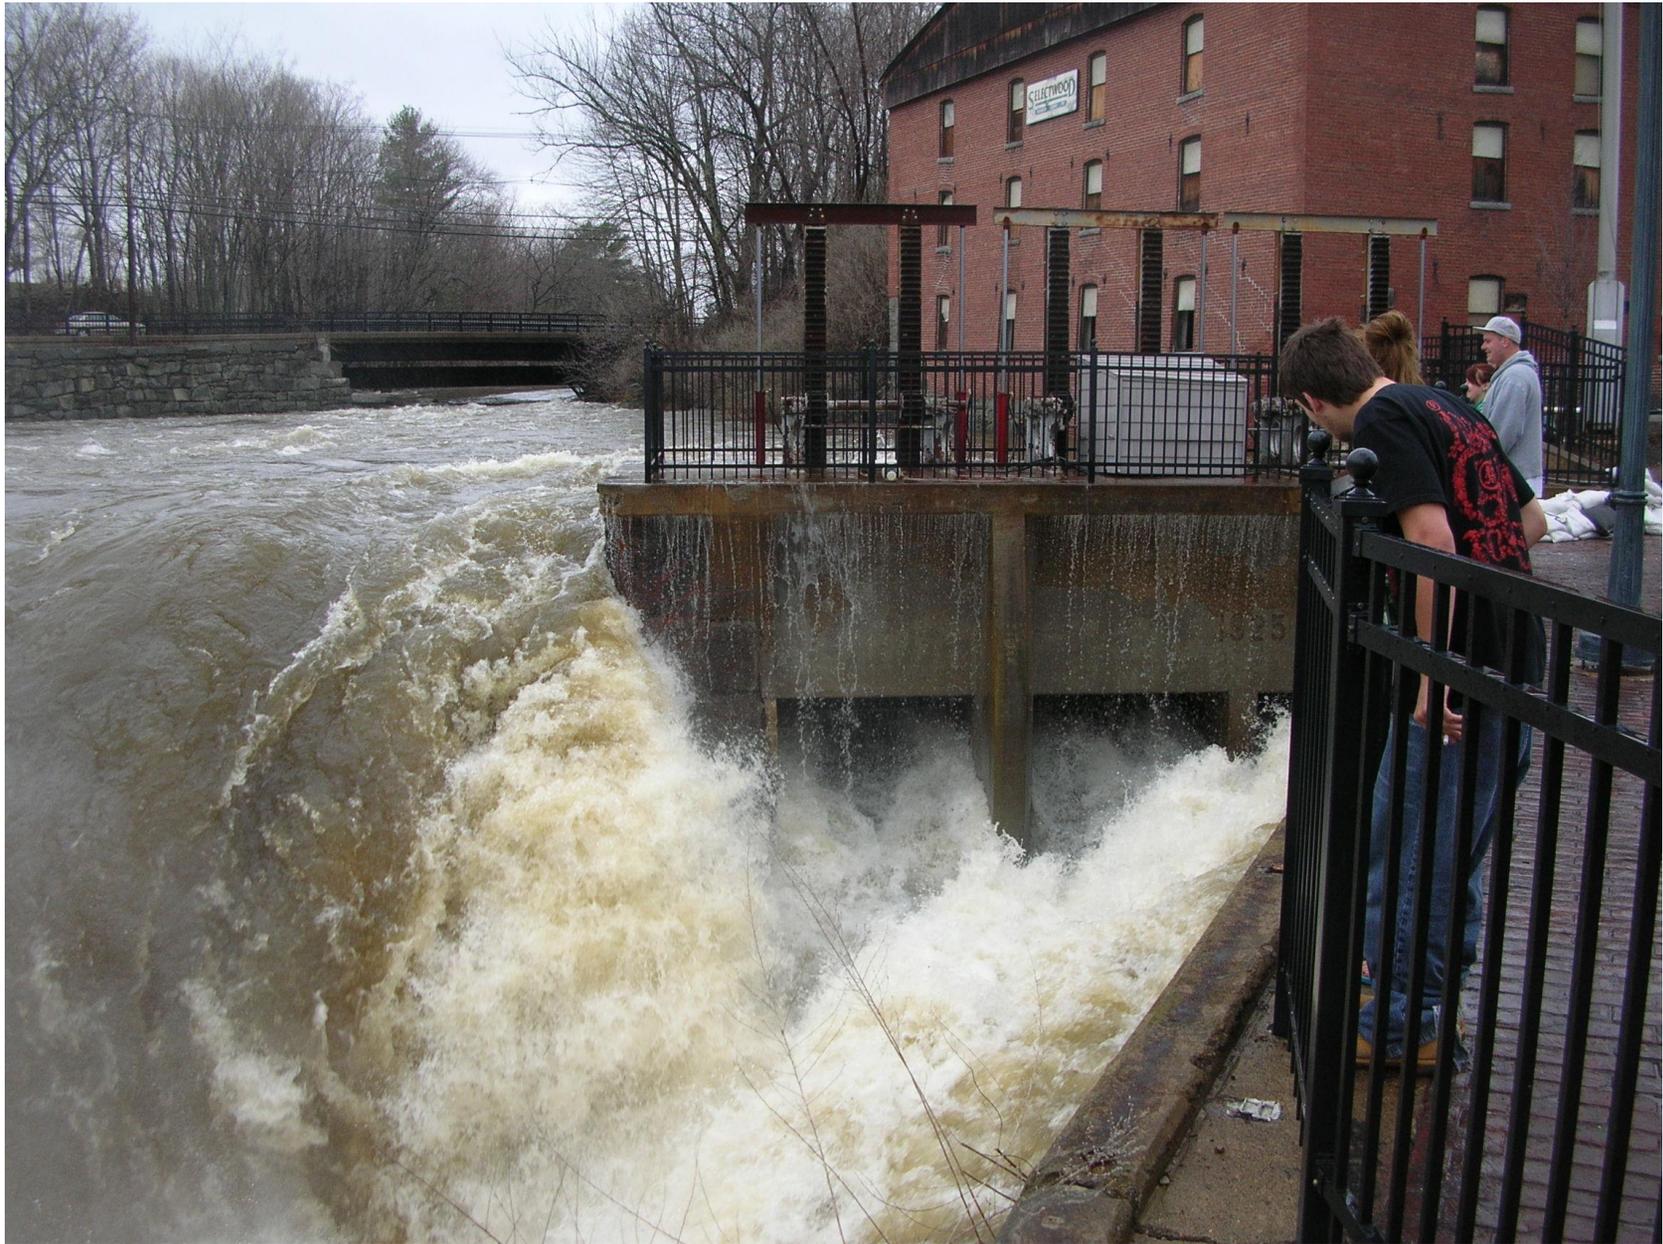
Figure G-3: Macallen Dam during the April 2007 flood, provided by NHDES. Photograph taken around 1 PM on April 18, 2007. Photograph used to estimate WSE at downstream side of Veteran's Bridge.

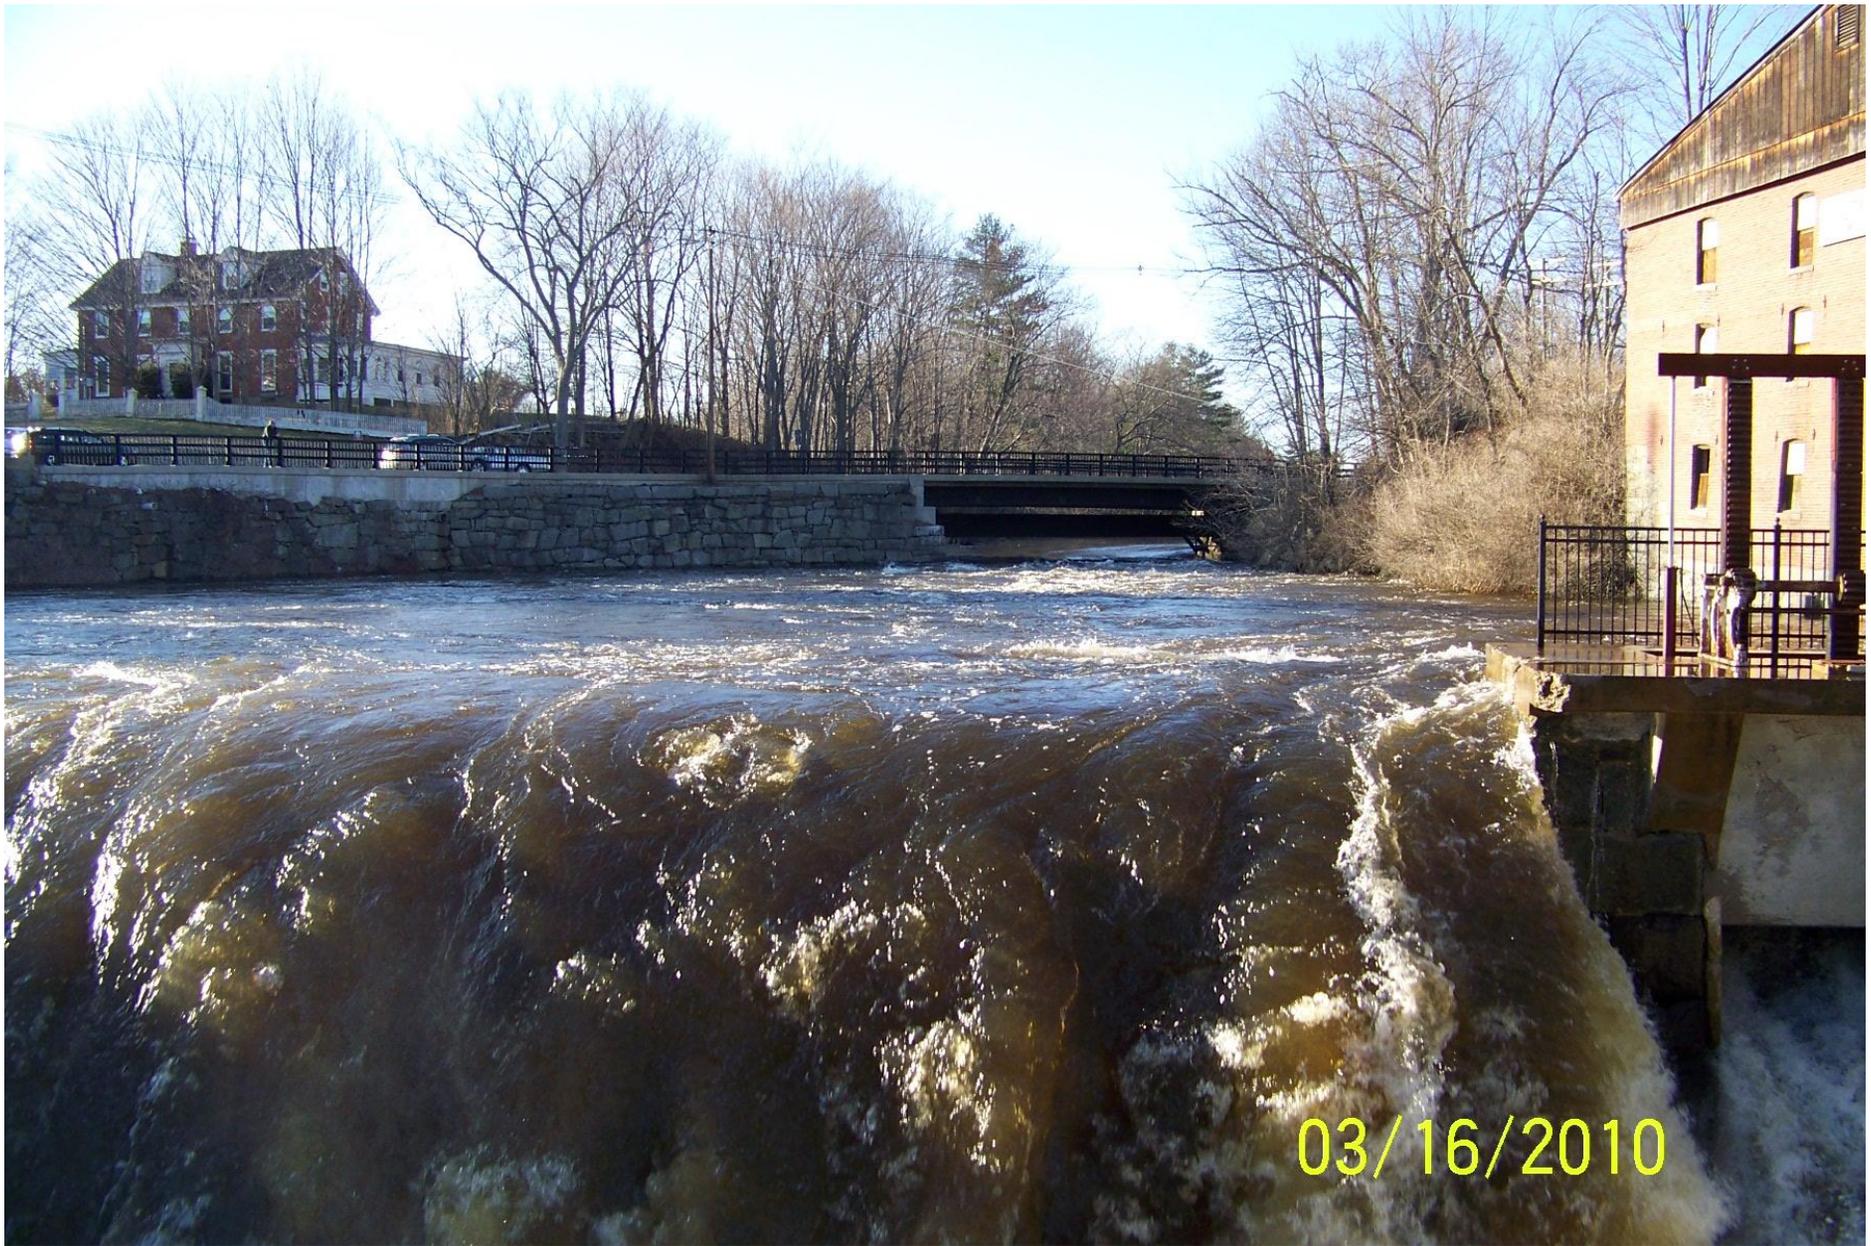
Figure G-4: Macallen Dam during the March 2010 flood, provided by NHDES. Photograph taken afternoon of March 16, 2010. Photograph used to estimate WSE at downstream side of Veteran's Bridge and at Macallen Dam.

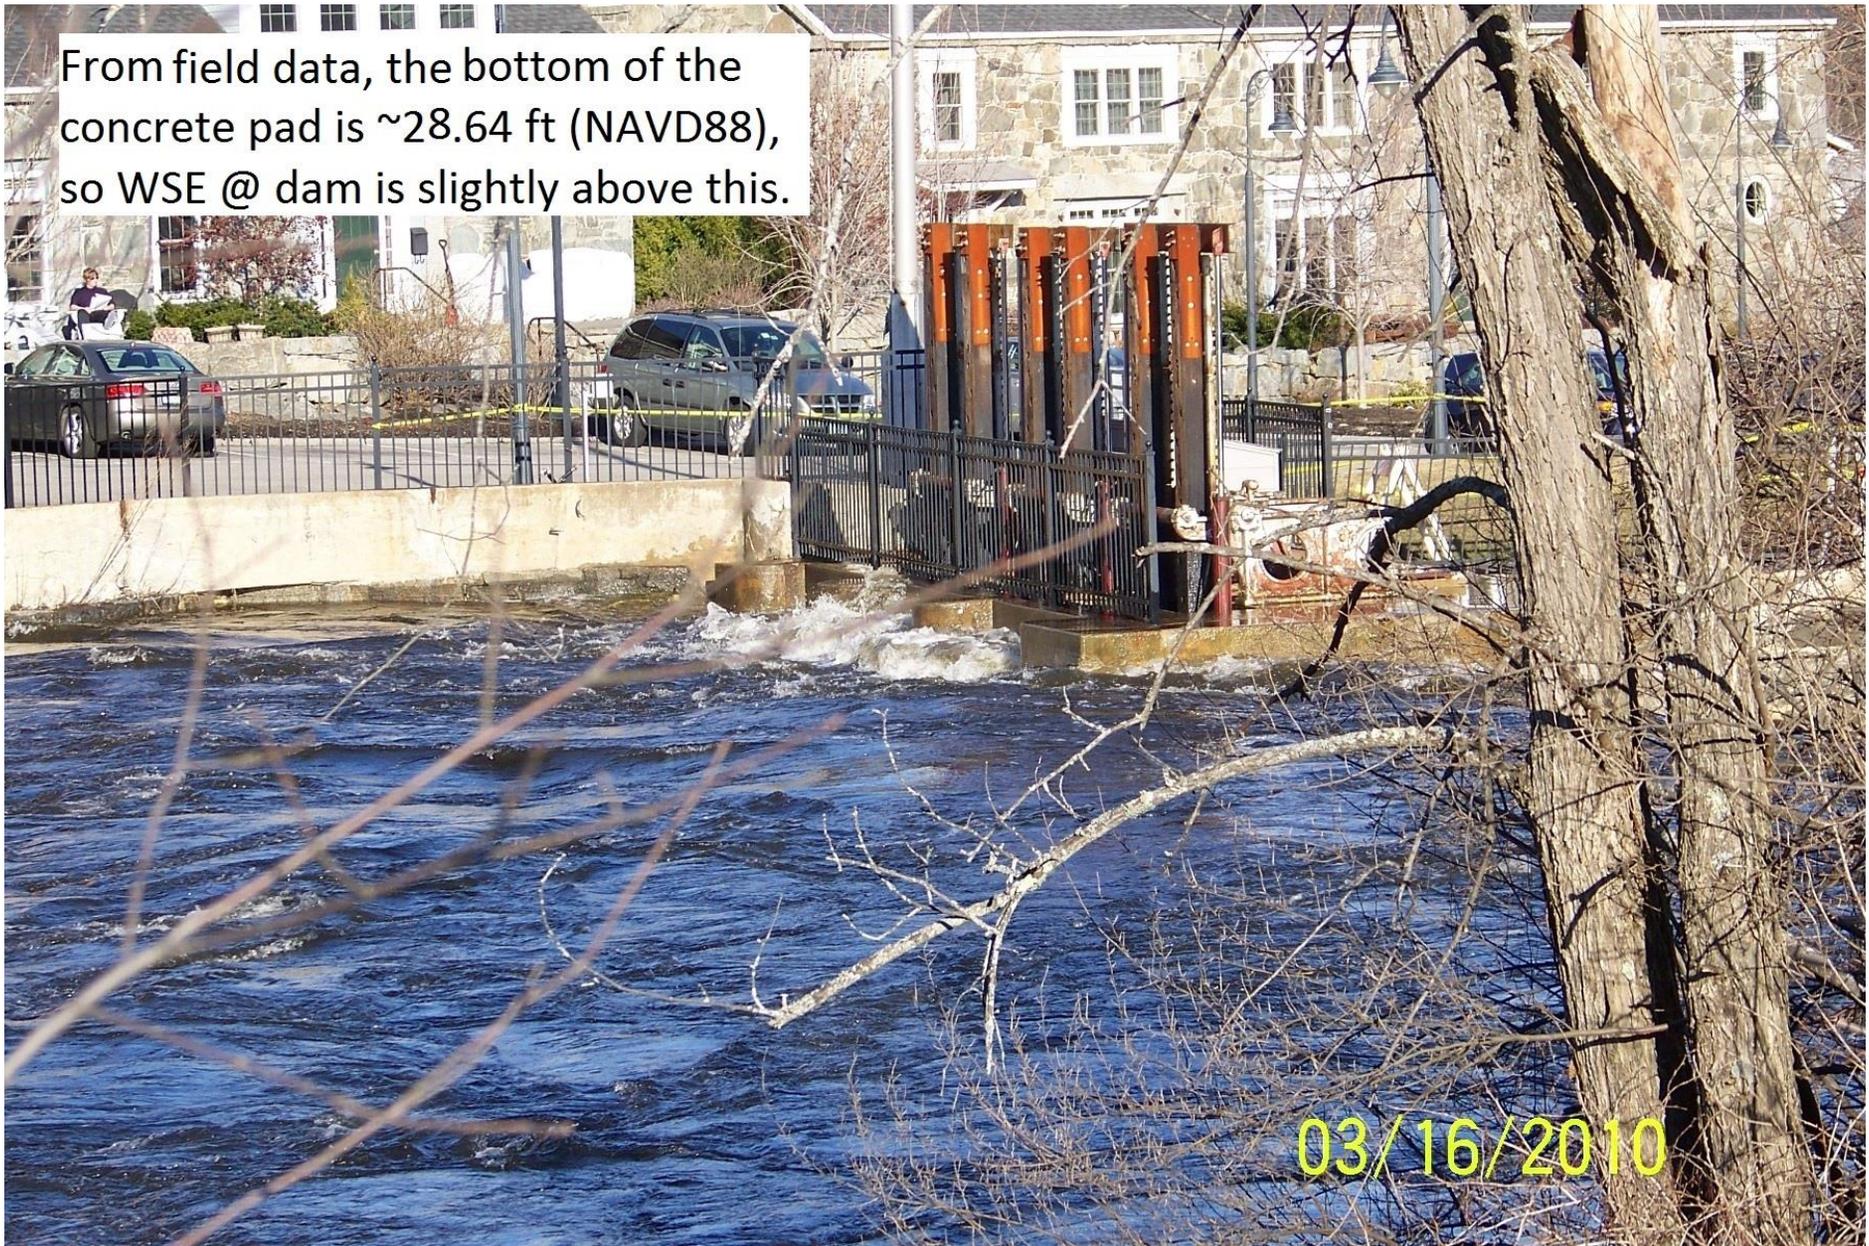
From field data, the bottom of the concrete pad is ~28.64 ft (NAVD88), so WSE @ dam is slightly above this.

Figure G-5: Macallen Dam during the March 2010 flood, provided by NHDES. Photograph taken afternoon of March 16, 2010. Photograph used to estimate WSE at Macallen Dam.

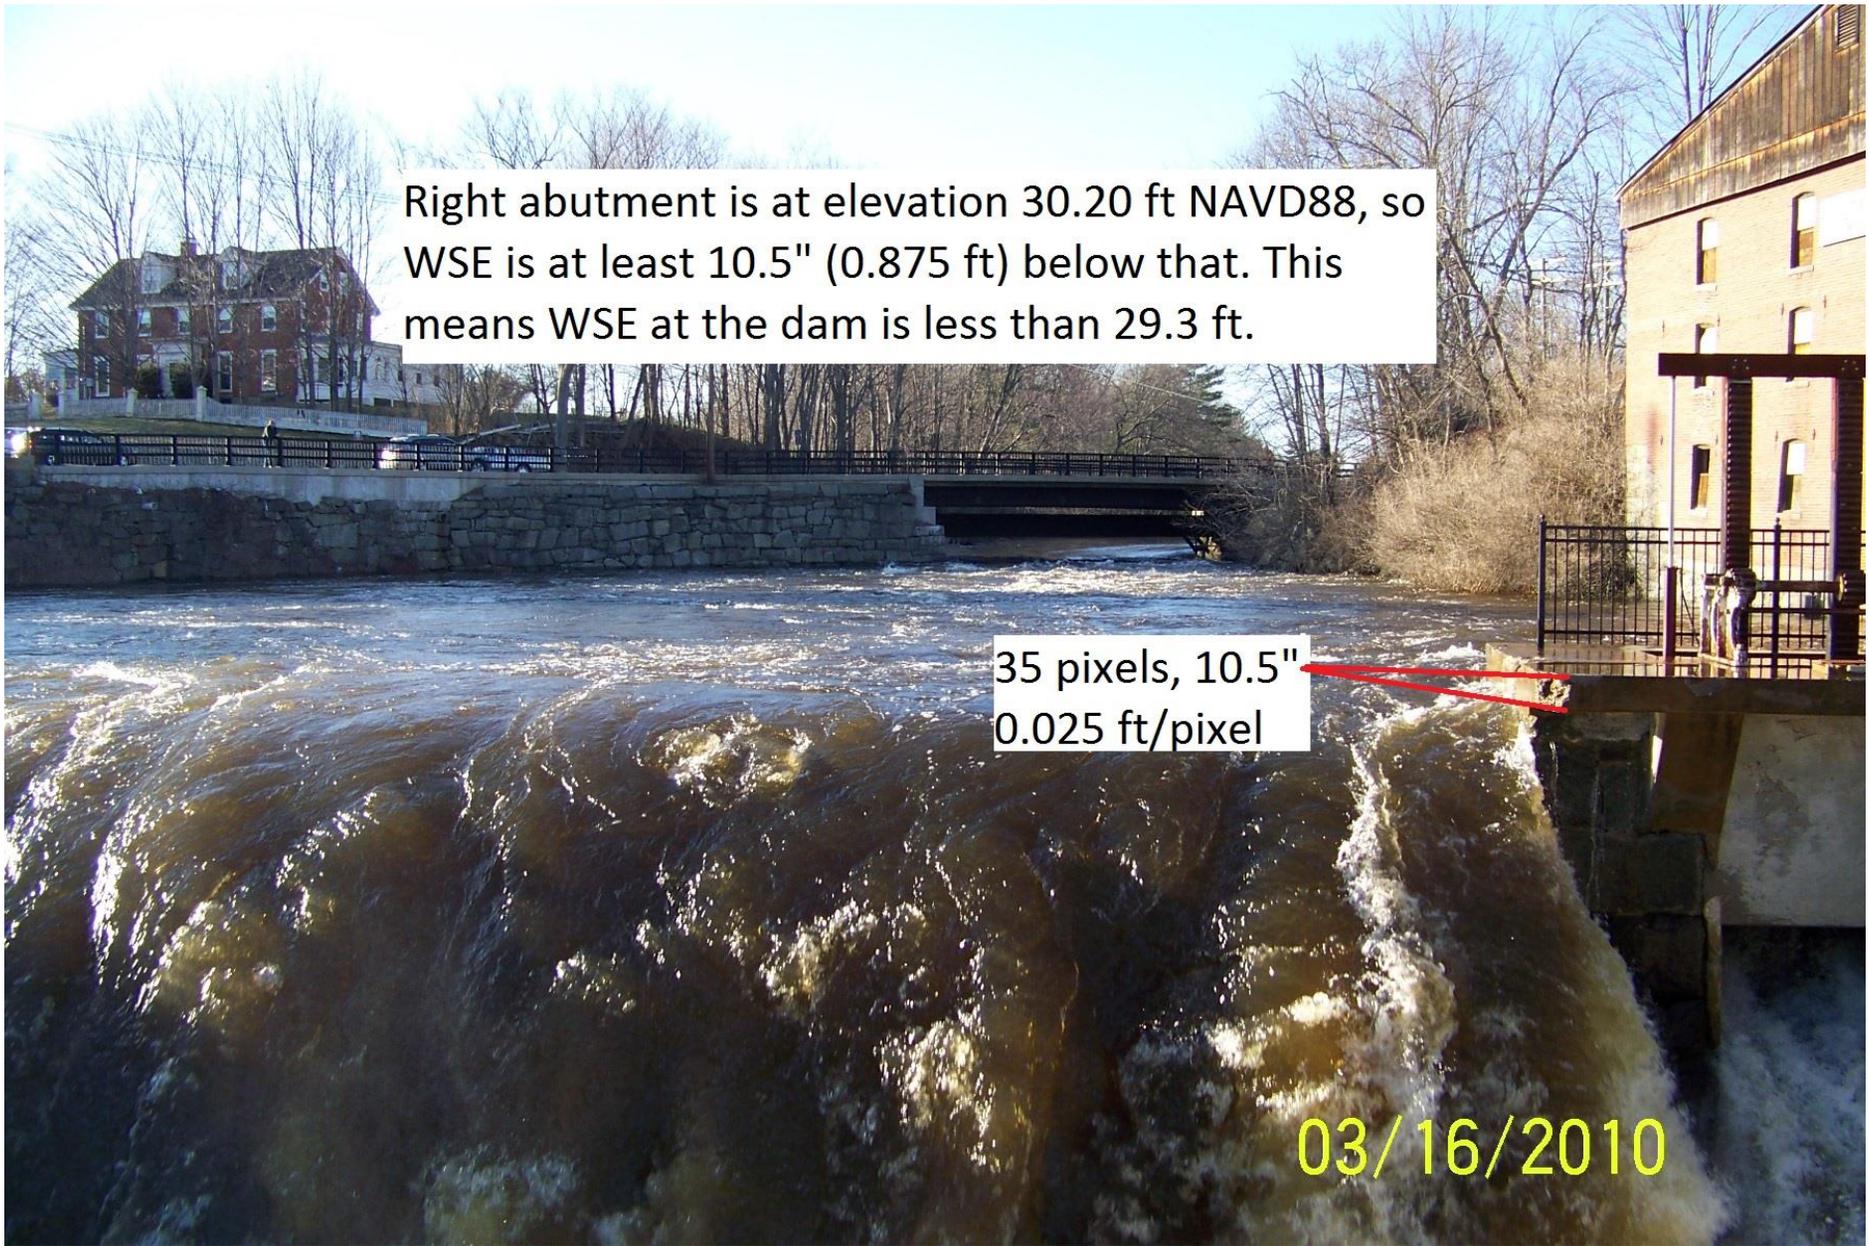
03/16/2010

Right abutment is at elevation 30.20 ft NAVD88, so WSE is at least 10.5" (0.875 ft) below that. This means WSE at the dam is less than 29.3 ft.

35 pixels, 10.5"
0.025 ft/pixel

Figure G-6: Macallen Dam during the March 2010 flood, provided by NHDES. Photograph taken afternoon of March 16, 2010. Photograph used to estimate WSE at Macallen Dam.

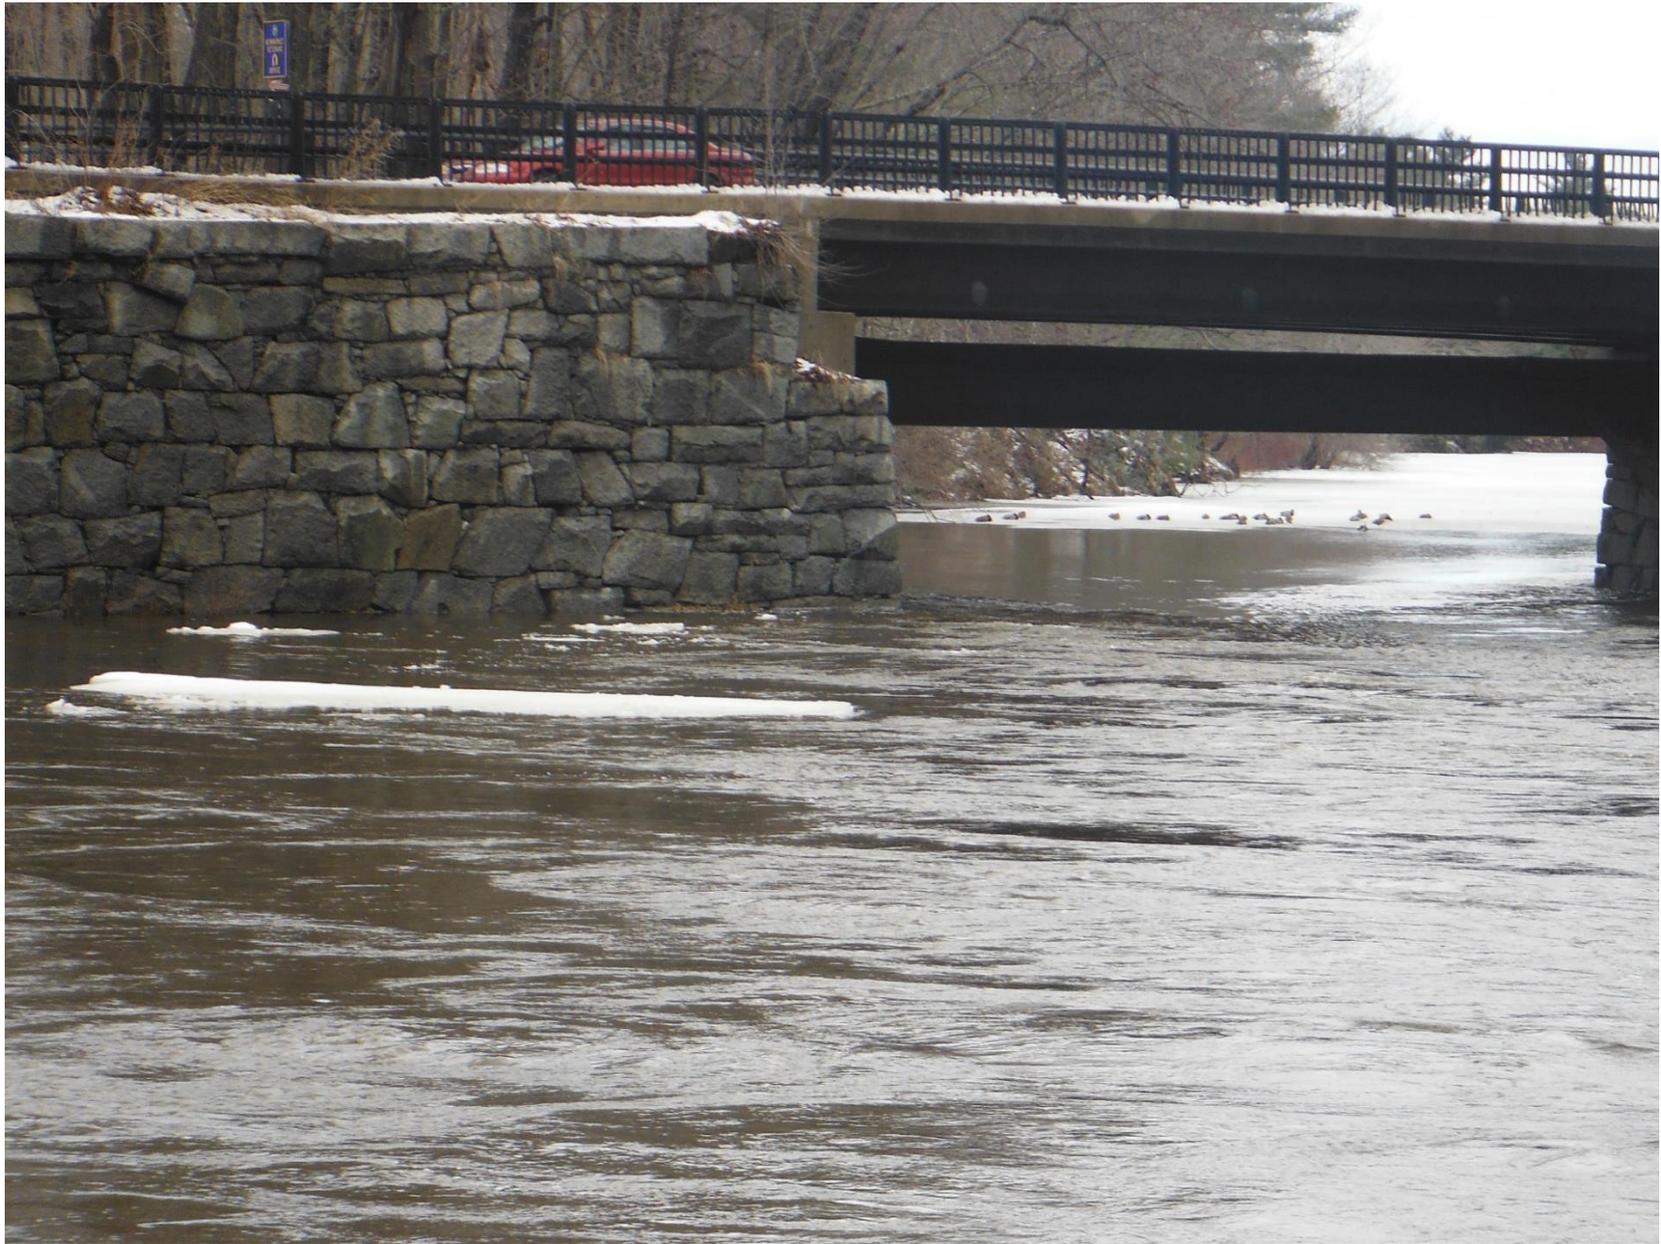
Figure G-7: Downstream side of Veteran's Bridge on 3-31-2014. Photograph taken March 31, 2014 around 4:30 PM. WSE measured at dam as approximately 25.6 ft. Flow directly measured as 2,495 cfs.

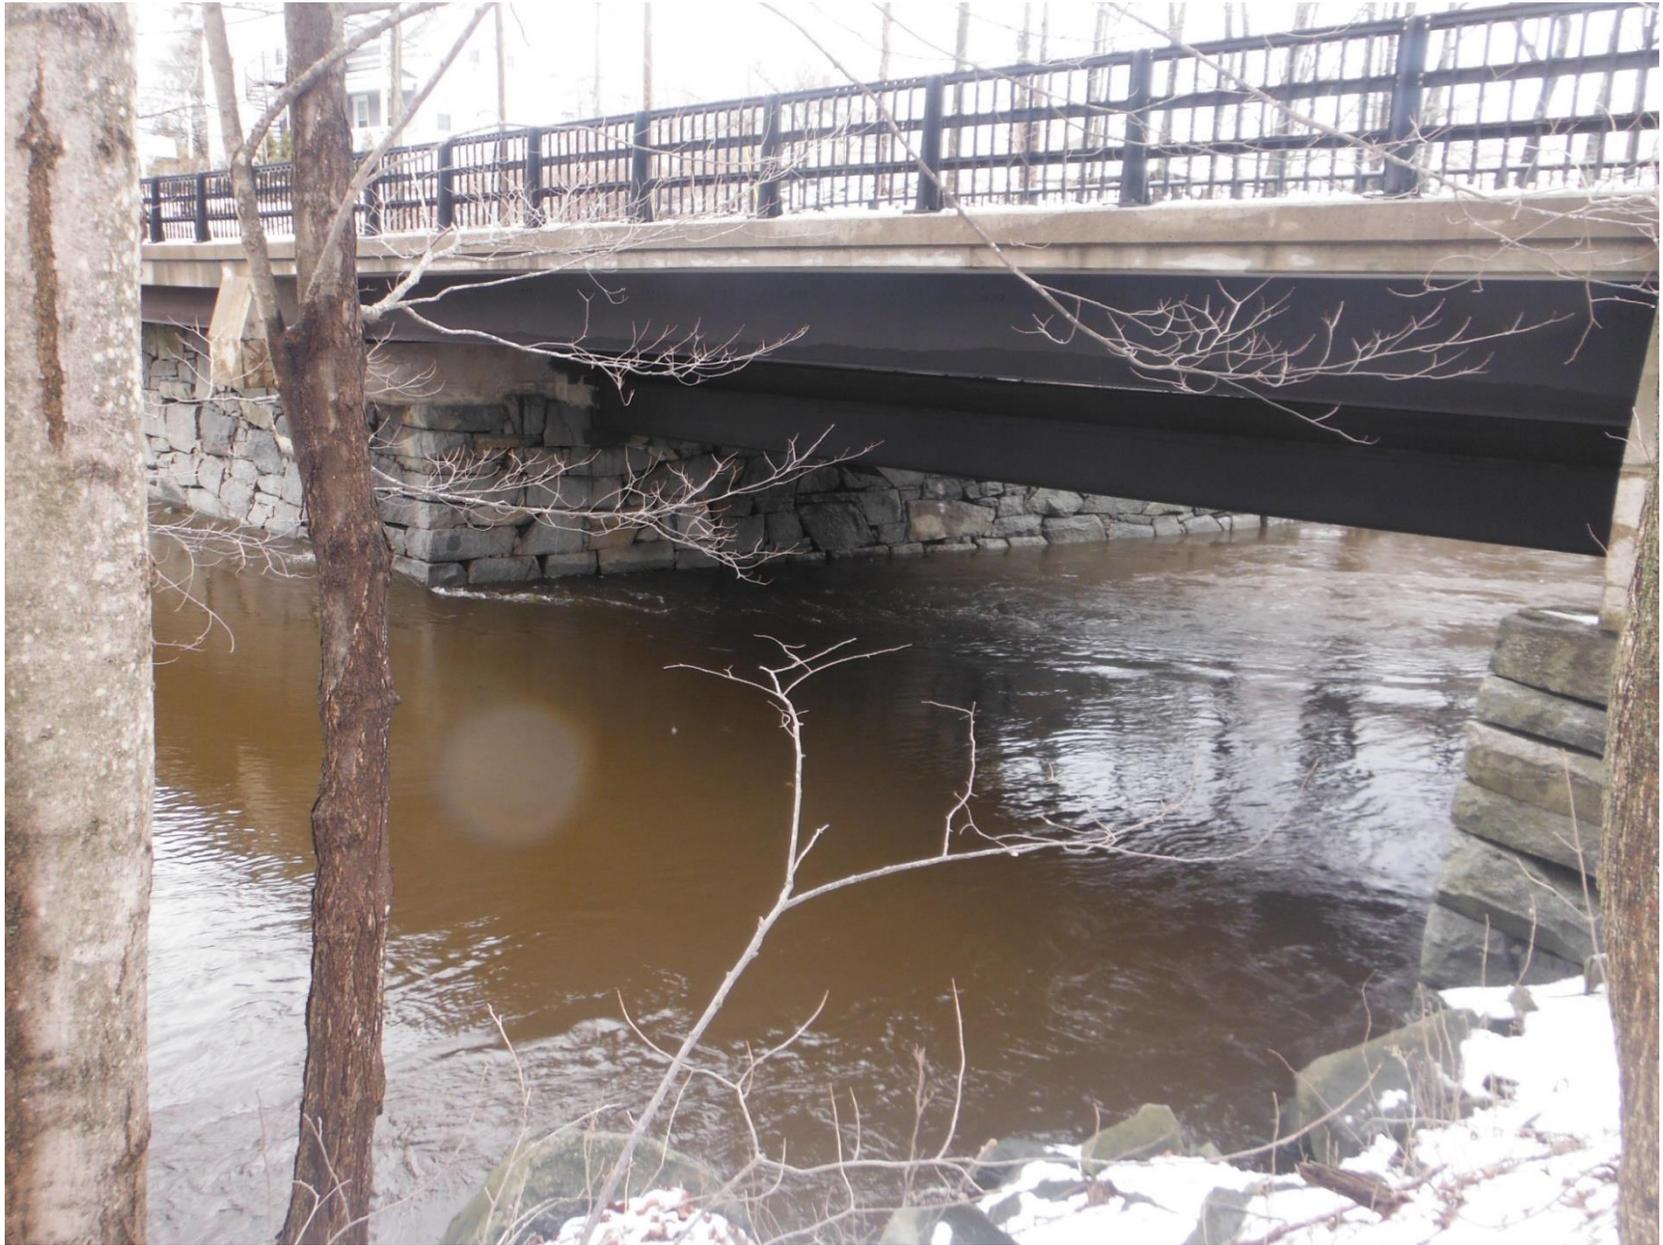
Figure G-8: Upstream side of Veteran's Bridge on 3-31-2014. Photograph taken March 31, 2014 around 4:30 PM. Flow directly measured as 2,495 cfs. Photograph indicates potential slight restriction due to bridge (not measured).

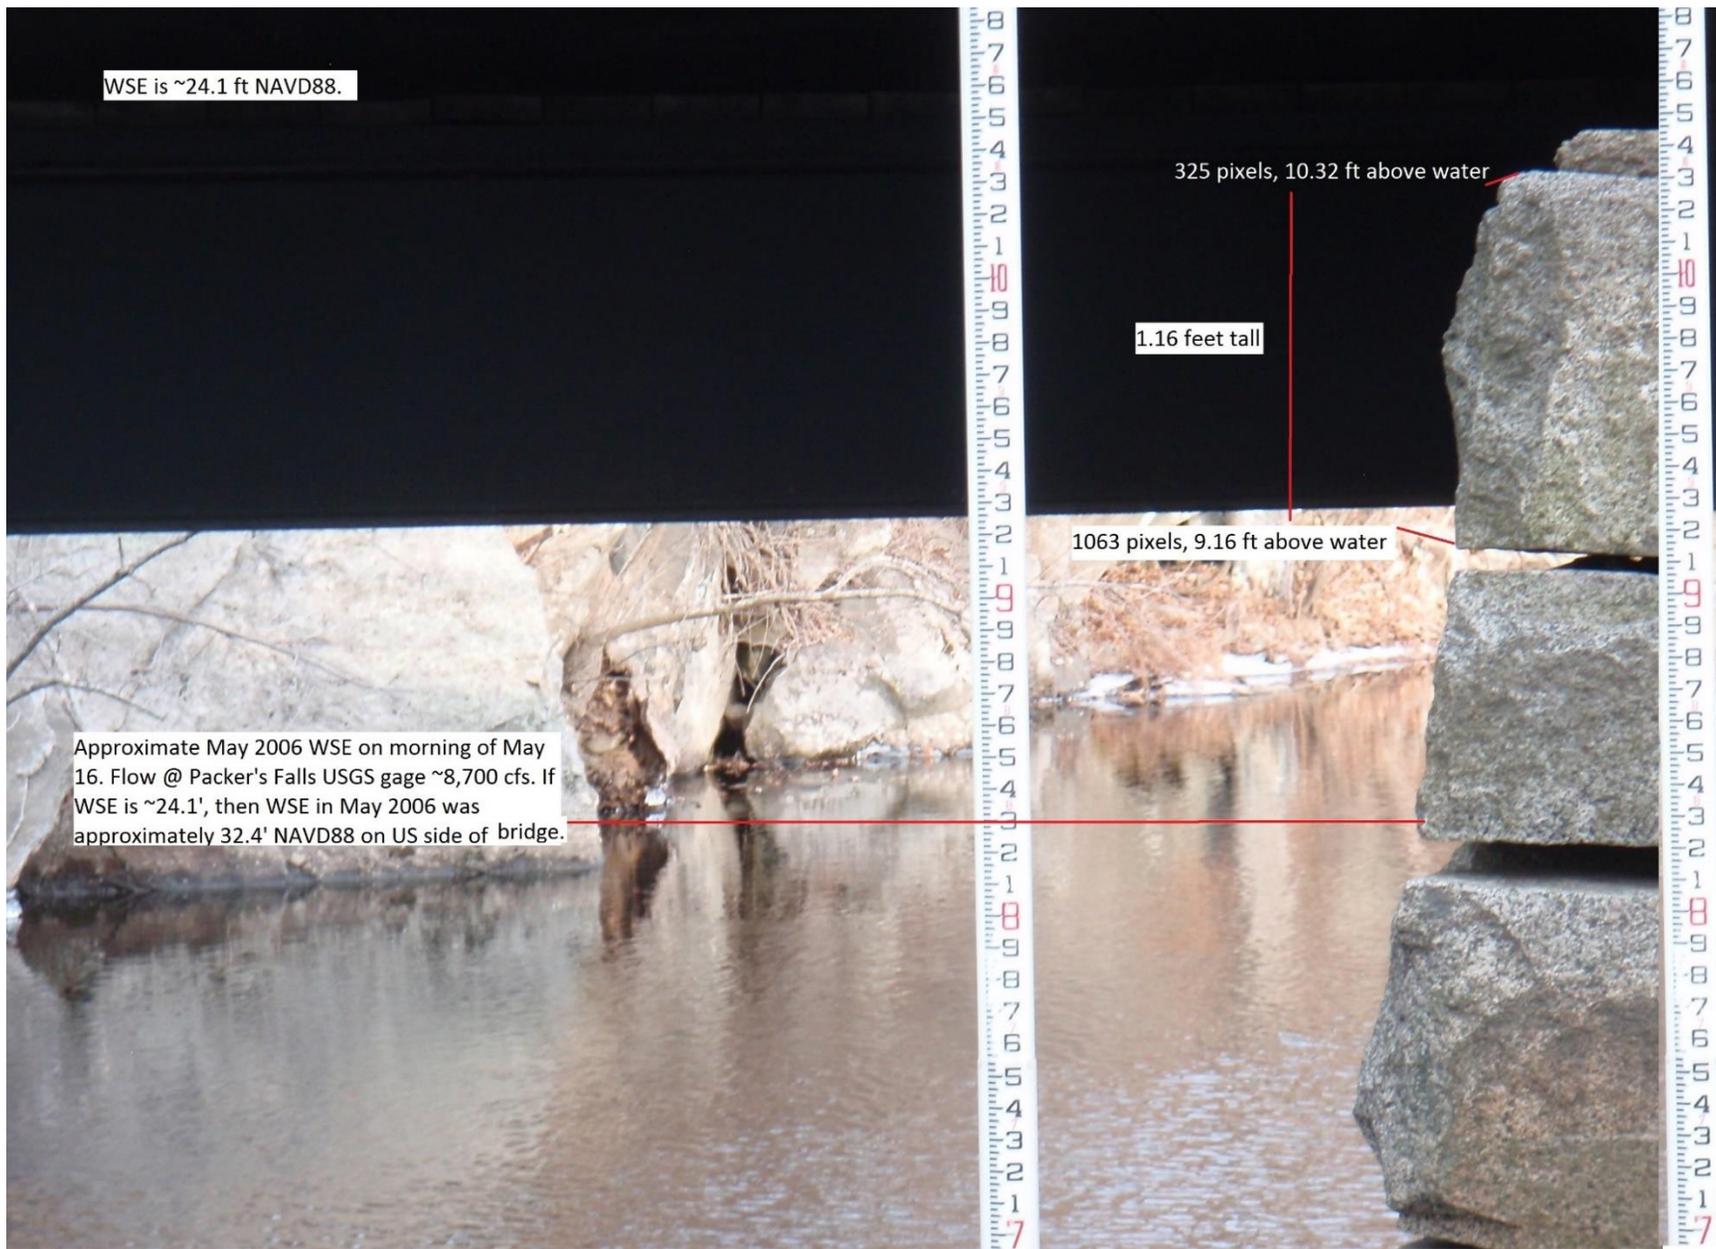
Figure G-9: Photograph taken March 27, 2014 around 5:00 PM. Survey rod was set to elevation 0 at the WSE (~24.1), with May 2006 WSE estimated on abutment based on Figure G-2.

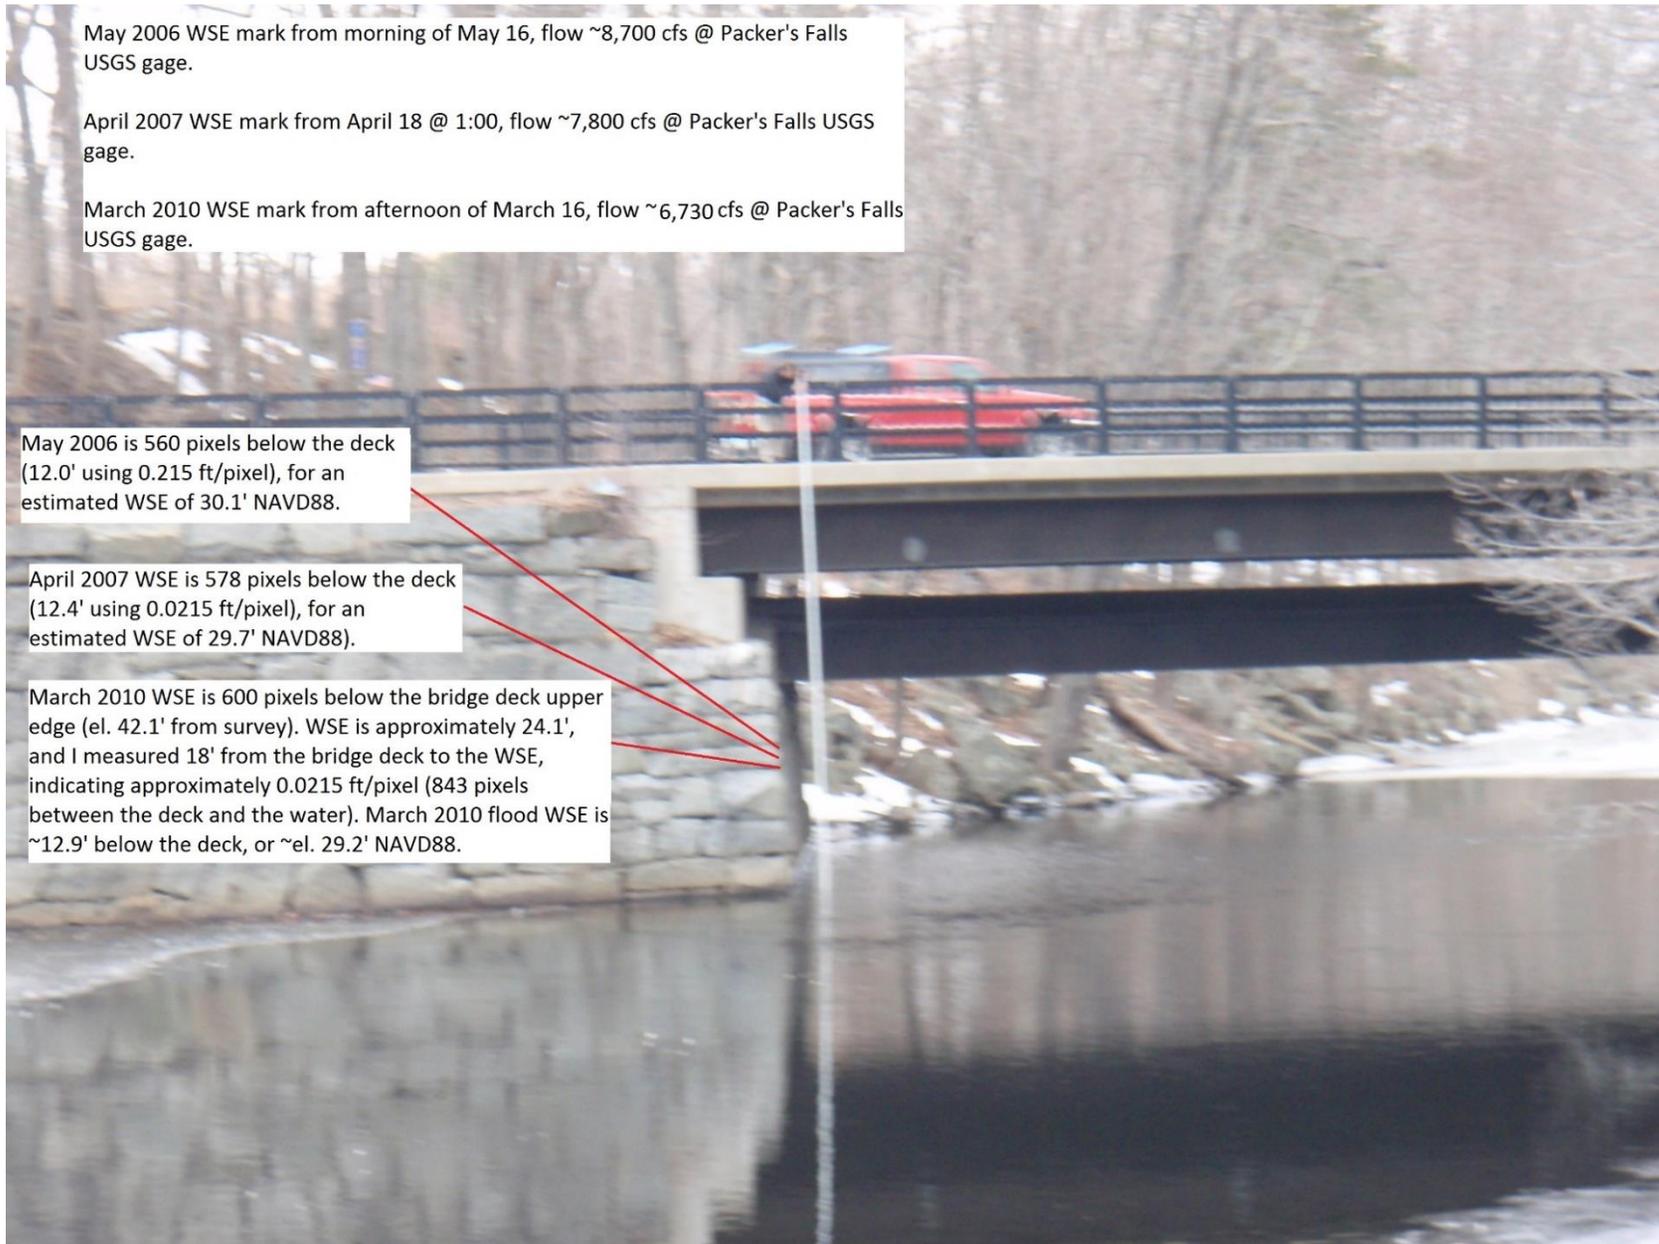
May 2006 WSE mark from morning of May 16, flow ~8,700 cfs @ Packer's Falls USGS gage.

April 2007 WSE mark from April 18 @ 1:00, flow ~7,800 cfs @ Packer's Falls USGS gage.

March 2010 WSE mark from afternoon of March 16, flow ~6,730 cfs @ Packer's Falls USGS gage.

May 2006 is 560 pixels below the deck (12.0' using 0.215 ft/pixel), for an estimated WSE of 30.1' NAVD88.

April 2007 WSE is 578 pixels below the deck (12.4' using 0.0215 ft/pixel), for an estimated WSE of 29.7' NAVD88.

March 2010 WSE is 600 pixels below the bridge deck upper edge (el. 42.1' from survey). WSE is approximately 24.1', and I measured 18' from the bridge deck to the WSE, indicating approximately 0.0215 ft/pixel (843 pixels between the deck and the water). March 2010 flood WSE is ~12.9' below the deck, or ~el. 29.2' NAVD88.

Figure G-10: Photograph taken March 27, 2014 around 5:00 PM. Survey rod was used to measure distance from bridge deck to WSE (18.0 feet), and then used to estimate May 2006, April 2007 and March 2010 WSE on abutment based on Figures G-1, G-3 and G-4.
