*Final Feasibility Report*  
*Dam Feasibility and Impact Analysis*  
**Macallen Dam, Newmarket, NH**

**Volume 1 of 2: Main Report**

**Town of Newmarket, New Hampshire**

July 2014

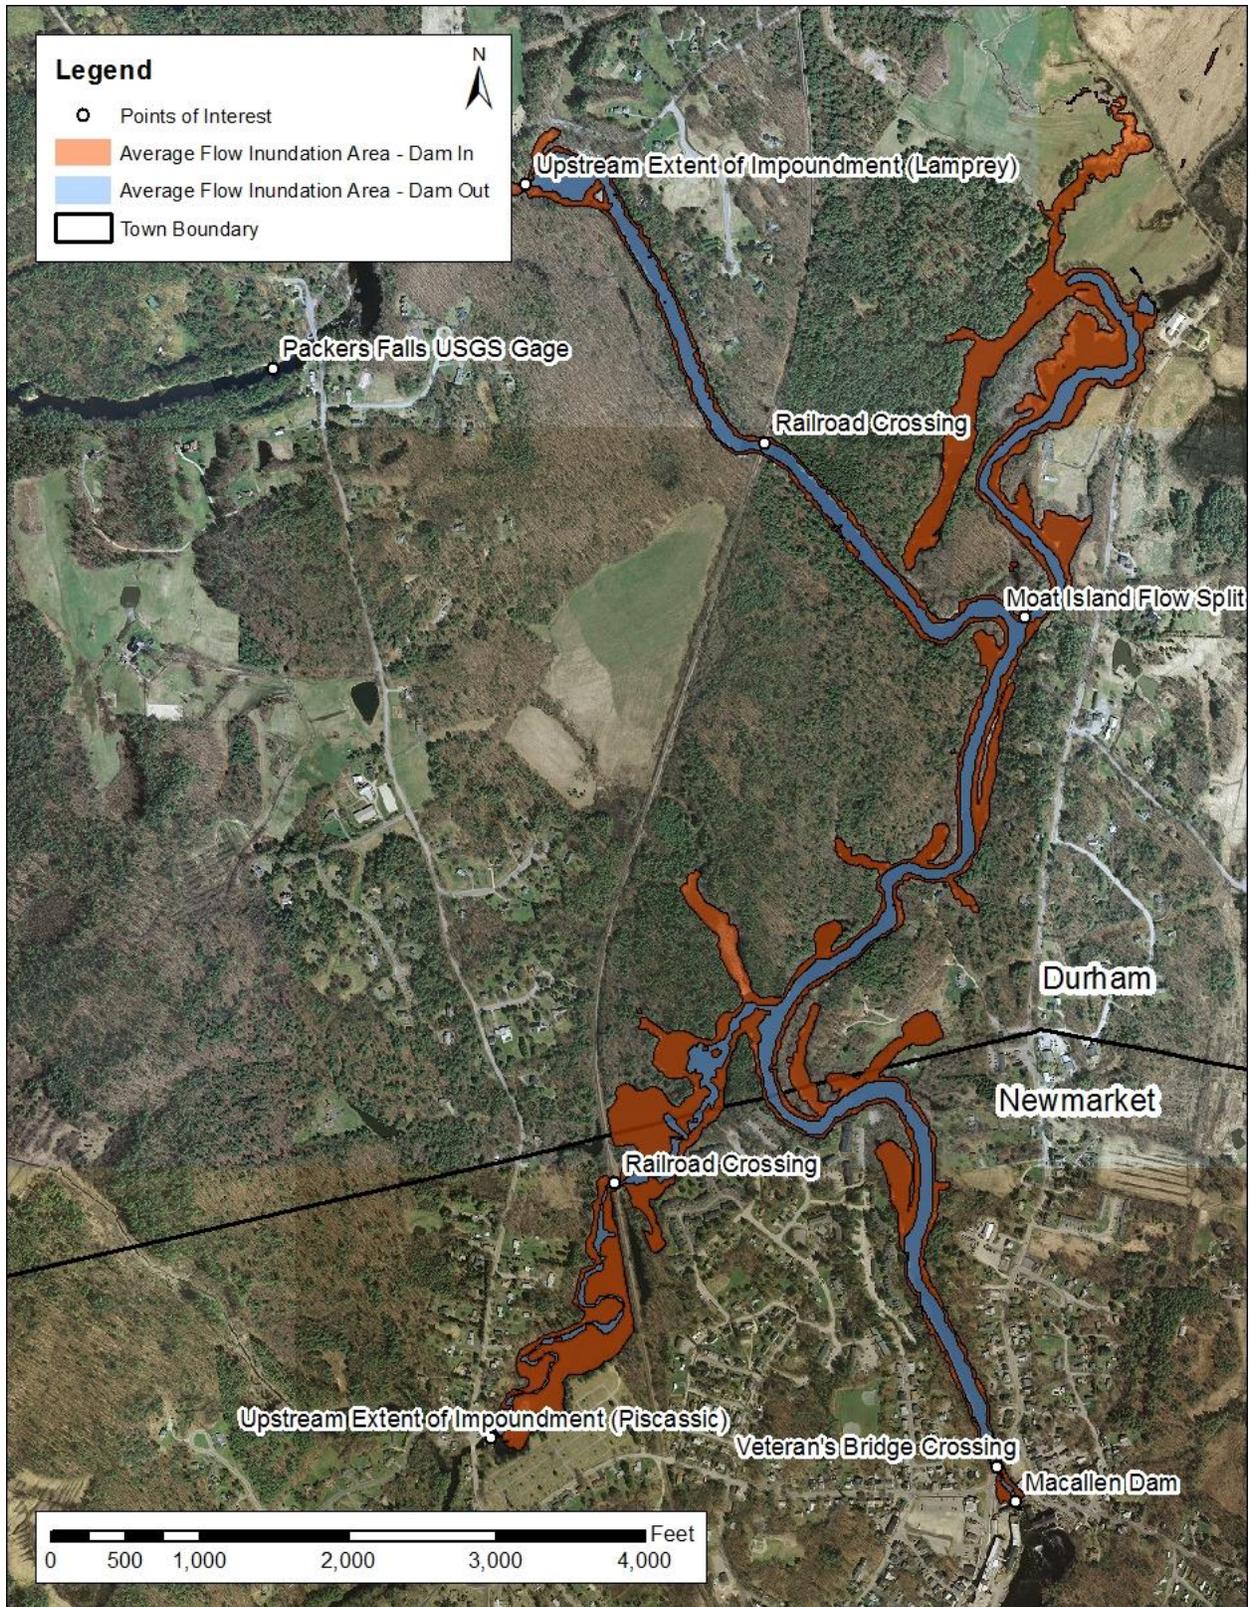
Figure ES-2: Inundation Map for the 100-year flow for Dam-in and Dam-Out conditions.

- Under dam-out conditions and under the 100-year flood, there are marginal flood benefits realized from removing the dam as shown in the inundation map in Figure ES-2. The greatest reduction in the flood depths occurs between the dam and Veterans Bridge and decreases above the Veterans Bridge. Based on the bathymetric mapping and hydraulic modeling there is a hydraulic control at Veterans Bridge due to the narrowing of the channel width as well as an elevated channel bed beneath the bridge.

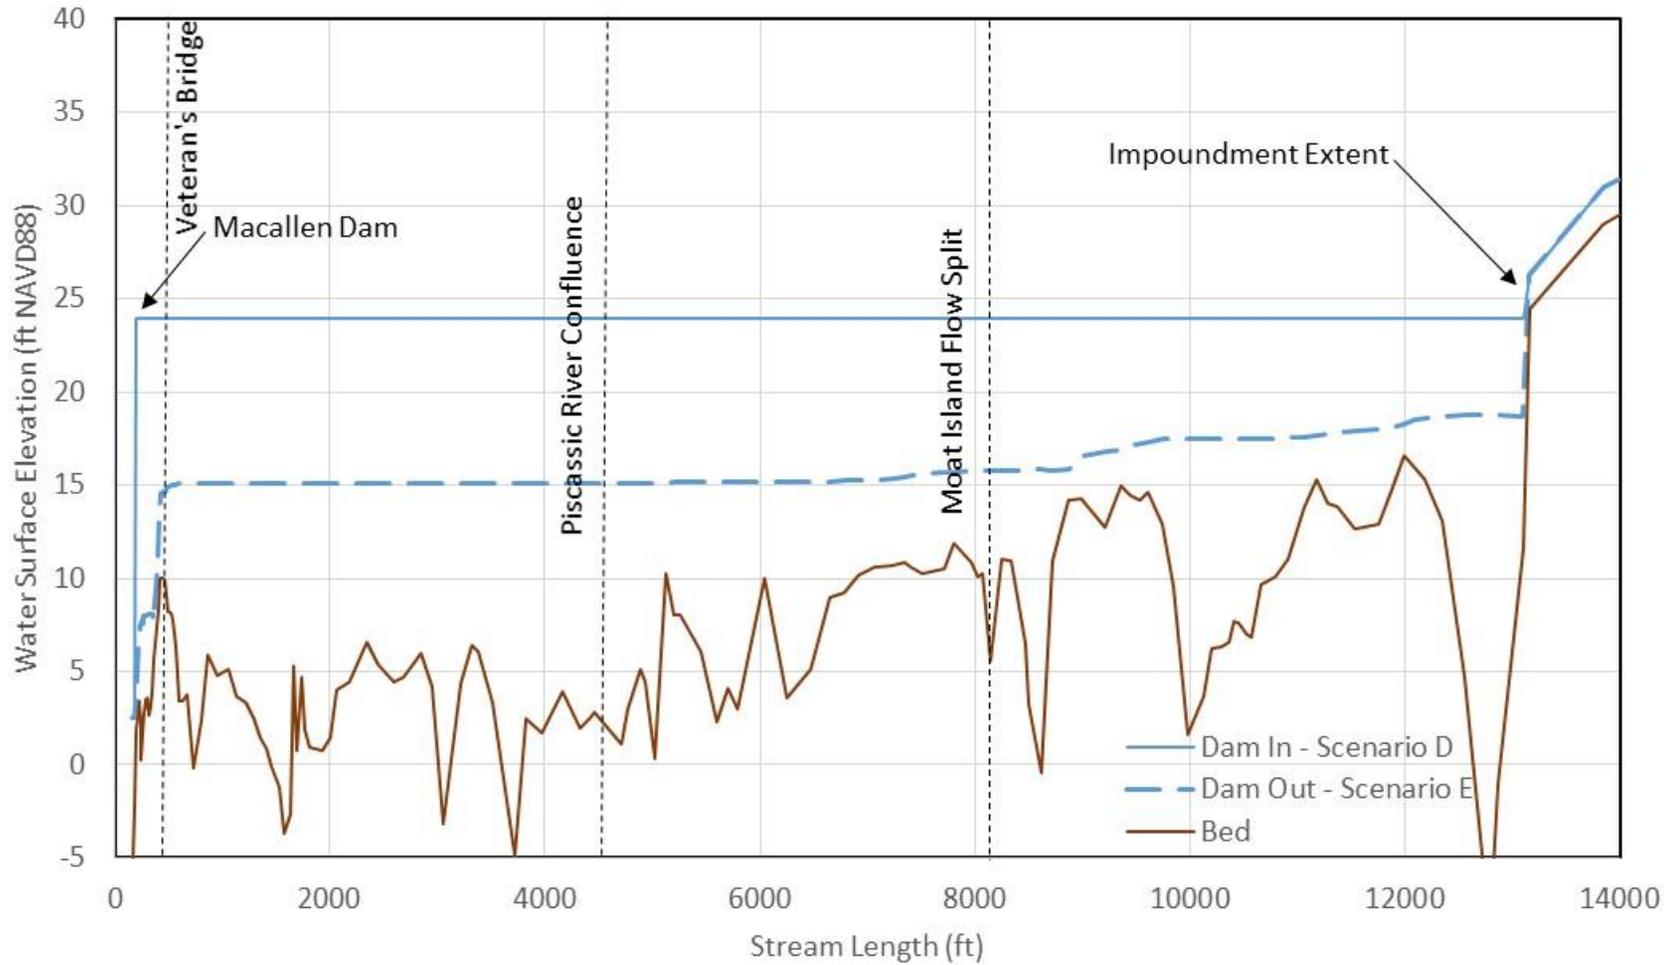
Figure ES-4: Longitudinal WSE profile for the Average Annual Flow for Dam-In and Dam-Out conditions.

- Under dam-out conditions and under the average annual flow, the impounded reach width would be reduced, with the most drastic changes occurring in the backwatered bays and in the Piscassic impounded reach as shown in Figure ES-3. The current boat launch on the Piscassic River would be rendered unusable. The river depth would be reduced on the order of 5 to 9 feet above the Veterans Bridge as shown in Figure ES-4.

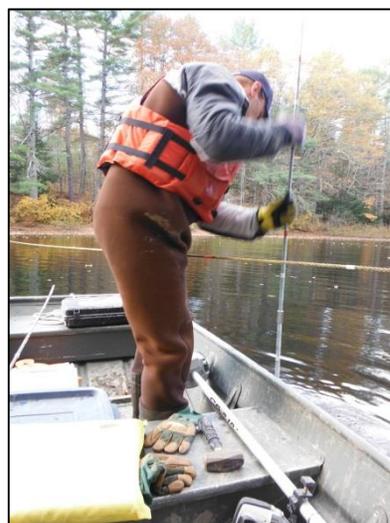
Sediment thickness measurements (see inset for measurements in Macallen impoundment) occurred on October 7 for Transects T1-T7 (during the fall 2013 drawdown) and October 24 for Transects T-8-T10 (when the impoundment was at normal levels). The mean daily flows (provisional) on October 7 and 24, as recorded at the USGS gage on the Lamprey River near Packers Falls was 60 cfs and 104 cfs, respectively, or approximately 70 cfs and 121 cfs, respectively at the Macallen Dam. Note that the October 7 sediment thickness occurred during the drawdown when the water level was maintained near the crest gate elevation, hence the WSEs were low. During the October 24 sediment thickness measurements, the gates were closed and thus the WSE was closer to the spillway crest elevation.

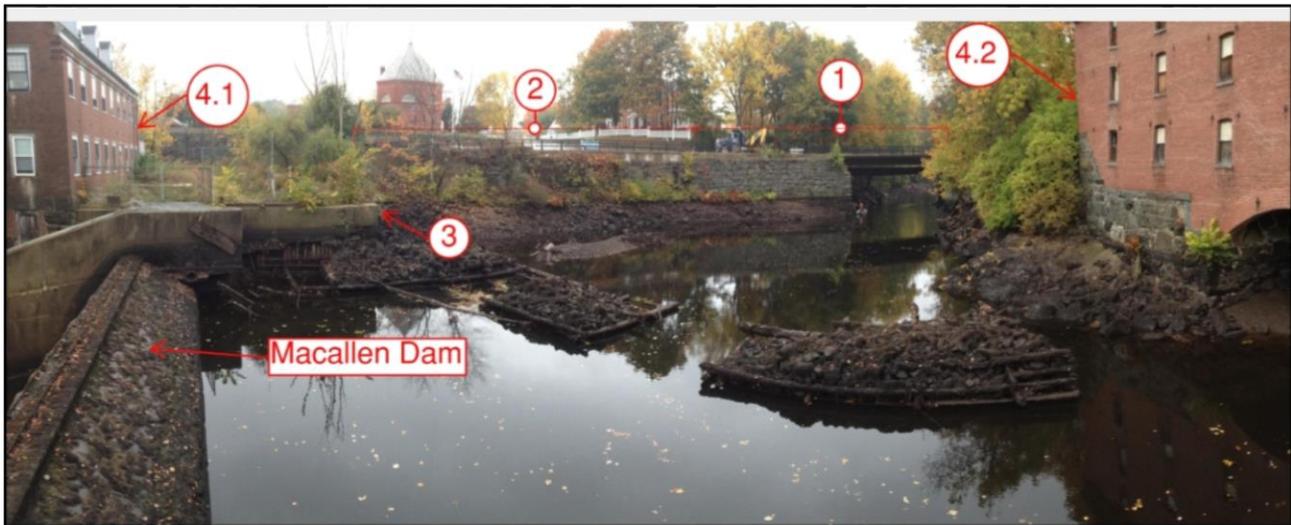
View Upstream of Dam (Numbering Refers to the Following Sections)

- 1- Veterans Bridge (1.1- West Abutment, 1.2- East Abutment, 1.3 Southwest Wall)
- 2- Retaining Wall (2.1- Section I, 2.2- Section II, 2.3- Section III, 2.4- Section IV, Traverse Wall Adjacent to Dam)
- 3- Building Foundations
- 4.2- Selectwood Building
- 4.1- Durham Book Exchange Building

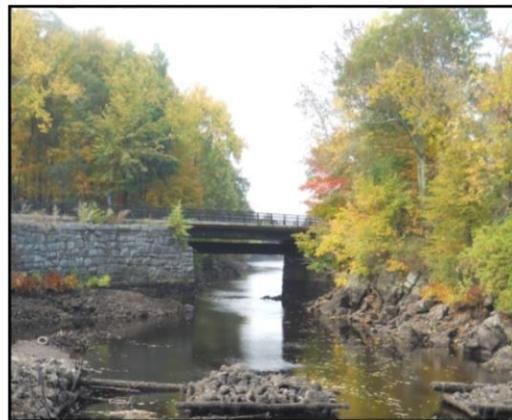
Downstream Elevation of Veteran's Bridge

Veterans Bridge was built in 1955. Based on the existing 1954 bridge plans, it appears that the original superstructure was replaced and the existing substructure was rehabilitated to accommodate a roadway widening upstream. The existing bridge is a single span carrying two lanes of traffic and one sidewalk located on the downstream side of the bridge. The bridge superstructure consists of steel I-beams with a reinforced cast-in-place concrete deck. The substructure consists of dry-laid cut granite stone masonry abutments and wingwalls that bear on ledge. Concrete caps consisting of bridge seats and backwalls were constructed on top of the stone abutments during the 1954 construction and were not doveled into the existing stone. The concrete cap at the east abutment cantilevers upstream to accommodate the roadway widening. The abutment stone is laid in such a way that the front face is battered. The upstream wingwalls are u-back (parallel to the roadway) and the downstream wingwalls are flared. The existing southwest wingwall was raised with dry squared stone masonry during the 1954 rehabilitation and a concrete cap was constructed on top of the existing northwest wingwall. A concrete facing was constructed on the northeast wingwall to support the steel I-beam carrying the cantilever concrete

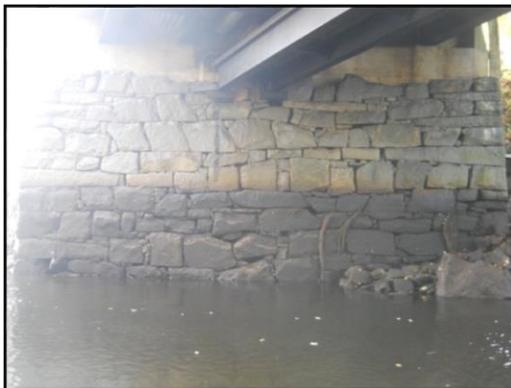
West Abutment

The west abutment consists of rectangular stone varying in height from 16 to 30 inches and a 12-inch wide stone footing where the abutment is not directly on ledge. Stone has been placed in front of the wall at the upstream corner and upstream wingwall. There is no vegetation in the abutment and no signs of bulging stones. A three (3) foot void is located at the downstream end of the abutment, between the ledge and footing and extends five (5) feet diagonally into the abutment. It is unclear if the gap is due to a missing stone or the abutment was constructed with the gap; however, the abutment does not appear to be undermined. Chinking stones placed

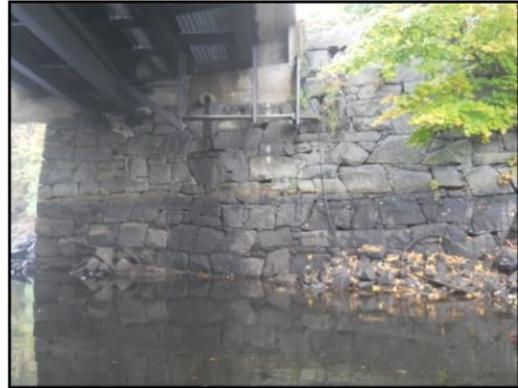
East Abutment

portion of the footing on the east abutment is visible and the river bottom is bedrock with cobbles. Chink stones appear to be missing, approximately 40%, at several locations below the waterline.

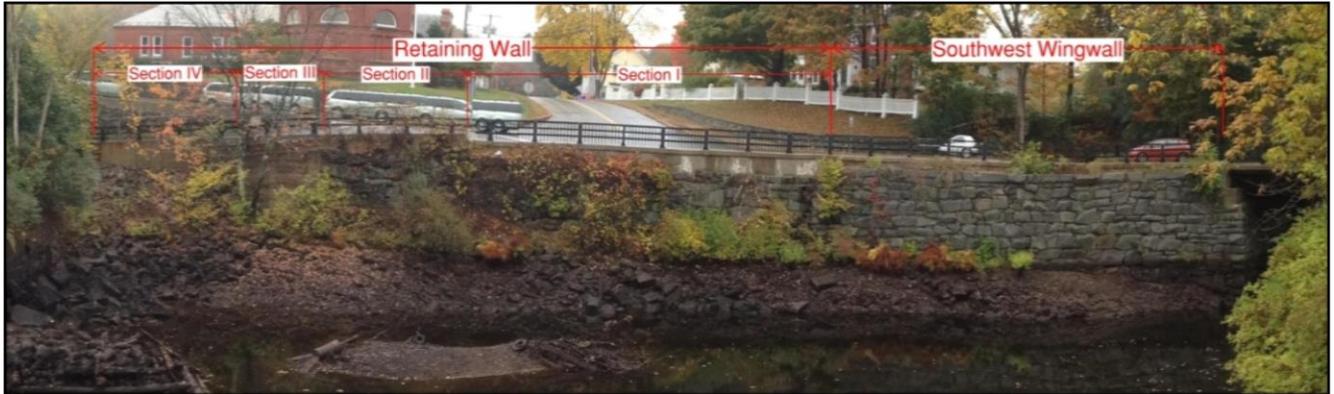
Southwest Retaining Wall Elevation

- Overall the southwest retaining wall and transverse wall adjacent to the dam on the right side of the river between the bridge and dam are in satisfactory condition. Although there is minor local bulging of the stones, the walls remain stable. The stone in front of the walls appears stationary and provides some protection from scour.
- The condition of the Durham Book Exchange building foundation (right side of river, immediately below dam) is good as no concerns related to scour were observed. The condition of the Selectwood Building (left side of river, just upstream of the dam) foundation is poor and appears to be settling and unstable. Scour protection should be investigated for this building.

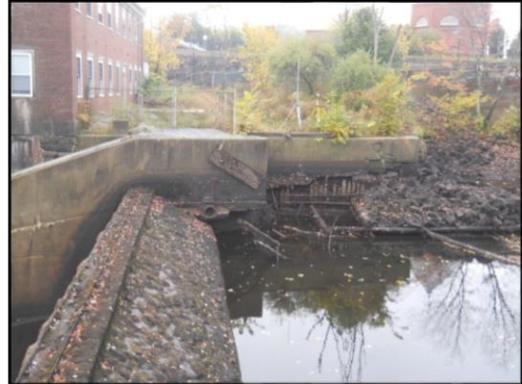
Transverse Wall Adjacent to Dam

The transverse wall adjacent to the dam abuts the old timber crib, which is filled with stone. The section of wall near the retaining wall consists of stone with a regular bond and transitions to a stone base with a concrete cap. There are tilted stones and many chinking stones throughout locations adjacent to the cribbing. There is a pipe through the base of the stone wall. Behind the wall are trees and heavy vegetation and in front of the wall, except at the cribbing end, are large stones.

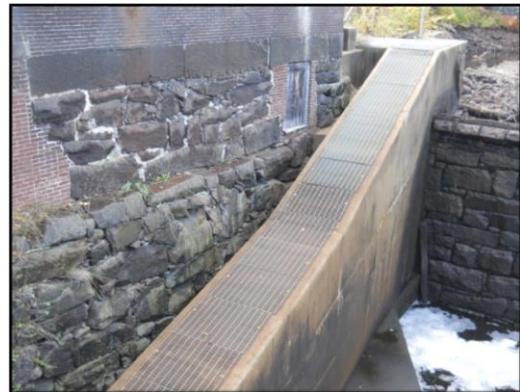
Durham Book Exchange Foundation

The owner noted that the building was built in 1840. The masonry building has a stone foundation and water has leaked through during high flows. The transverse wall adjacent to the dam is shorter than the gate system west of the dam; therefore, during high flows the water overtops the transverse wall and flows towards the building. Town personnel have been placing sandbags behind the transverse wall to divert the overflow water away from the foundation during high flows, which has prevented water from leaking into the building foundation.

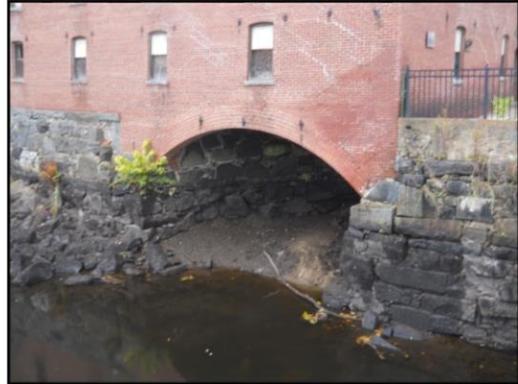
Selectwood Building Foundation

The concrete columns supporting the penstock closure, adjacent to the parking lot, are severely deteriorated at the normal water elevation. The owner has recently filled a sink hole that formed adjacent to the closed penstock and parking lot with stone fill. At the open penstock, sunlight was observed coming through the downstream corner bearing stone. This would indicate that the masonry arch is moving and settling. The concrete footings supporting the first floor wood columns exhibit minor concrete spalling and are undermined.

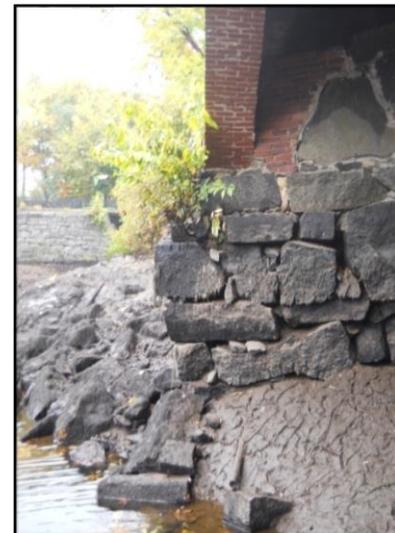
Selectwood Building Foundation  
(Upstream)

The condition of the Selectwood Building foundation is poor and appears to be settling and unstable. Scour protection should be investigated for this building. As mentioned above, the owner is aware that the foundation will require further evaluation.

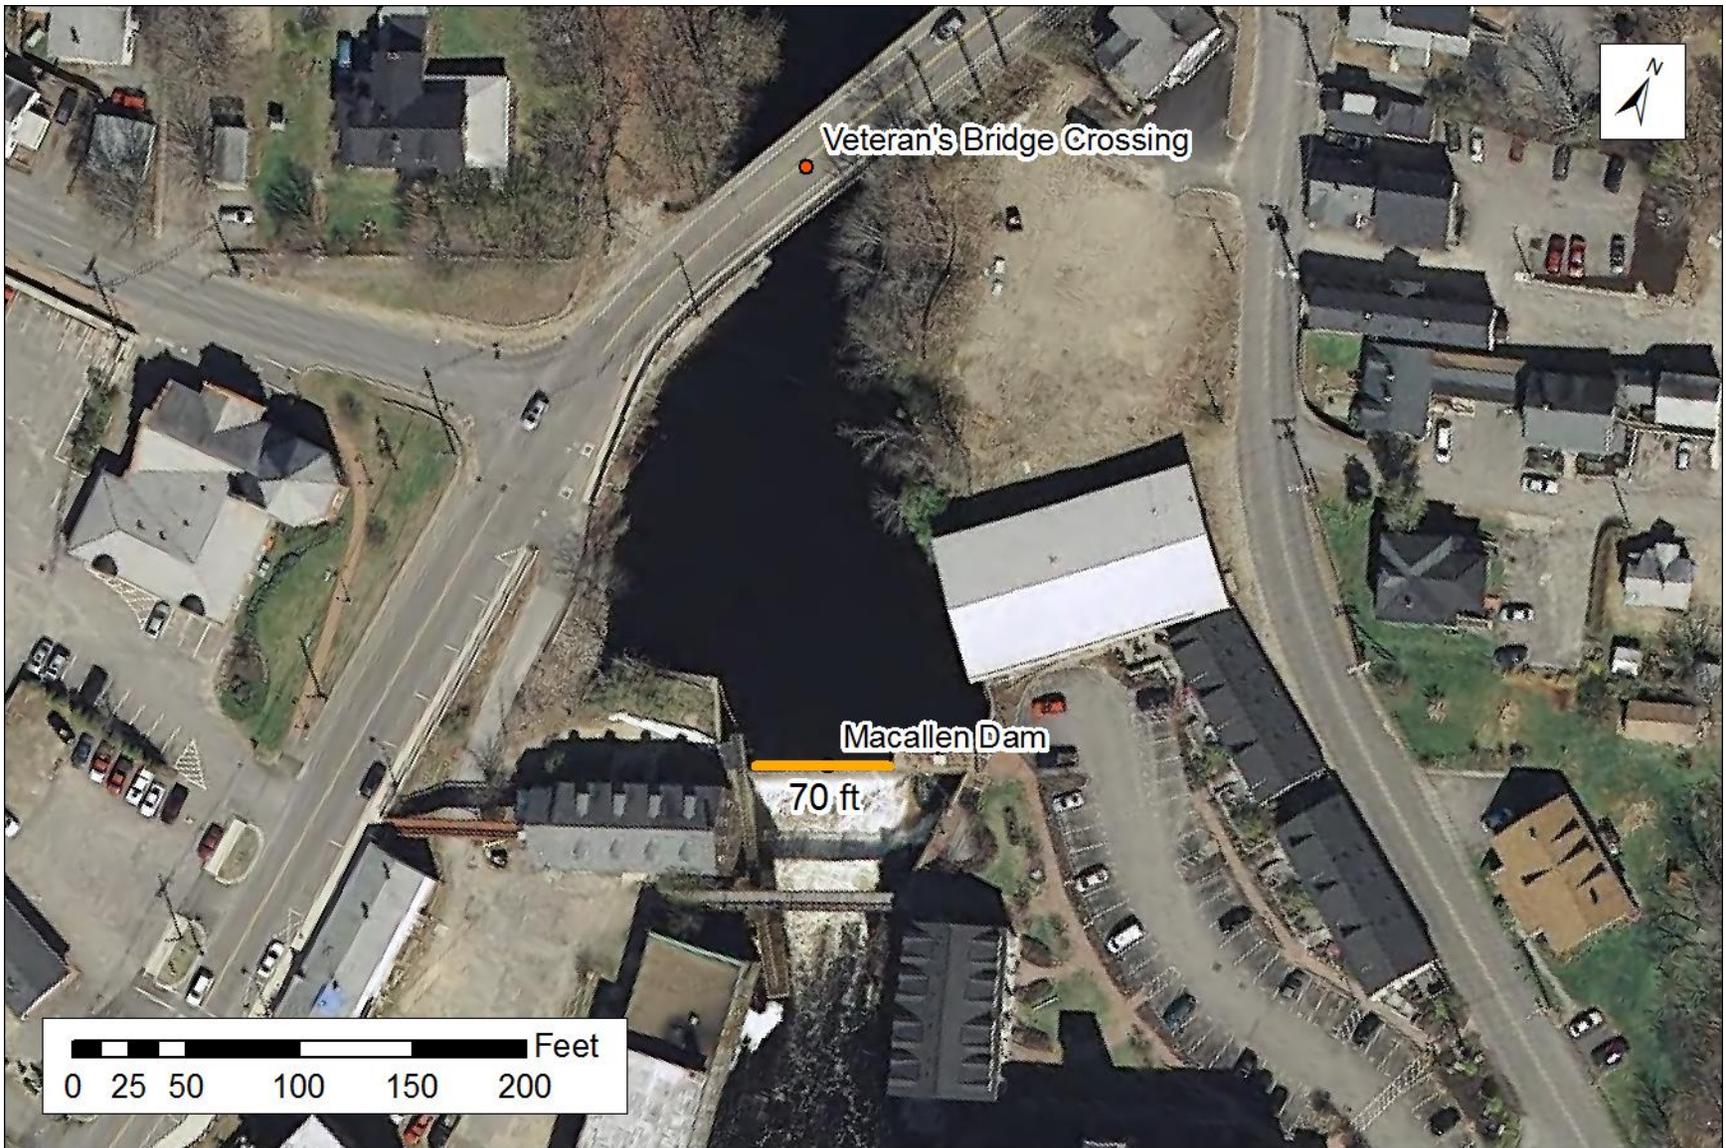
Figure 2.1-2: Aerial close-up of Macallen Dam

The Macallen Dam is located on the Lamprey River in downtown Newmarket, NH. Figure 2.1-1 is an aerial map of the impoundment; Figure 2.1-2 is a close-up aerial view of the dam. Based on existing mapping and survey conducted as part of this study, an existing conditions plan of the dam and project area was developed as shown in Figure 2.1-3. The dam is readily visible from the Veterans Bridge (Route 108) located immediately upstream of the dam, from the walkway spanning the Lamprey River below the dam, and from various locations on each side of the river. There is considerable infrastructure development around the dam including buildings and parking lots (see Figures 2.1-2 and 2.1-3) making access for a potential dam removal challenging. The dam creates an impoundment extending approximately 2.5 miles up the Lamprey River and approximately 0.75 miles up the Piscassic River – a major tributary to the Lamprey River. The impoundment extends into Durham, NH and creates several backwater/bay areas, including an impounded area nearly circling what is referred to as Moat Island. The dam's presence creates a backwater extending up the Piscassic River from its confluence with the Lamprey River to the bedrock falls marking the upstream extent of the Macallen Dam impoundment.

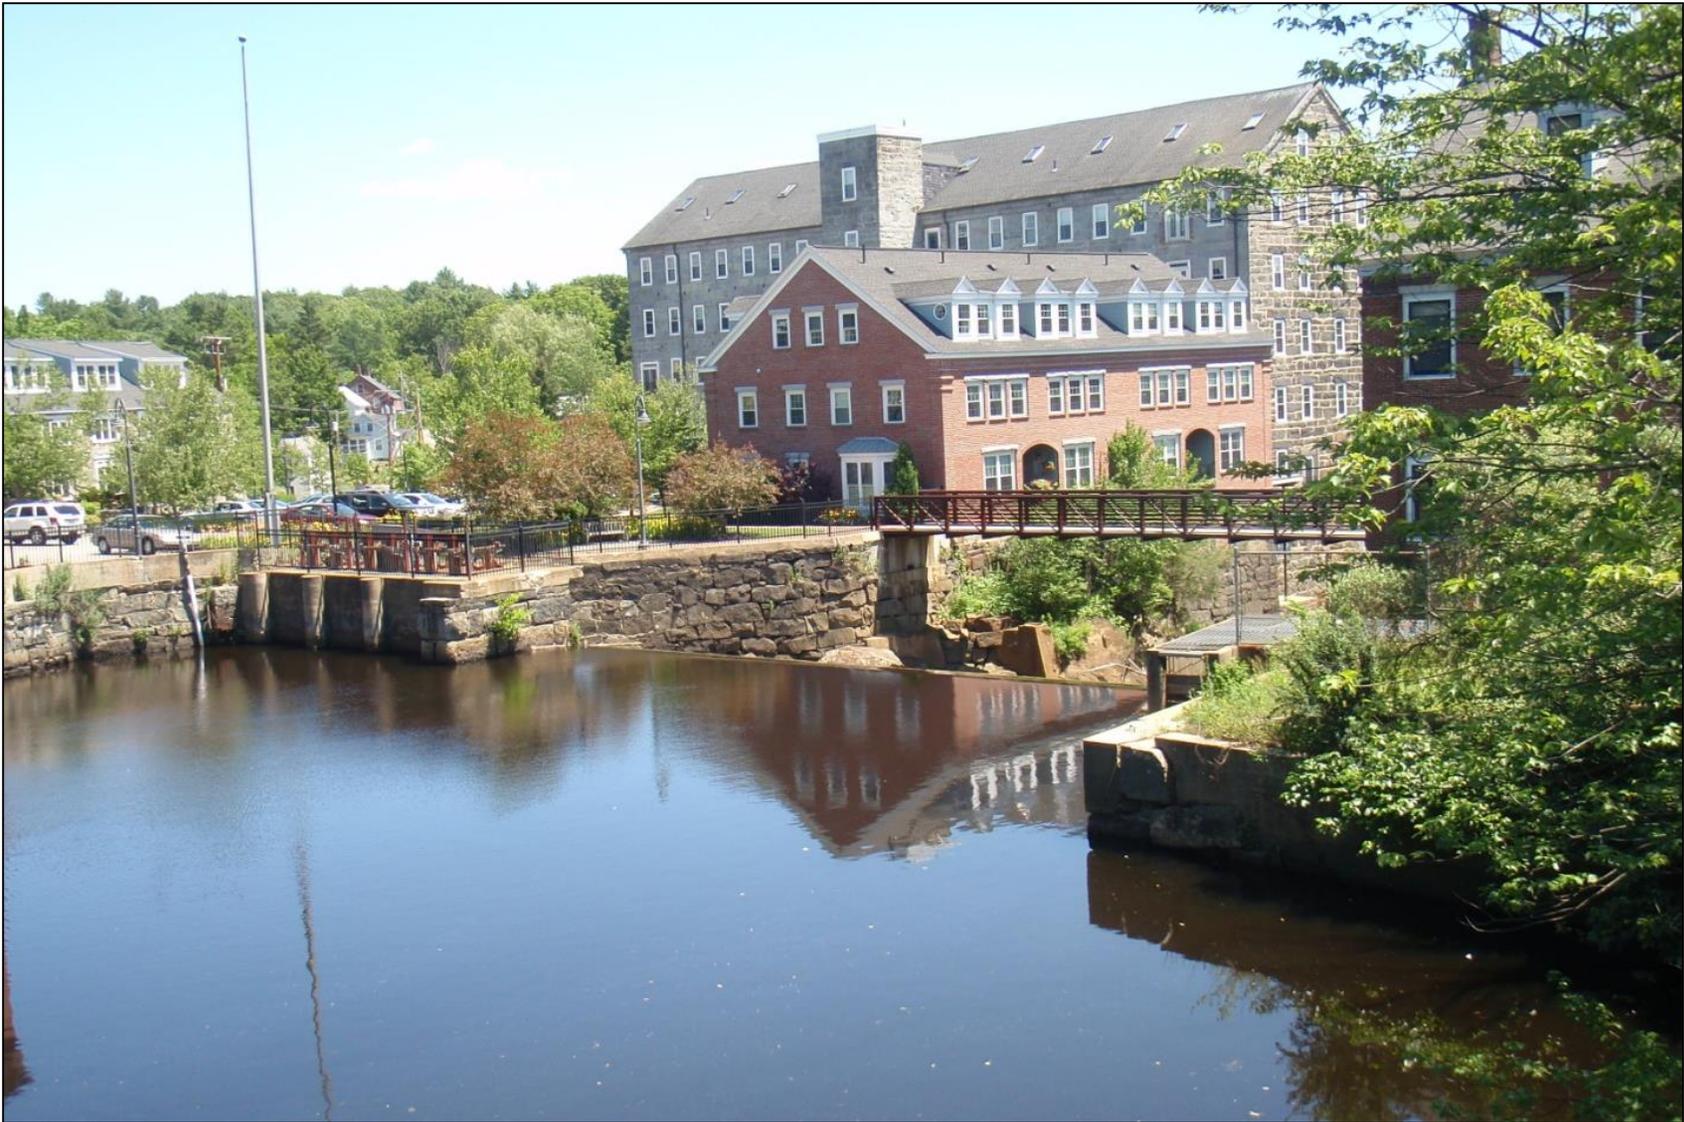
Figure 2.2-1: Looking downstream toward Macallen Dam's left abutment, right abutment and spillway sections. Photo taken July 2012.

The dam consists of the following three main sections: the right abutment (Figure 2.2-1), the spillway section (Figure 2.2-2), and the left abutment/crest gate section (Figure 2.2-3). The right abutment is a stone-block and concrete wall, which is structurally attached to the fish ladder. The right abutment has

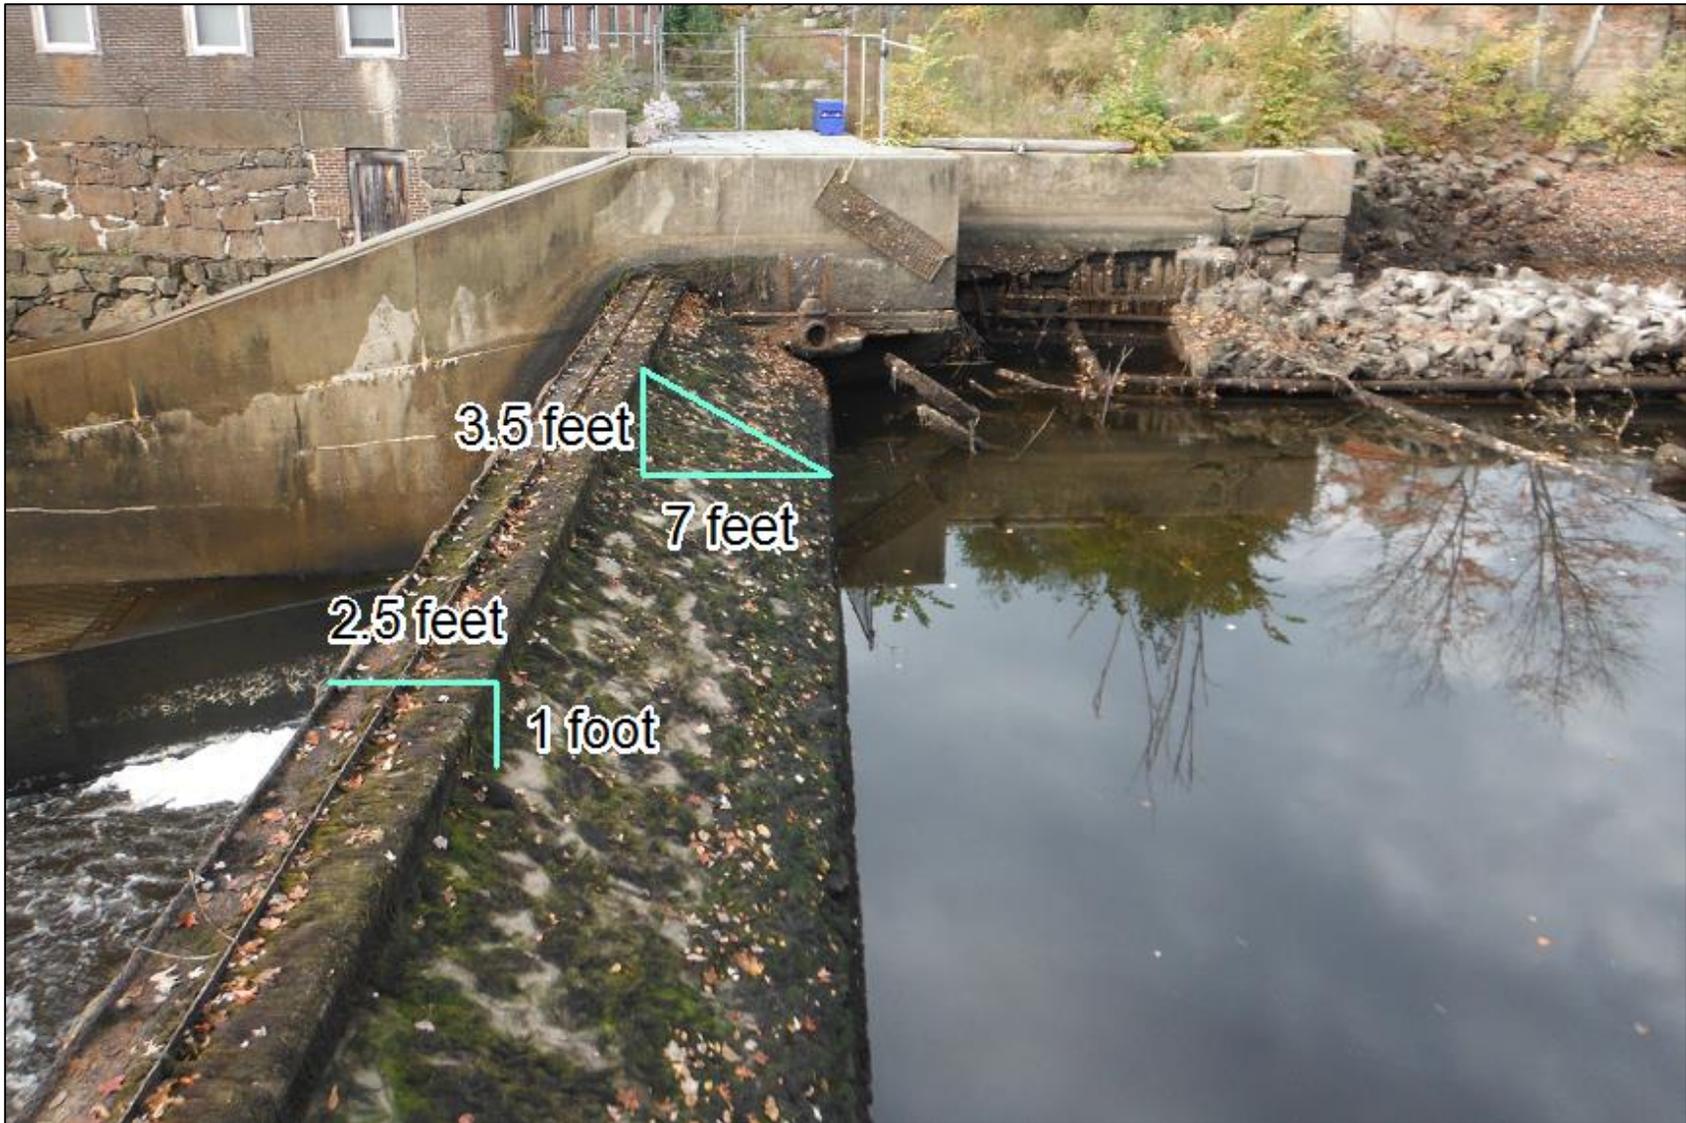
Figure 2.2-2: Photo of the dam's right abutment and spillway sections, including geometry of the sloped upstream face of the dam. Photo taken during the October 2013 drawdown. Note the metal lip running along the center of the spillway crest.

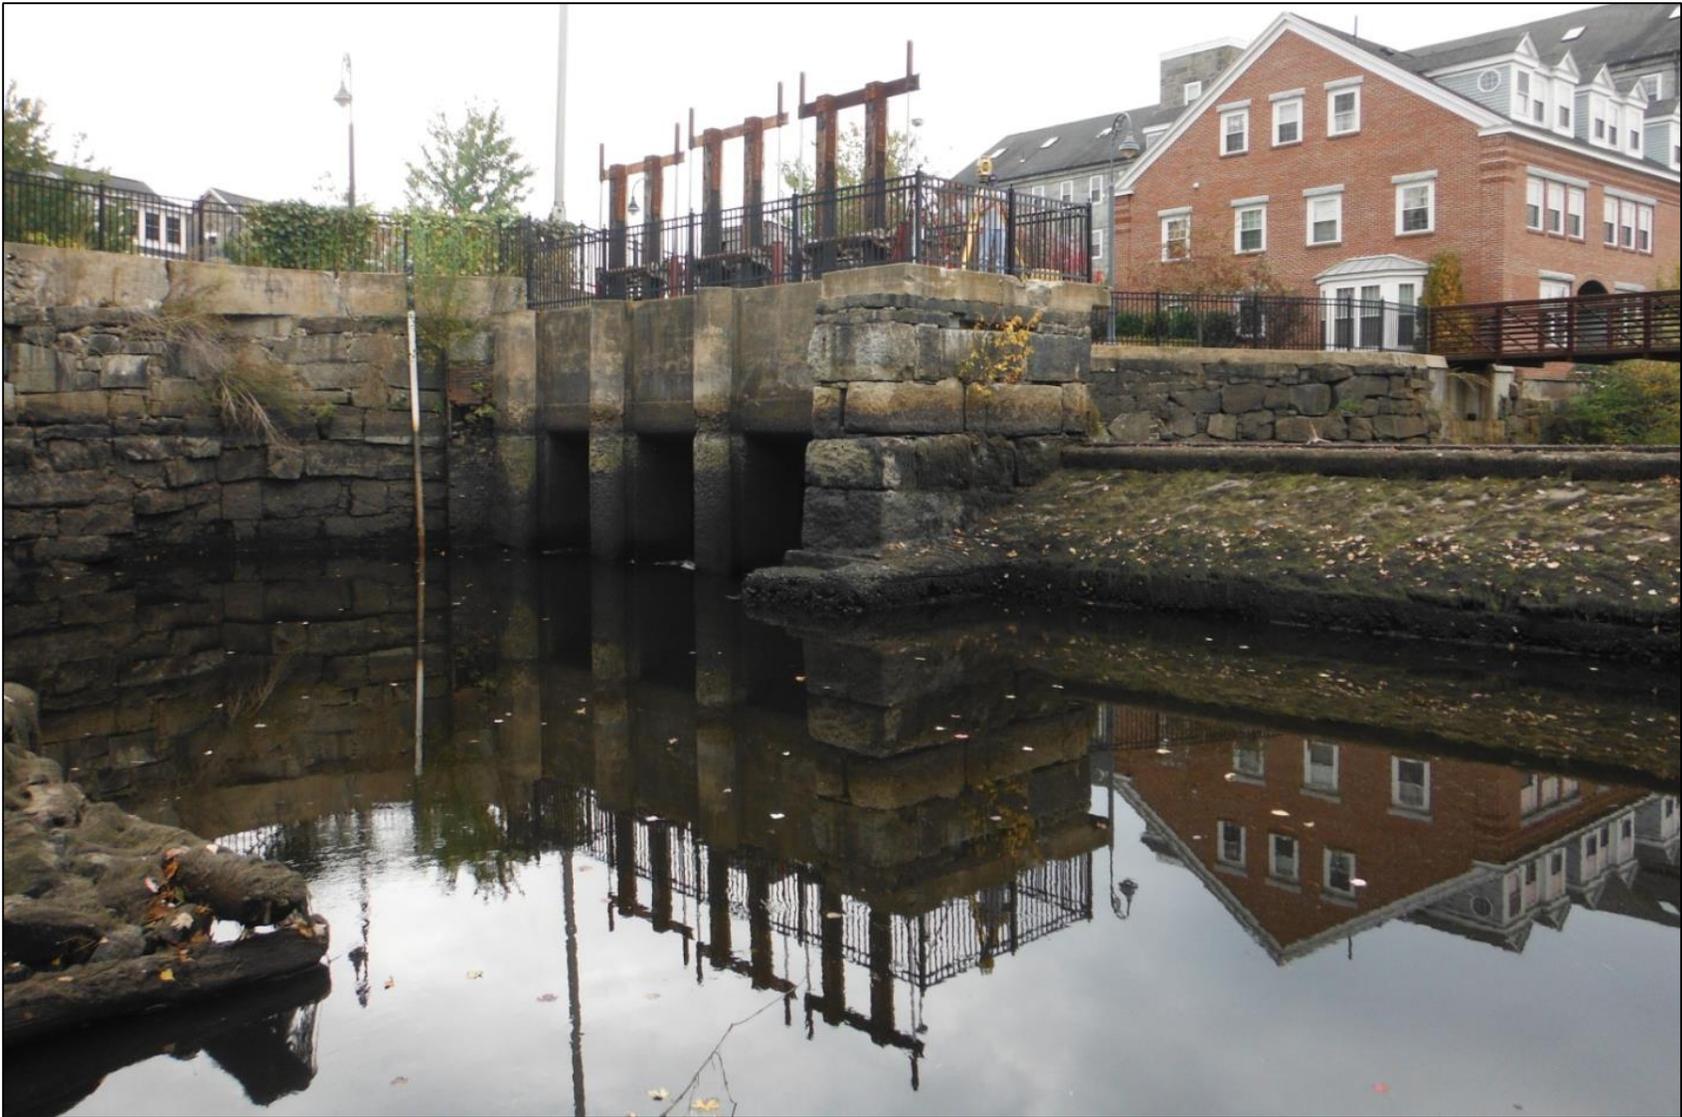
Figure 2.2-3: Left abutment and crest gates. Photo taken during the October 2013 drawdown.

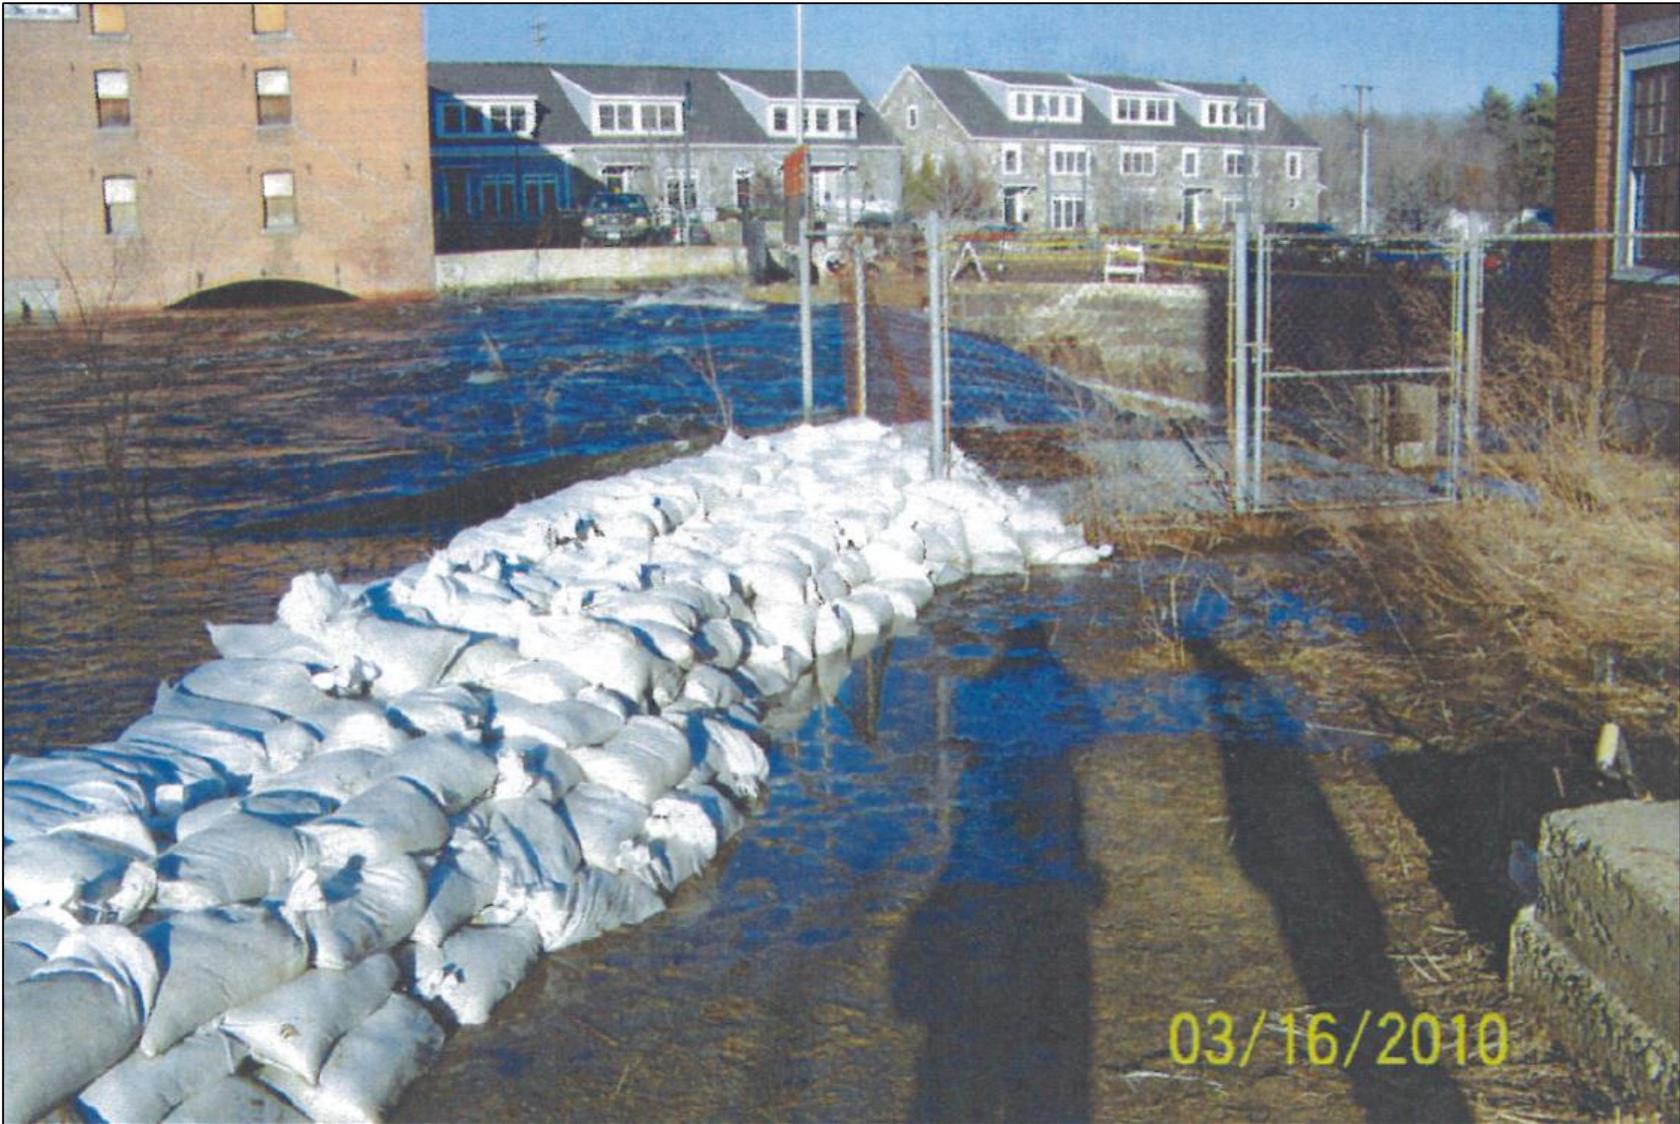
Figure 2.2-4: Macallen Dam during the March 16, 2010 flood event. Flow is approximately 6,710 cfs. Photo is taken from the right abutment, looking toward the spillway and left abutment. Photo source: NHDES Dam Bureau.

The Macallen Dam has two means of passing water: the overflow spillway and the crest gates. During normal hydrologic conditions, flow passes exclusively over the spillway (or a small amount through the fish ladder during certain times of the year). During high flow or flood events, the crest gates are typically opened to allow more flow to pass with the goal of not overtopping<sup>20</sup> the dam. During some recent extreme flood events (May 2006, April 2007, March 2010), the dam abutments were overtopped even with the gates open (Figure 2.2-4), and sandbagging was needed as described later.

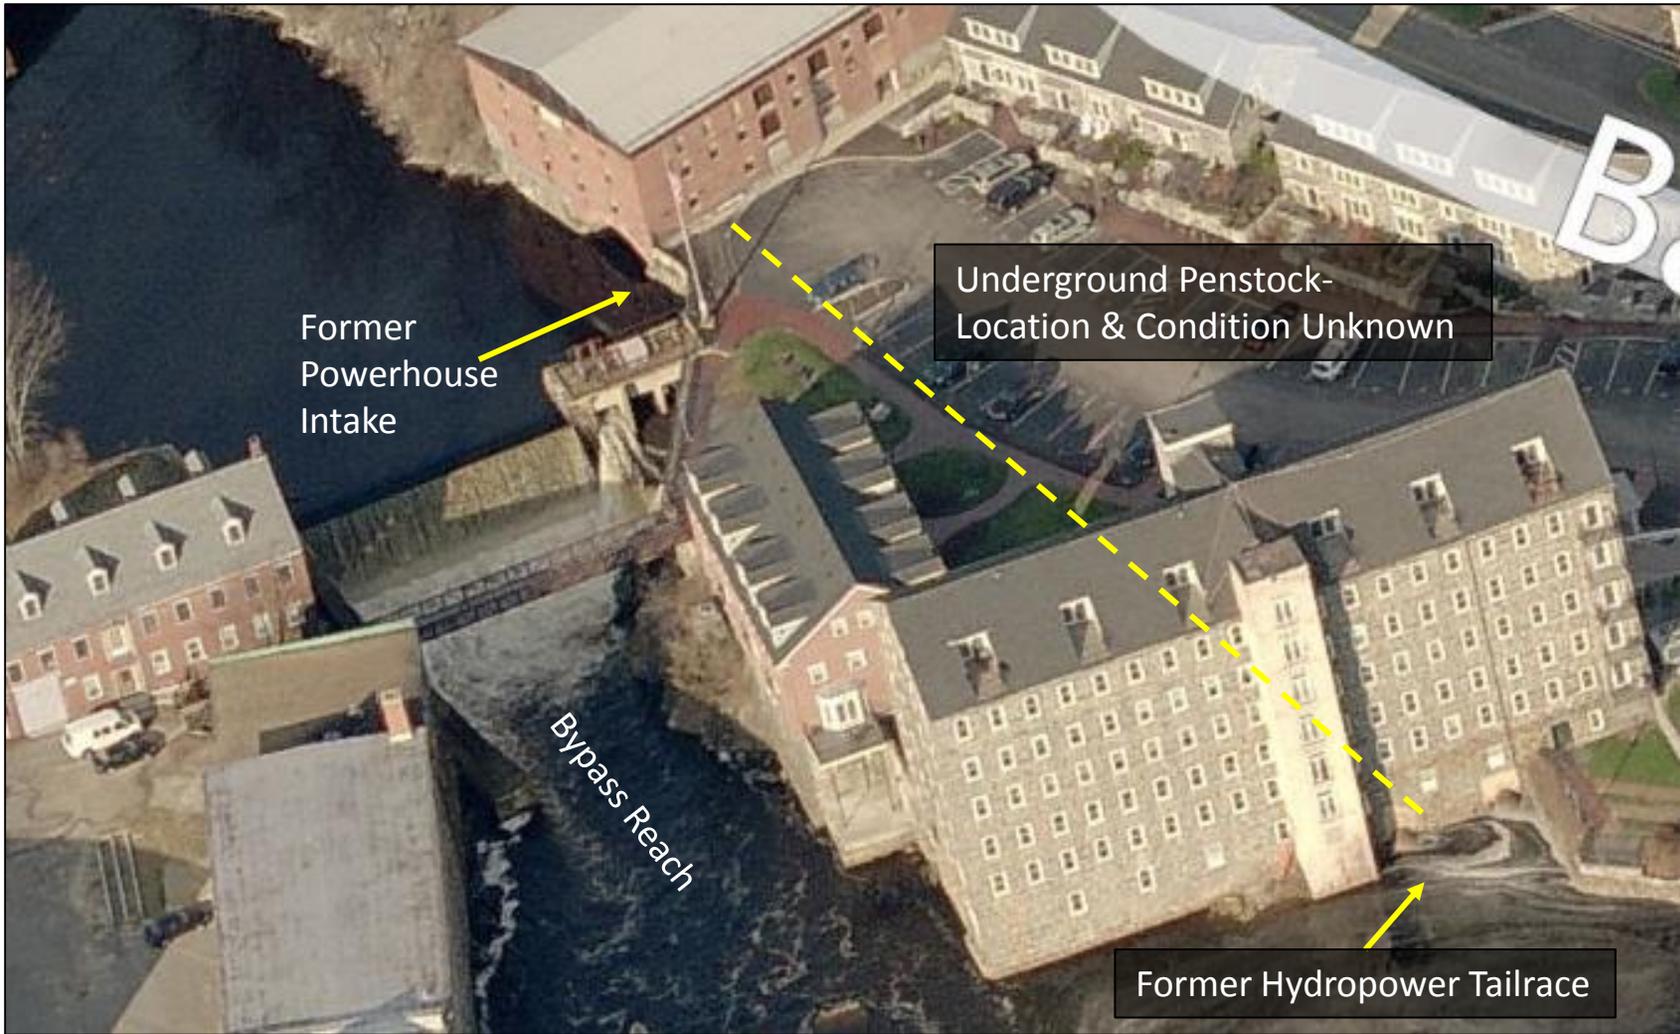
Figure 6.2.3-1: Aerial View of Macallen Dam's Former Hydroelectric Works

There has been considerable discussion about resurrecting hydroelectric power at the Macallen Dam, which previously generated hydroelectric power until the 1950s. It is our understanding that at one time, there was a 500 kilowatt (KW) turbine on the left side of the river and a 50 KW turbine on the right side. It appears that the intake for the 500 KW turbine was located at the arch of the Selectwood Building located adjacent to the dam, and then conveyed flow via an underground penstock to a turbine located in the basement of a building located below the dam (see Figure 6.2.3-1).

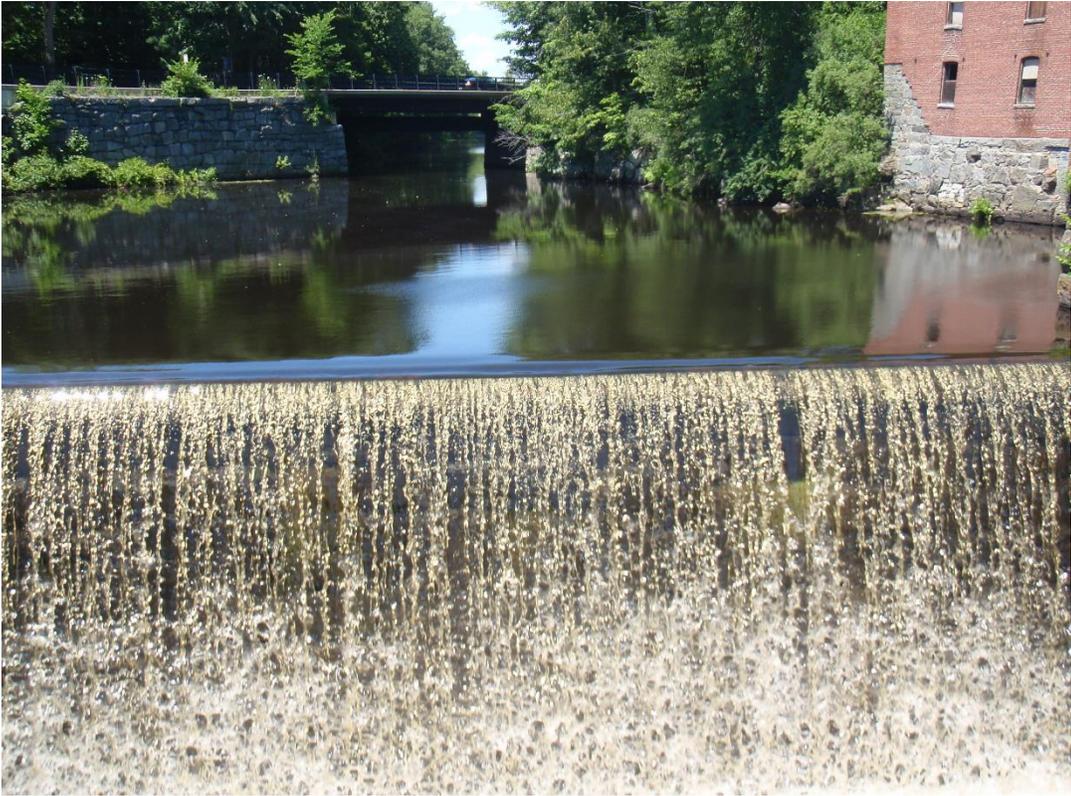
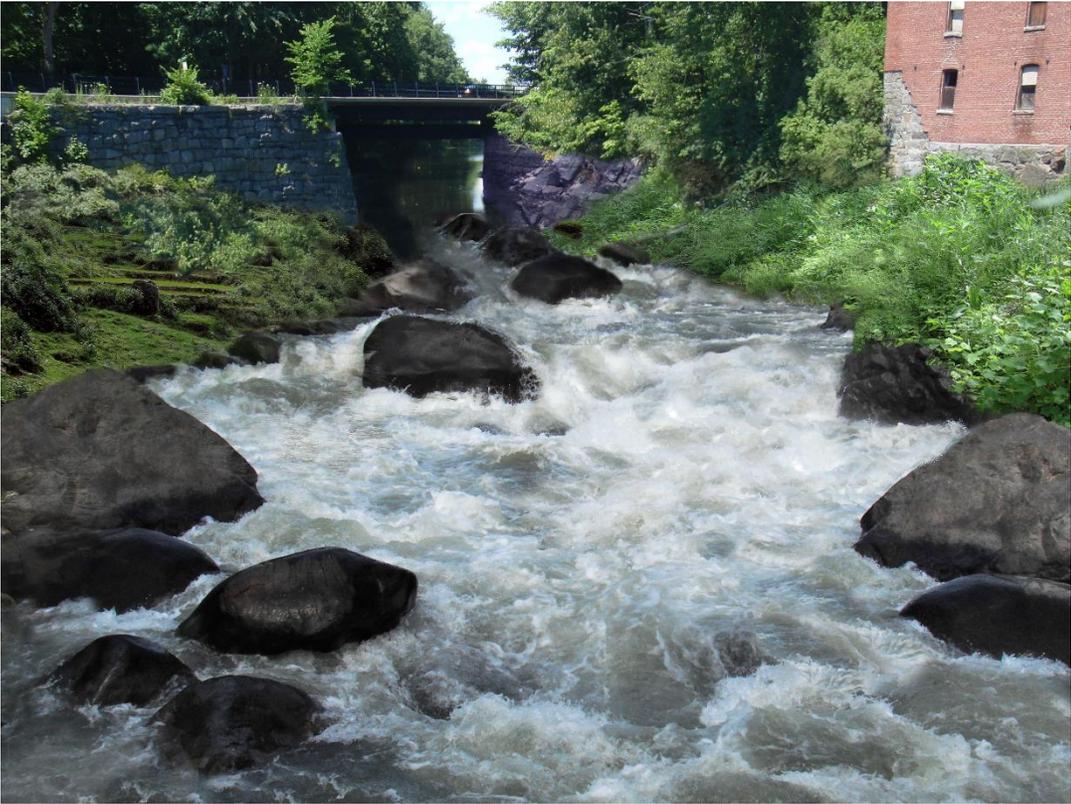
Figure 10.1-2: Visual rendering of Macallen Dam before and after removal

The preliminary dam removal design is based on managing flows during the demolition period of up to 100 cfs (this flow is equaled or exceeded approximately 30% of the time in July, 20% in August and 15% in September). Shown in Figure 10.1-1 is a conceptual plan for removal. A visual rendering showing what the area around the dam potentially may look like after the dam is removed is shown in Figure 10.1-2. The general sequencing steps are described below.
