*Final Feasibility Report*  
*Dam Feasibility and Impact Analysis*  
**Macallen Dam, Newmarket, NH**

**Volume 1 of 2: Main Report**

**Town of Newmarket, New Hampshire**

July 2014

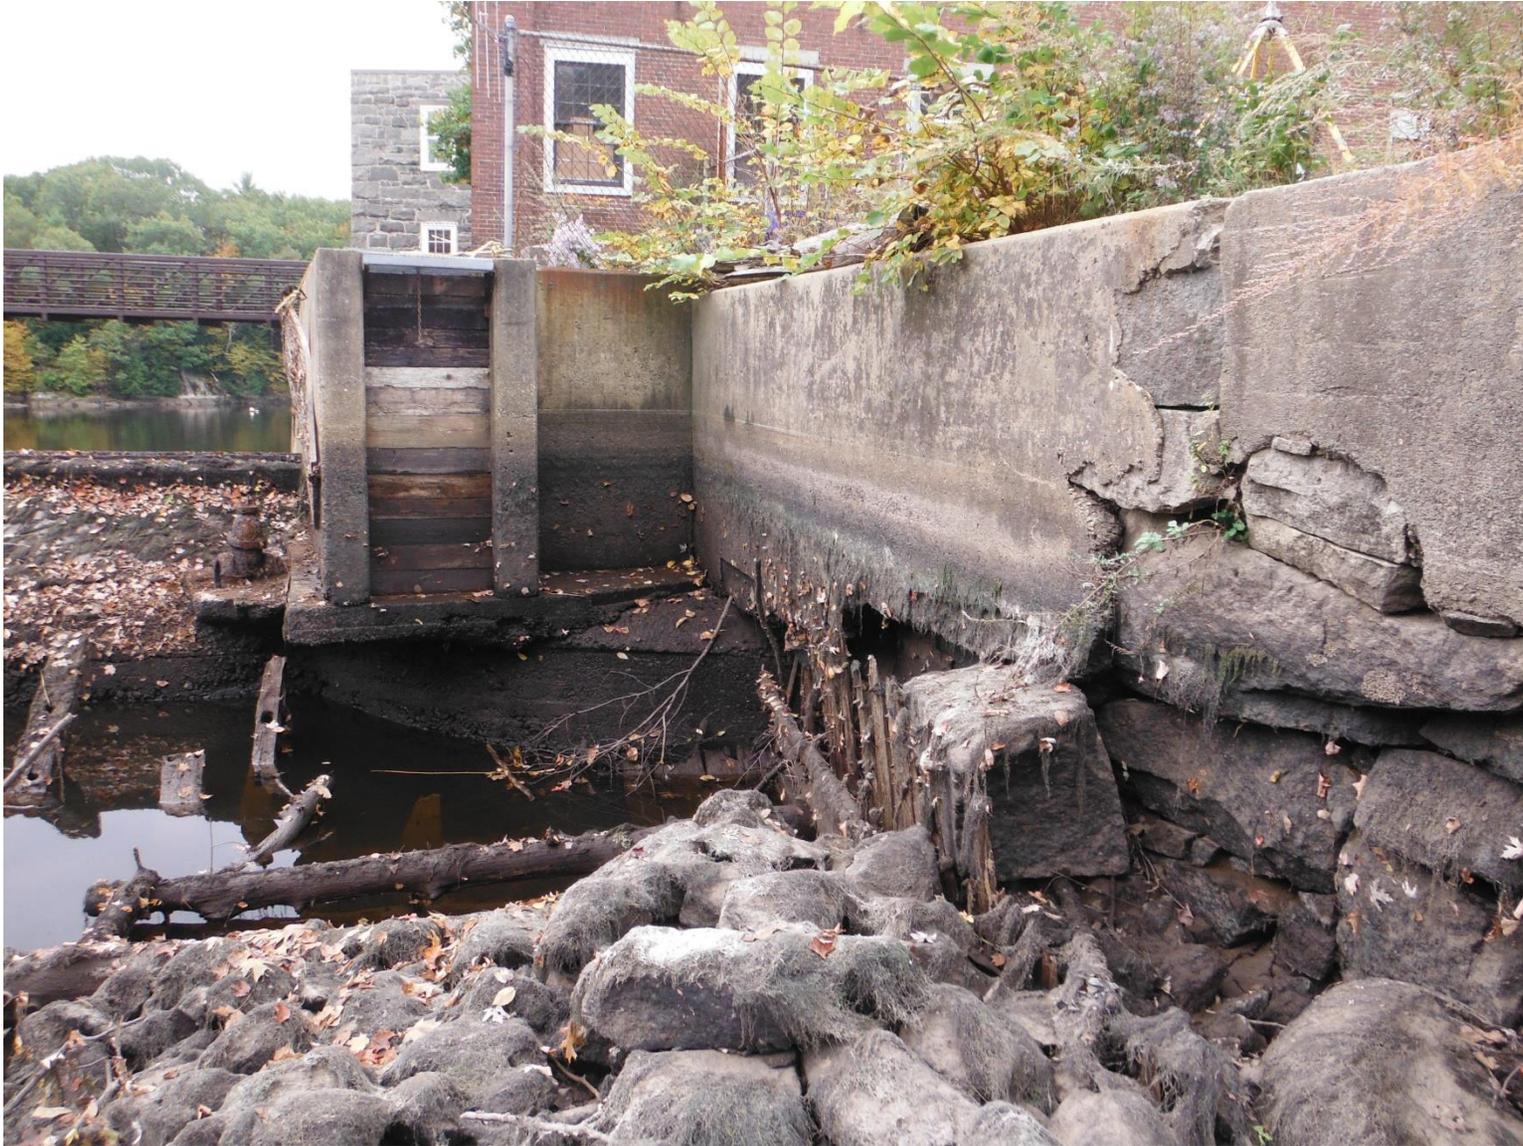
Figure E-4: View of the dam's right abutment, fish ladder and a portion of the legacy timber crib dam. Photograph taken 10/4/2013.

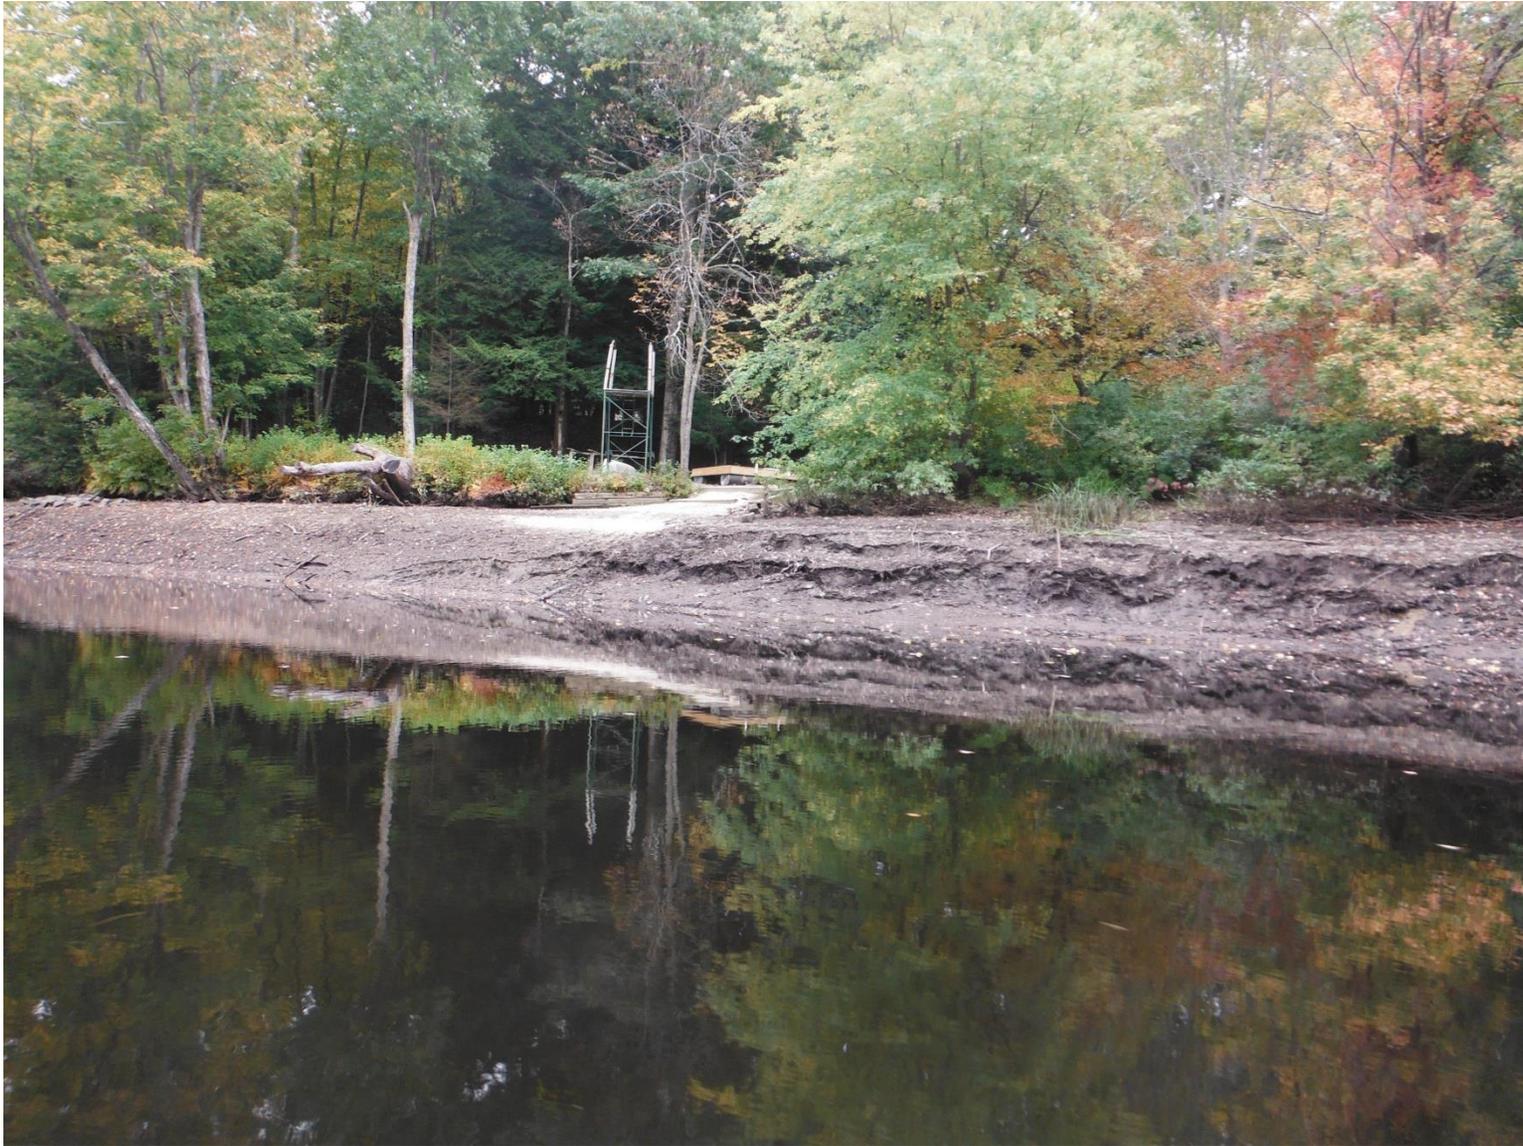
Figure E-9: Sloughing portion of riverbank between Moat Island and the Piscassic confluence. Photograph taken 10/5/2013.

would result in mobilizing instream sediments. In addition, significant sloughing of the river banks was observed during the drawdown.

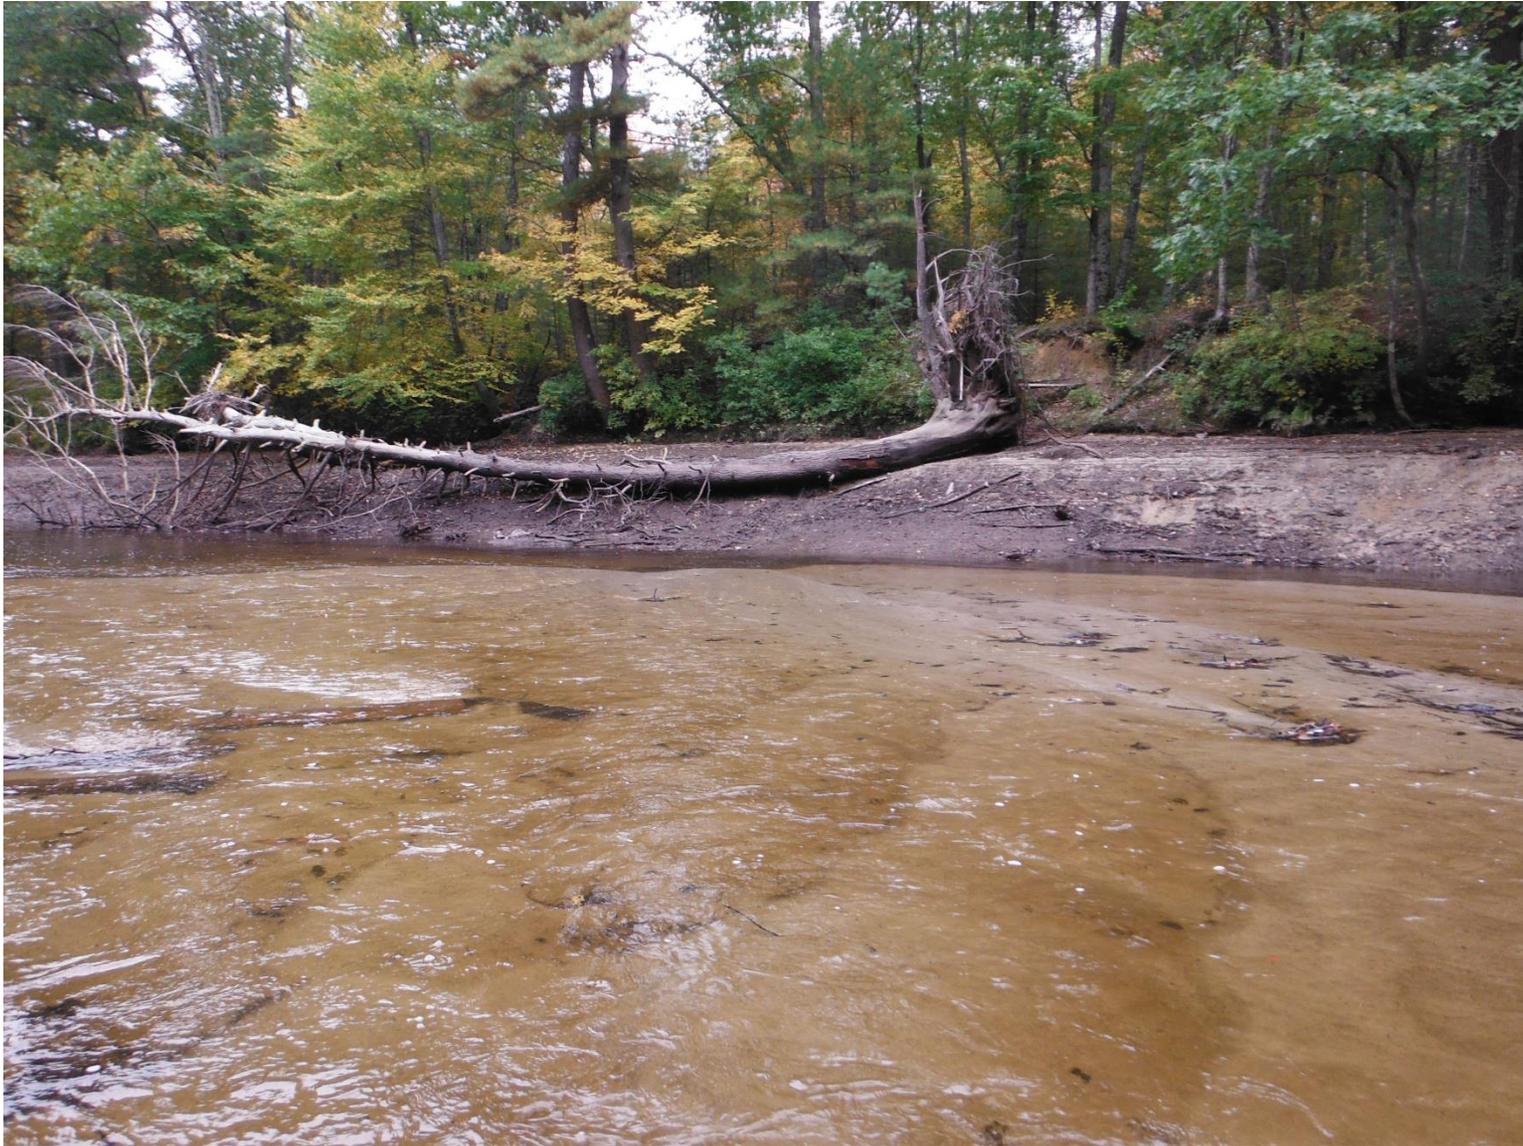
Figure E-14: Shallow riffle section downstream of pool near Packer's Falls. Active erosion noticeable. Photograph taken 10/5/2013.

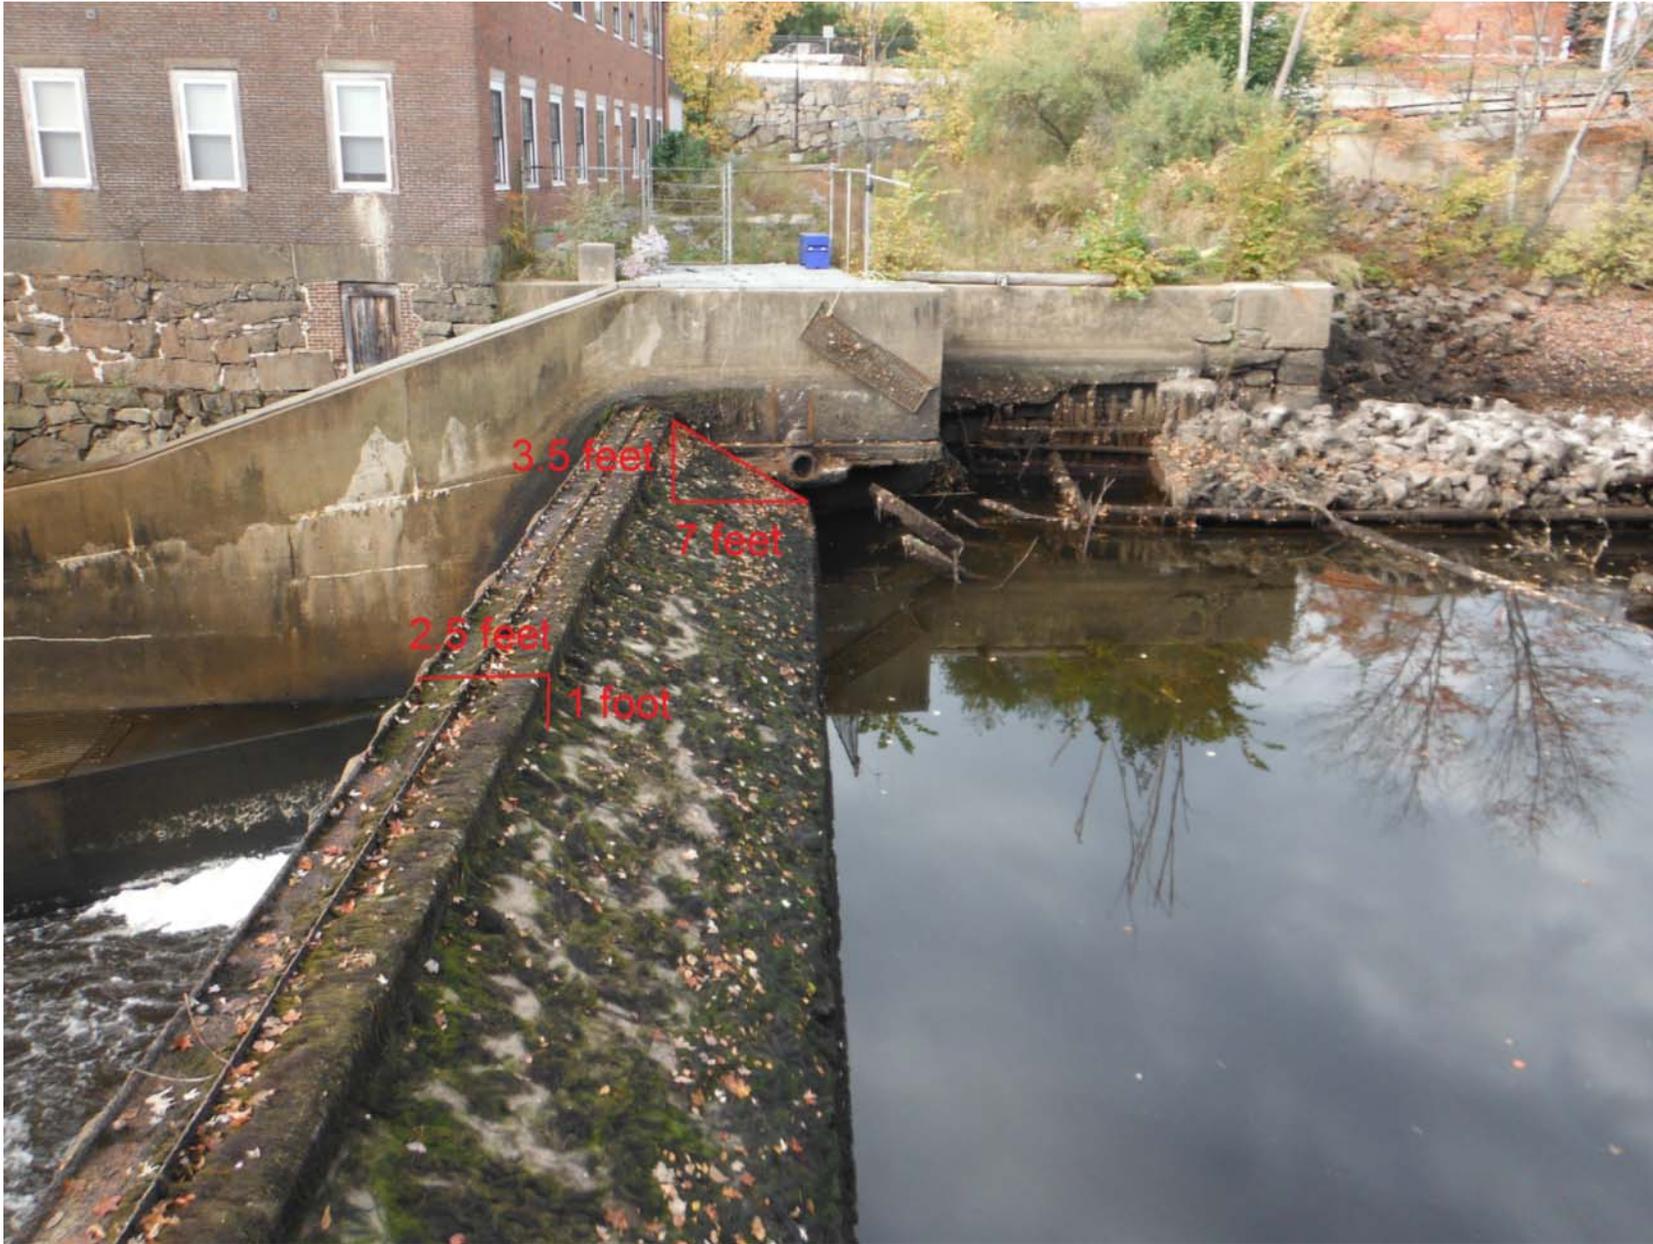
Figure F-1: Side-view of Macallen Dam.

A weir coefficient of 3.32 is approximately 26% higher than the 2.63 weir coefficient used in the W-P report. This translates into the spillway being able to pass 26% more flow than W-P estimated, for a given headwater elevation. Therefore, our hydraulic model and calculations will show lower water surface elevations than the W-P report indicated, when comparing

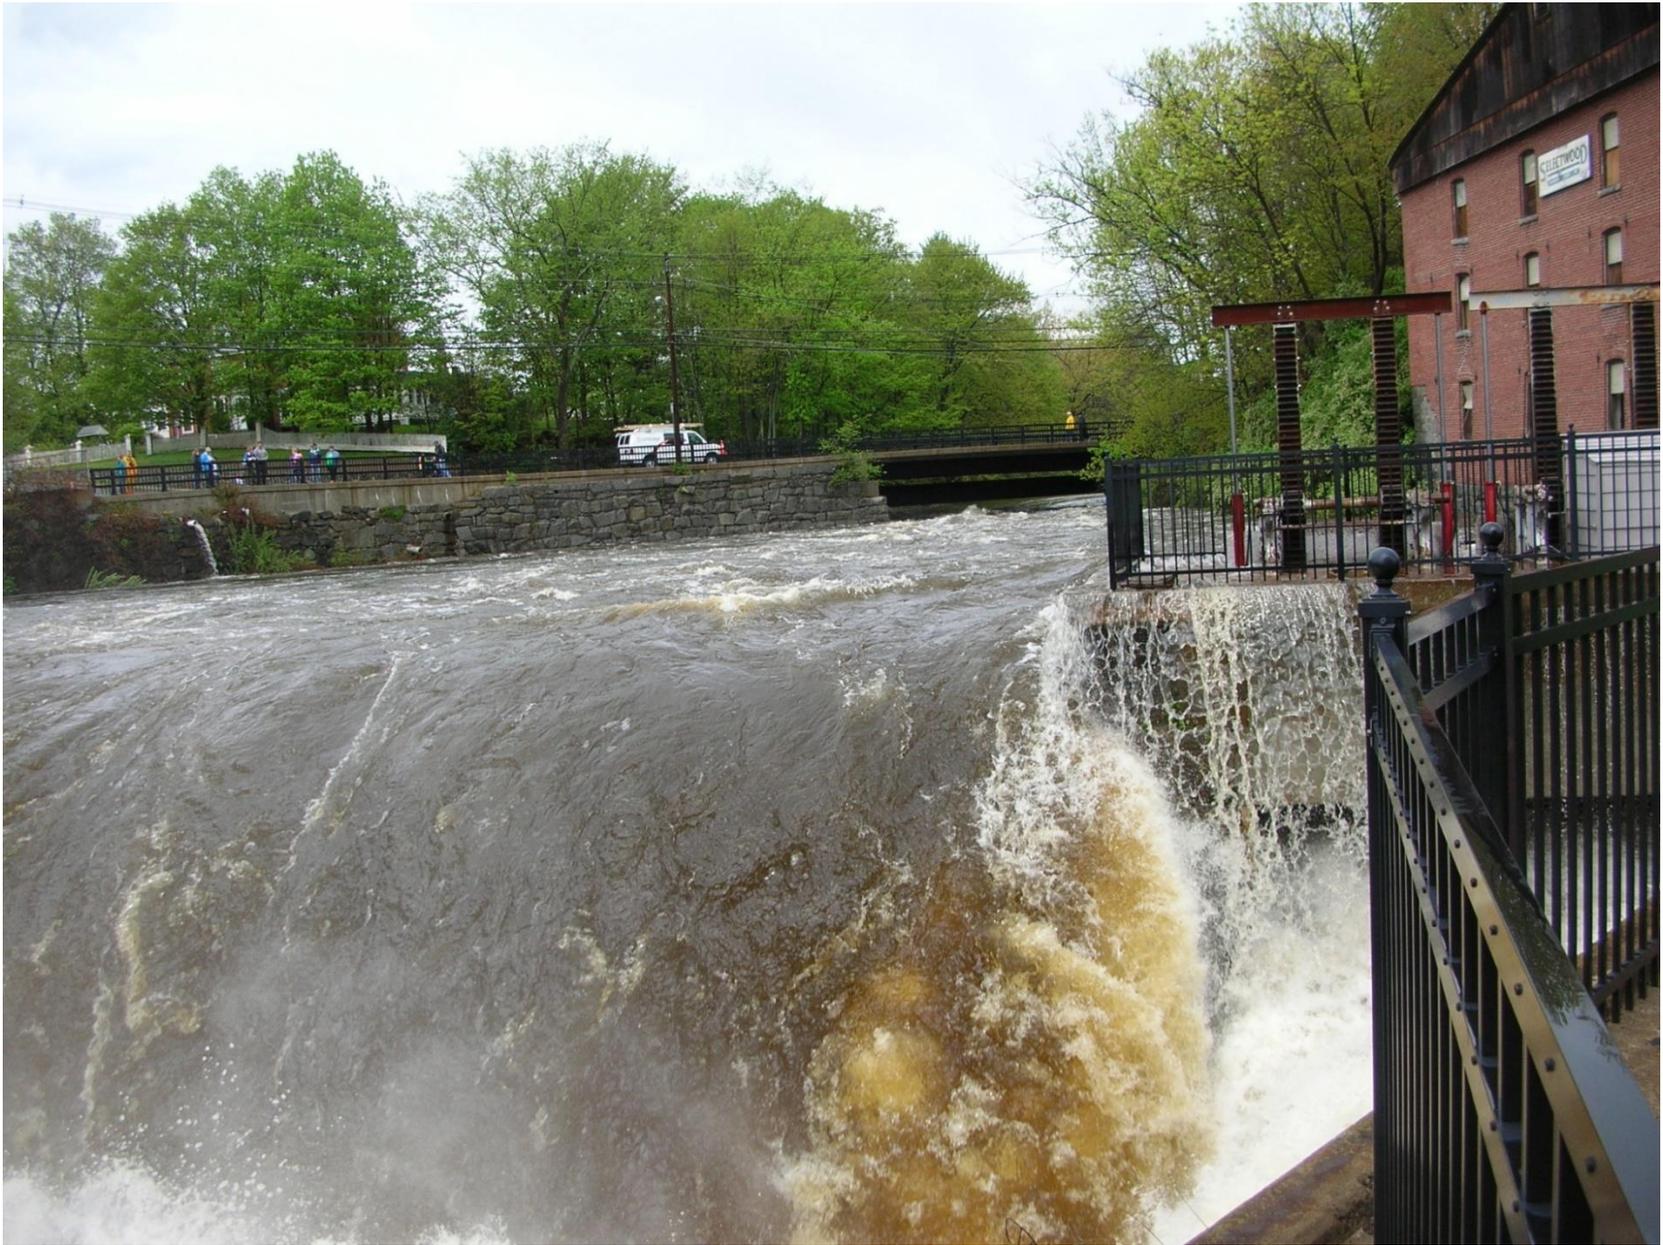
Figure G-1: Macallen Dam during the May 2006 flood, provided by NHDES. Photograph taken morning of May 16, 2006. Photograph used to estimate WSE at Macallen Dam and on downstream side of Veteran's Bridge.

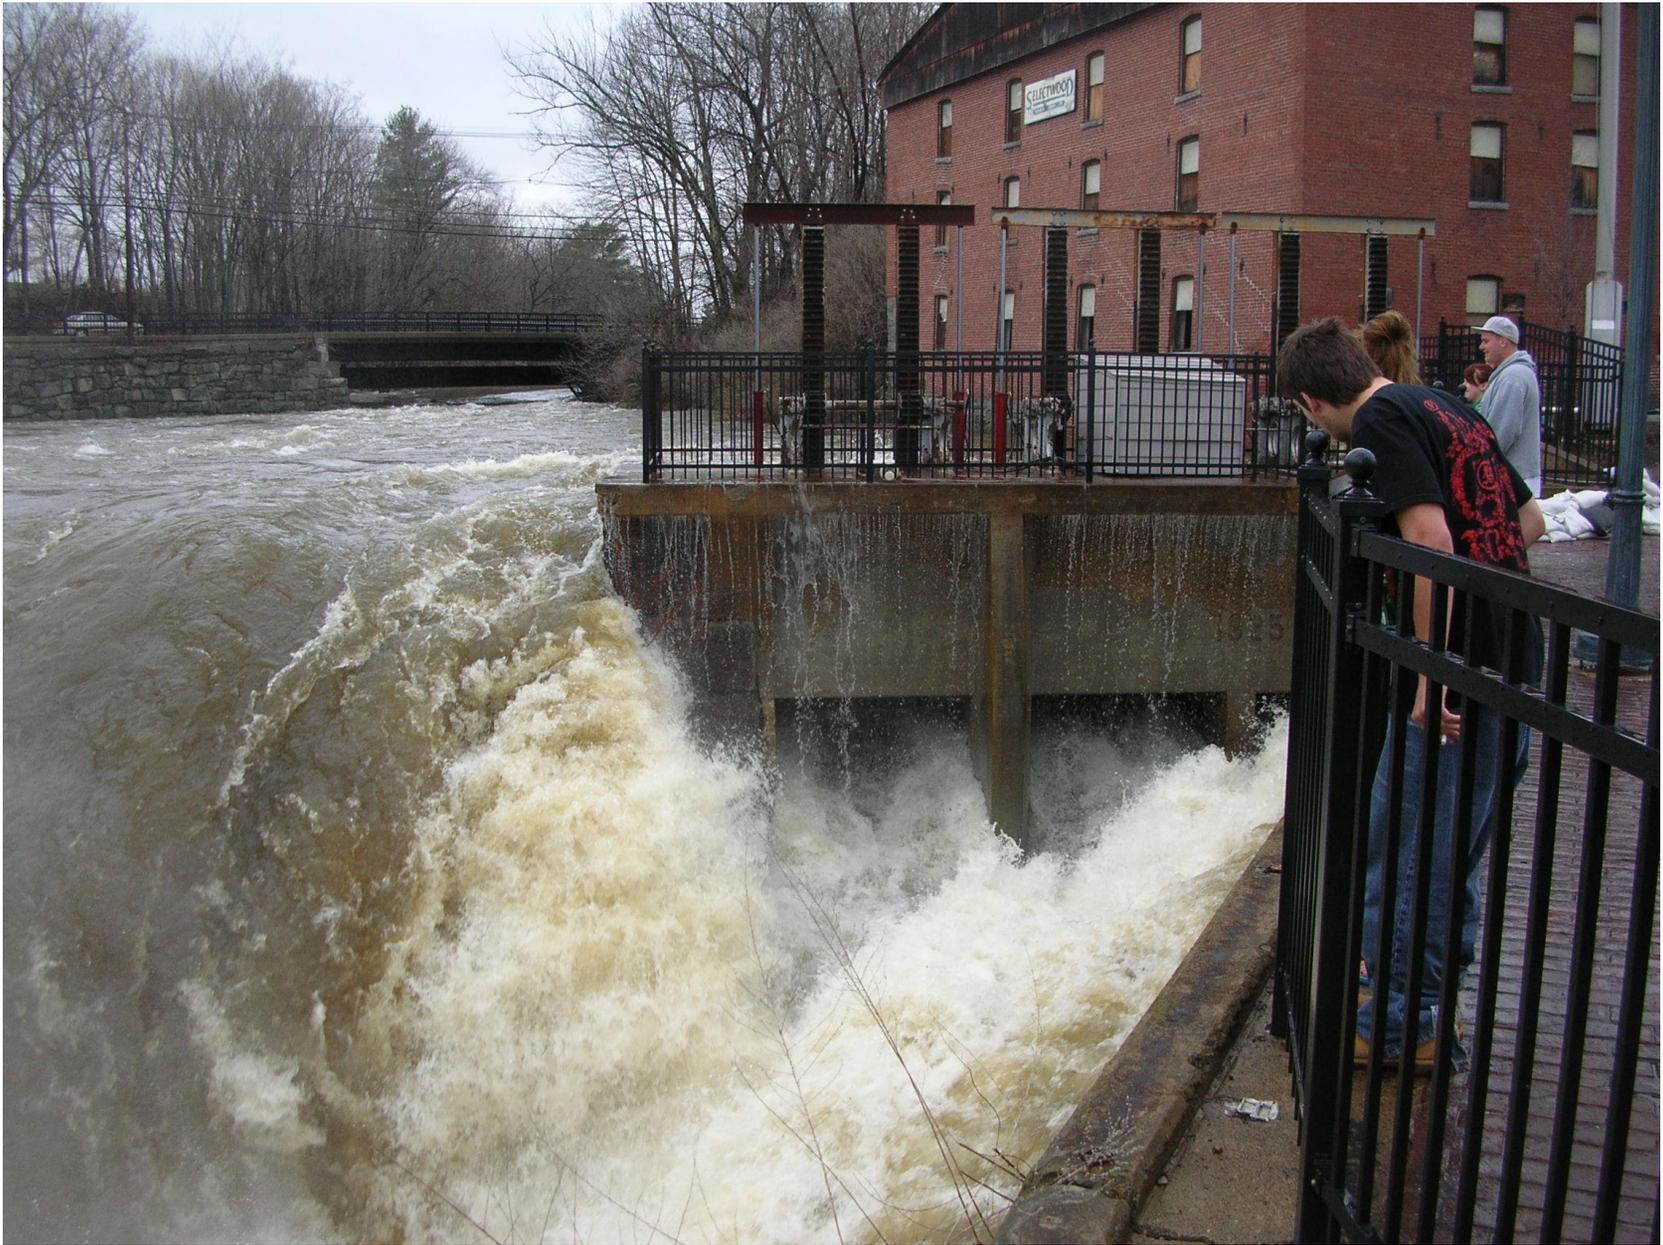
Figure G-2: Macallen Dam during the May 2006 flood, provided by NHDES. Photograph taken morning of May 16, 2006. Photograph used to estimate WSE at upstream side of Veteran's Bridge.

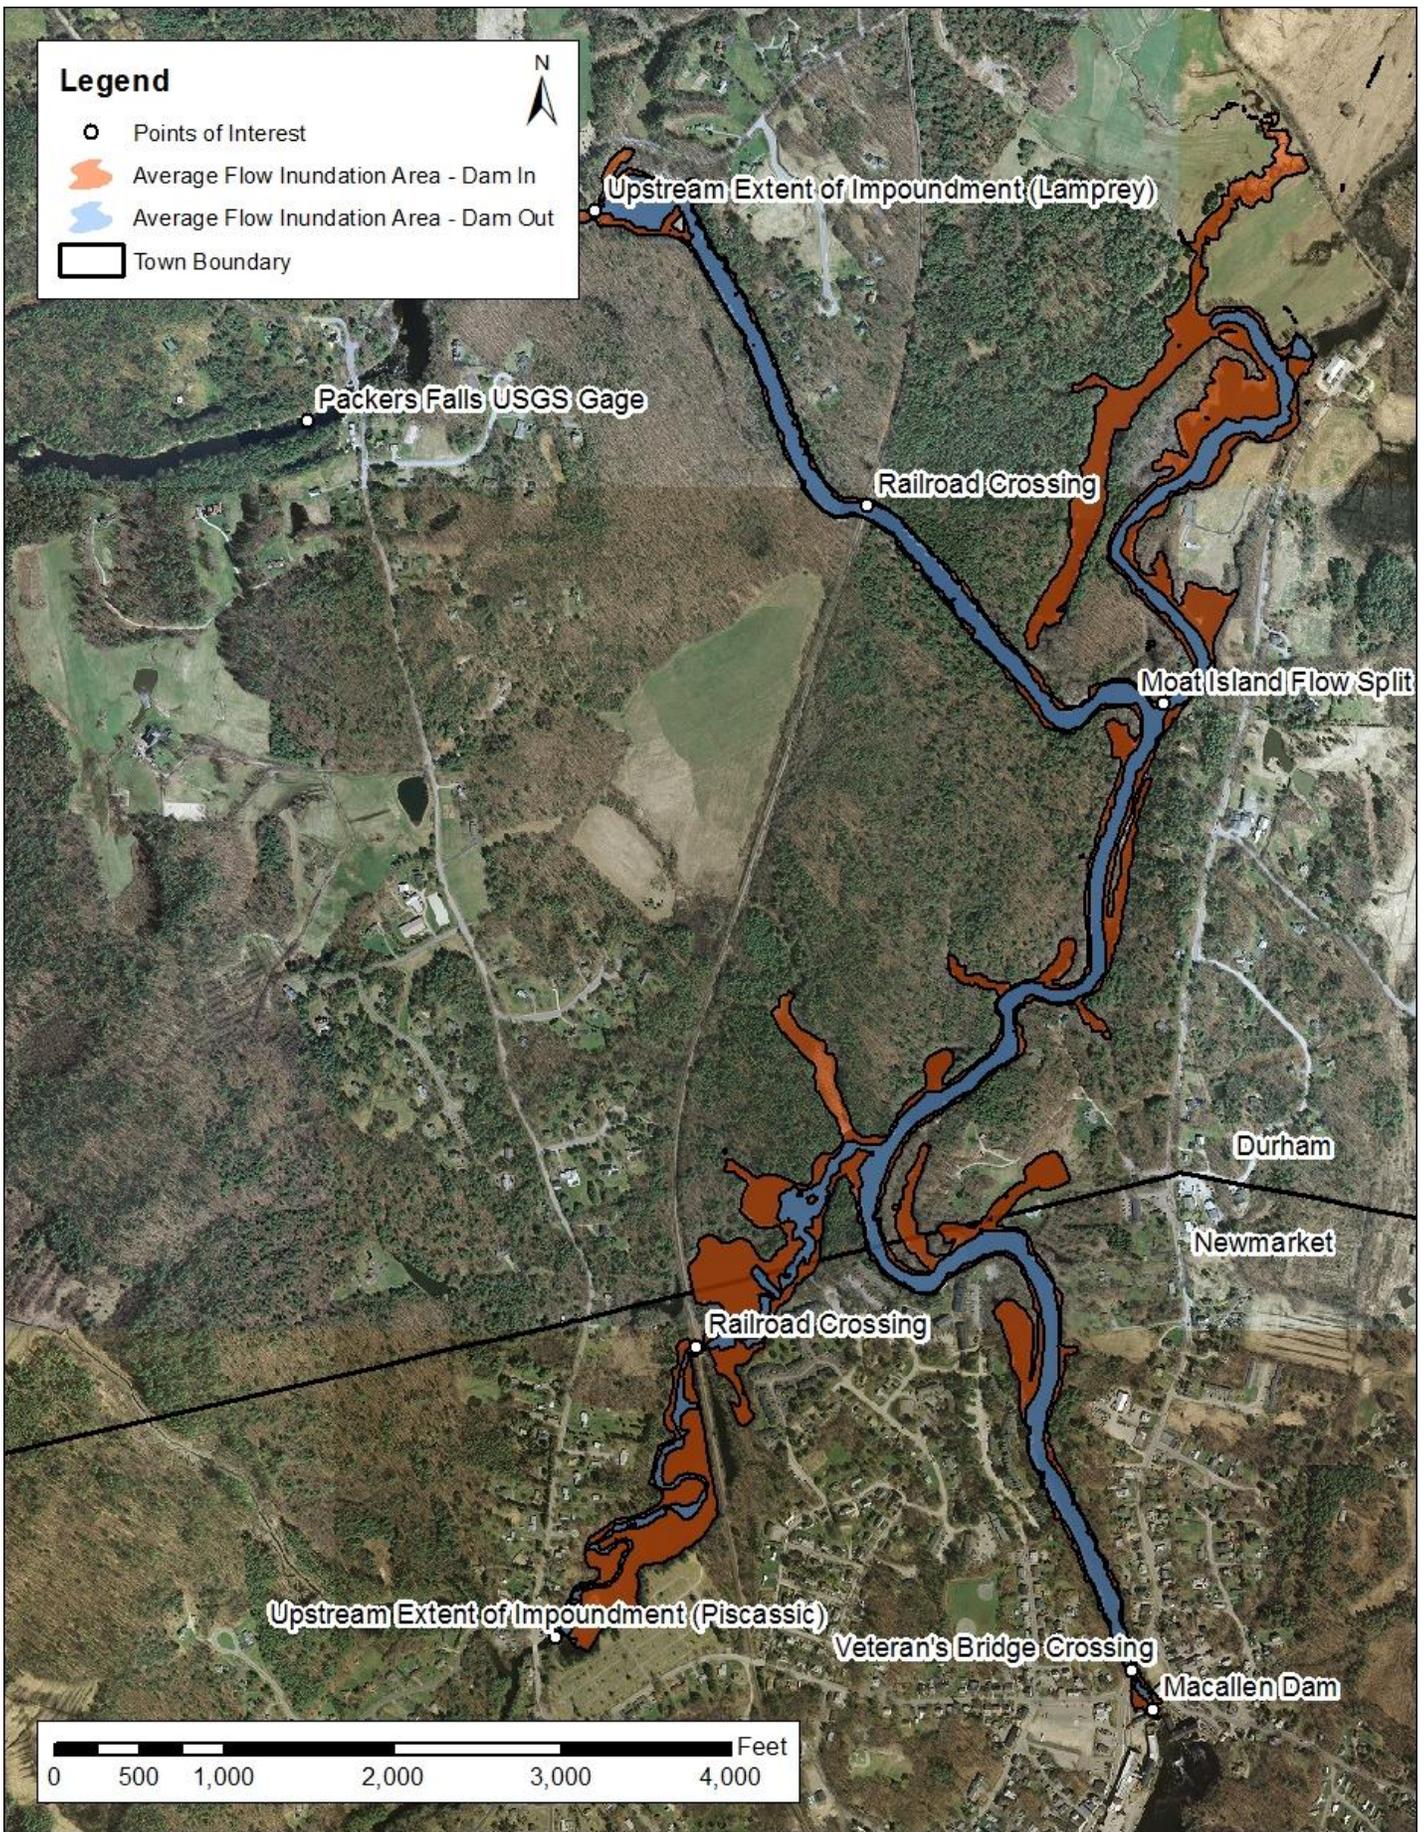
Figure 3. Daily average inundation area within the Macallen Dam impoundment.

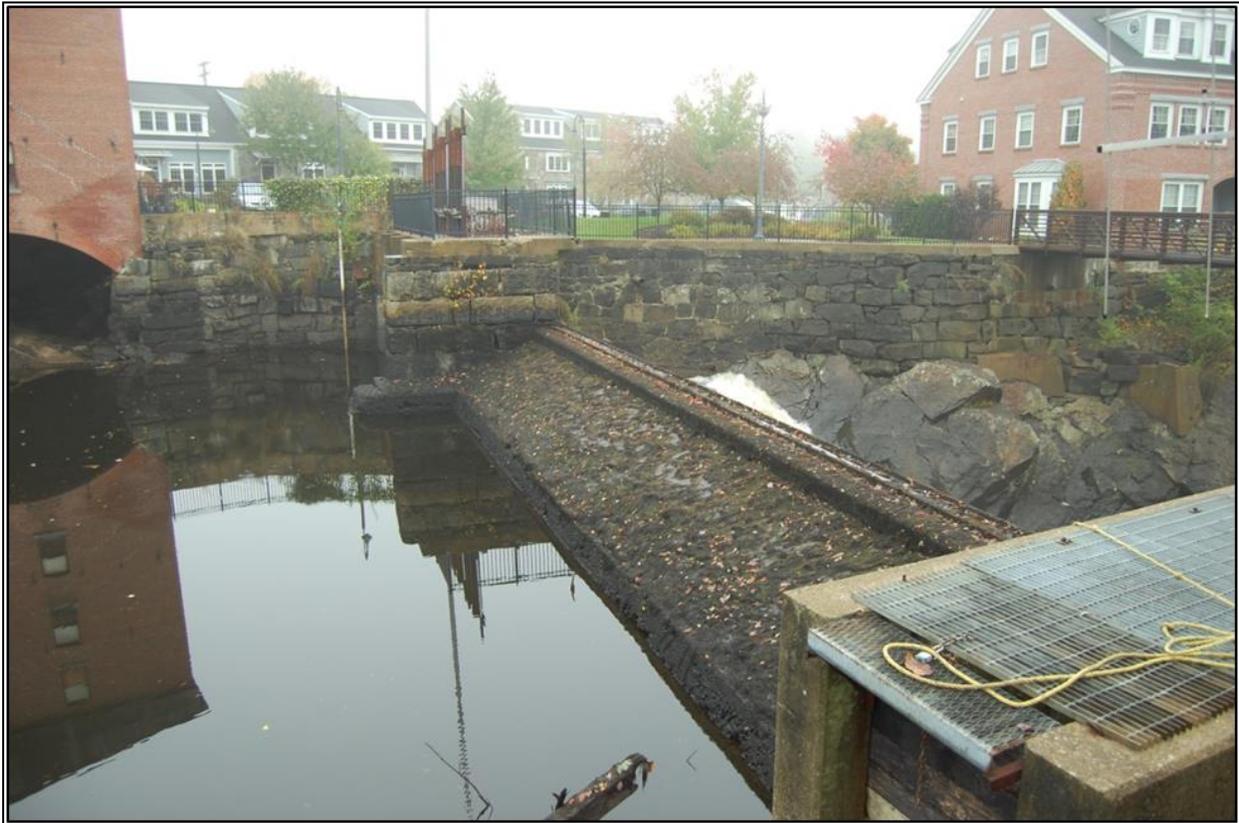
Photograph 1. Setting of Macallen Dam within the former Newmarket Manufacturing Company complex, view south down the Lamprey River from Main Street.

The Town of Newmarket (the Town) is exploring the option of removing the Town-owned Macallen Dam (state dam no. 177.01), located at head-of-tide on the Lamprey River in Newmarket, New Hampshire (Figure 1 and Photographs 1–4). Macallen Dam has several documented deficiencies, the most problematic of which is insufficient spillway capacity, and has been classified as a “high” hazard dam by the New Hampshire Department of Environmental Services (NHDES). In addition to dam removal, the Town is also exploring other options for addressing the dam’s deficiencies, such as dam modification. A 2010 study by Wright-Pierce Engineers provided a cost estimate to address the deficiencies and associated repairs to the dam, while a 2012 study by Wright-Pierce Engineers provided a cost estimate for dam modifications necessary to meet the spillway capacity deficiency. Before proceeding with that work, the Town of Newmarket would like to examine the option of dam removal (the Project) as a means to address the deficiencies, potentially alleviate upstream flooding, and promote restoration of aquatic habitat and diadromous fish. Based on potential grant funding for dam repair or removal, compliance with Section 106 of the National Historic Preservation Act, as amended, may be required for dam removal. Under these circumstances, the National Oceanic and Atmospheric Association (NOAA), is anticipated to serve as the Lead Federal Agency. The purpose of this Request for Project Review is to initiate consultation with the New Hampshire Division of Historical Resources (DHR) regarding the identification of cultural resources in support of the Macallen Dam Removal Feasibility Study, and to solicit the DHR’s opinion regarding the necessity of any further cultural resources identification effort(s) that might be required as a component of dam removal permitting.

Macallen Dam is a 27-foot-tall-by-150-foot-wide, gravity type, run-of-the-river (aka weir) structure. The dam spillway is 70 feet long, has a trapezoidal cross section, and is constructed of granite ashlar (Figure 2, see Photographs 1–4). The current dam was built in 1887 and modified circa 1925 with a concrete sluice gate structure at its east (river left) end; however, a dam is shown at this approximate location on historical maps of Newmarket as early as 1832. A concrete fish ladder (owned and maintained by New Hampshire Fish and Game) was added to the dam along the west bank of the river (river-right) in 1971 and serves as the dam’s west abutment (ACOE 1980:6 – 1).

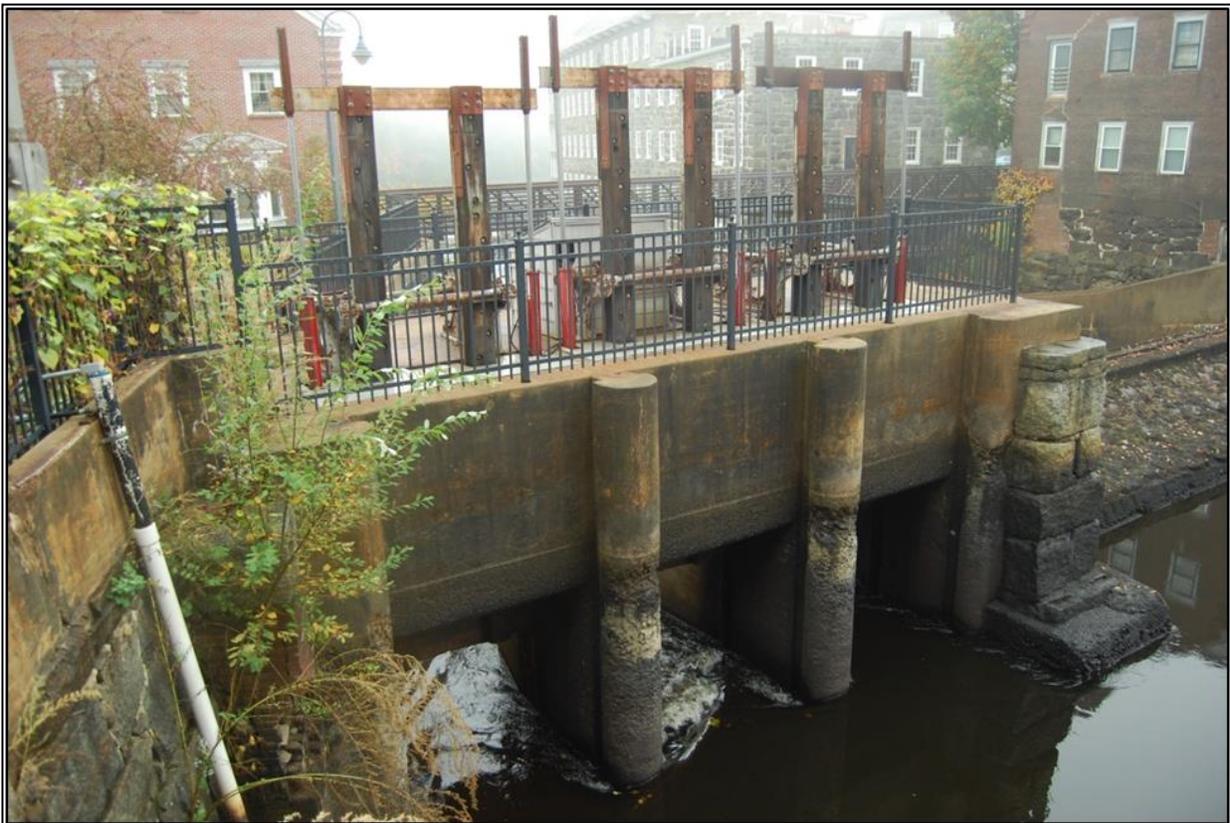
Photograph 3. Downstream face of Macallen Dam, view northeast from the west bank. Fish ladder is at left and sluice gate structure is at right. The Store House (NR resource no. 9, aka Selectwood Building ) is at rear right. Possible project access to between this building and the sluice gate on opposite bank.

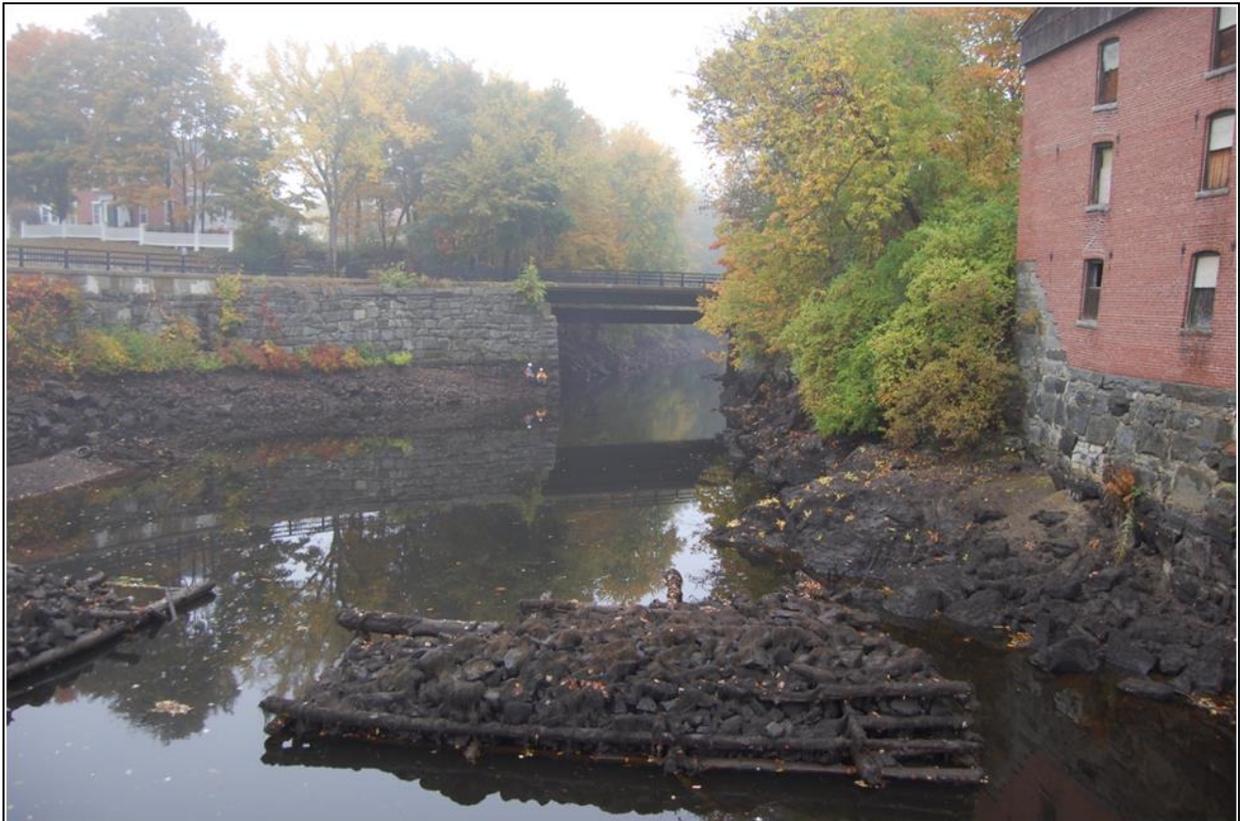
Photograph 9. In-stream wooden structures upstream of the dam, view west from east bank. Possible access from bank on far side of river, immediately to right of Machine Shop.

Field survey for the RPR was completed October 7, 2013, during a temporary impoundment drawdown. Adjacent lands immediately upstream, adjacent to, and downstream of the dam have been extensively developed for industrial activity during the nineteenth century, and further disturbed by commercial and residential development during the twentieth century. The river immediately upstream and downstream of the dam is channelized with split granite and concrete training/retaining walls, which in some instances serve as foundations for adjacent industrial buildings associated with the Newmarket Manufacturing Company (Photograph 5, see also Photographs 1-3). Bedrock outcroppings project from underneath the stone walls in some instances, suggesting that adjacent shorelines have been filled. The Newmarket Manufacturing Company, built 1823–1920, is a former textile plant consisting of two- to four-story stone and brick mill buildings that now house commercial offices, light manufacturing facilities, and residential condominiums (Photographs 6 and 7). Immediately upstream of the dam, the foundation former Cloth Room/Store House (now called the Selectwood Building), contains an arched headrace opening (see Photograph 3). The retaining wall on the west bank, just upstream of the Newmarket Manufacturing Company Machine Shop (now the Durham Book Exchange), contains a second possible headrace opening that is now filled with concrete (Photograph 8). Three deteriorated stone-filled timber cribs, identified on Project feasibility study plans as a legacy dam, are set in the river channel approximately 50 feet upstream of the dam (Photograph 9).

Upstream of the river walls, the east river bank is bedrock and the west river bank is covered with stone riprap. Main Street (Route 108) crosses the Lamprey River on Veterans Bridge, approximately 250 feet upstream of the dam (Photograph 10, see also Photographs 1, 3, and 9). The steel girder bridge was recently reconstructed and rests on concrete and granite abutments. Upstream of the bridge, the river shoreline reverts to a natural silt and gravel appearance, with some granite rubble or riprap

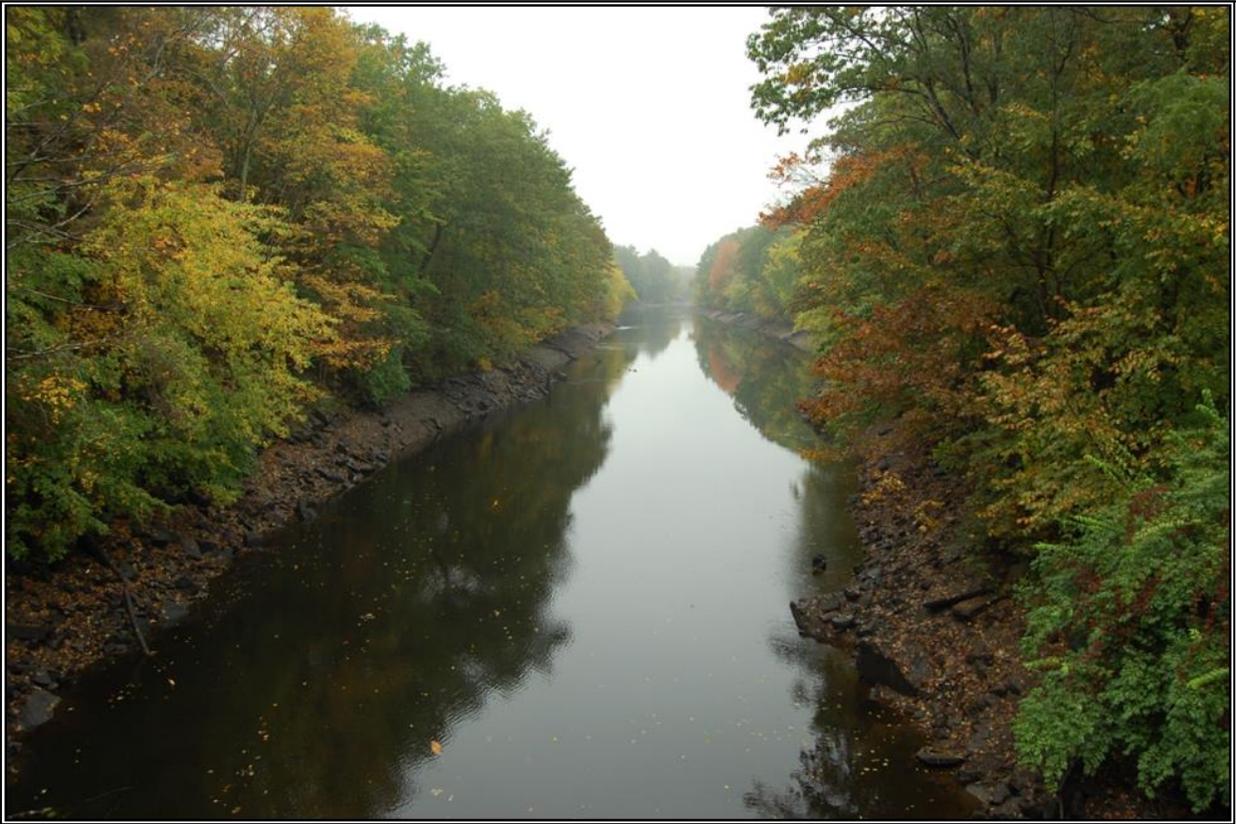
Photograph 10. View looking upstream (north) from Macallen Dam sluice gate to Veterans Bridge.
