Technical Memorandum

To: Sean Greig – Town of Newmarket, NH File No. 2929.08
Cc: David J. Mercier, P.E. – Underwood Engineers
From: Ross Baker, E.I.T. – Underwood Engineers
Date: September 26, 2023
Subject: **NEWMARKET SSES PHASE II – CCTV & MH INSPECTION
SUMMARY**

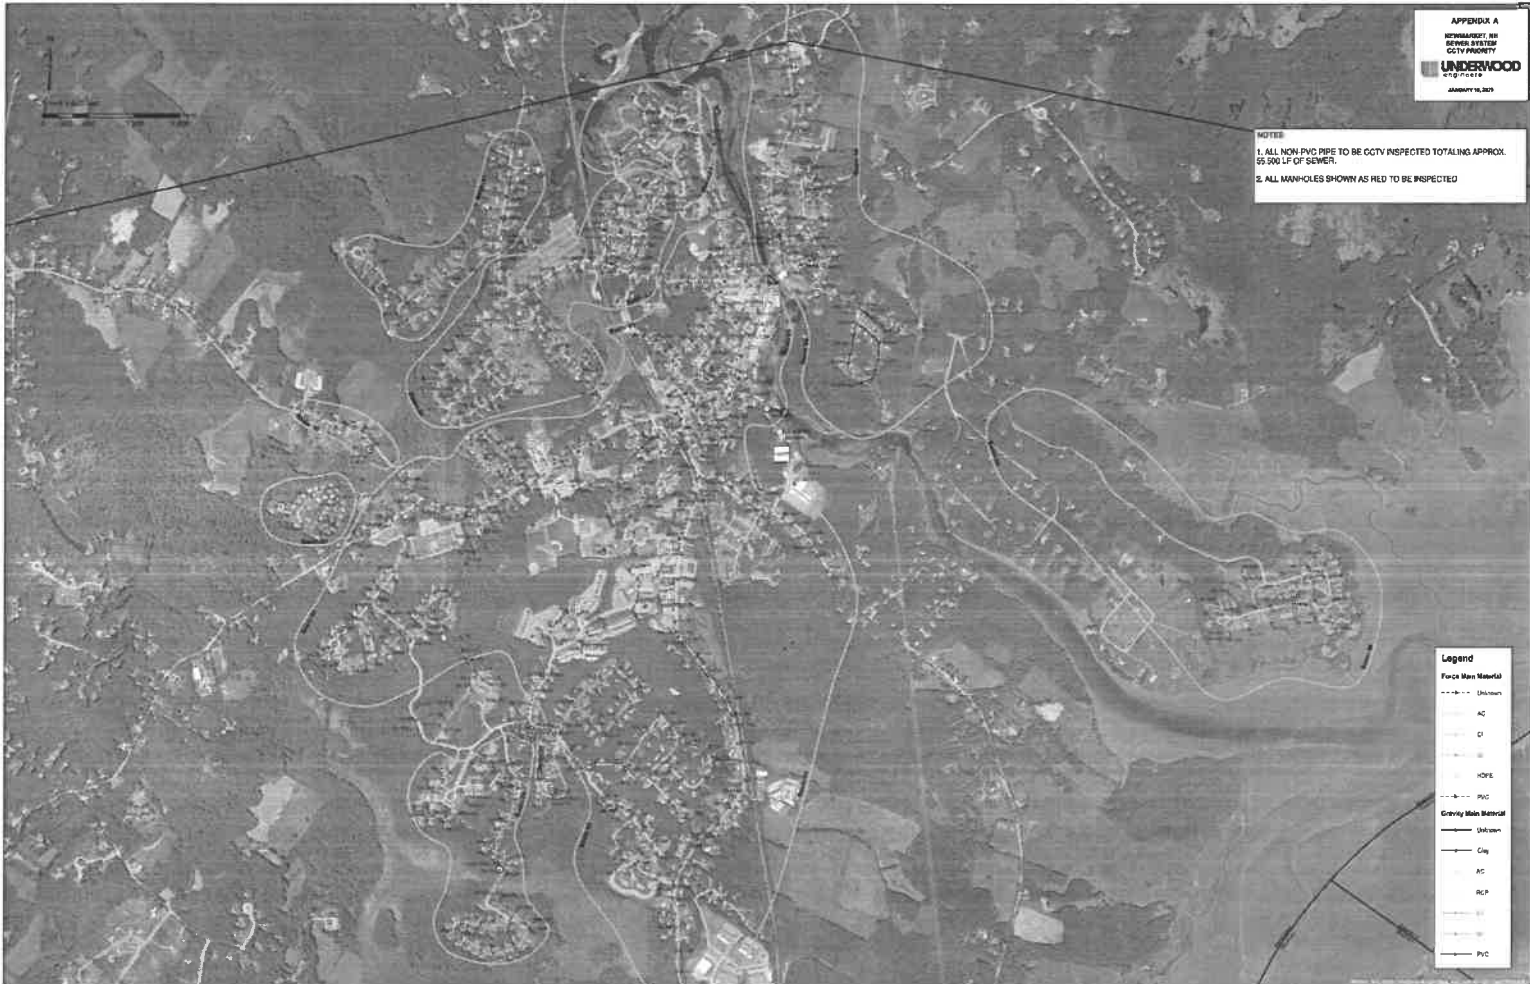
APPENDIX A

active I/I in the flow isolation investigations summarized in the previous technical memorandum issued April 27, 2022. The manholes identified in need of inspection were shown as red on the overview map (**Appendix A**).

NOTES
1. ALL NON PVC PIPE TO BE CCTV INSPECTED TOTALING APPROX.
55,500 LF OF SEWER.
2. ALL MANHOLES SHOWN AS RED TO BE INSPECTED
