March 8, 2010
W-P Project No. 12018A

Subject: Macallen Dam - Preliminary Report
Structural Analysis and Recommendations

Newmarket, NH
Macallen Dam Inspection
Project #12018A

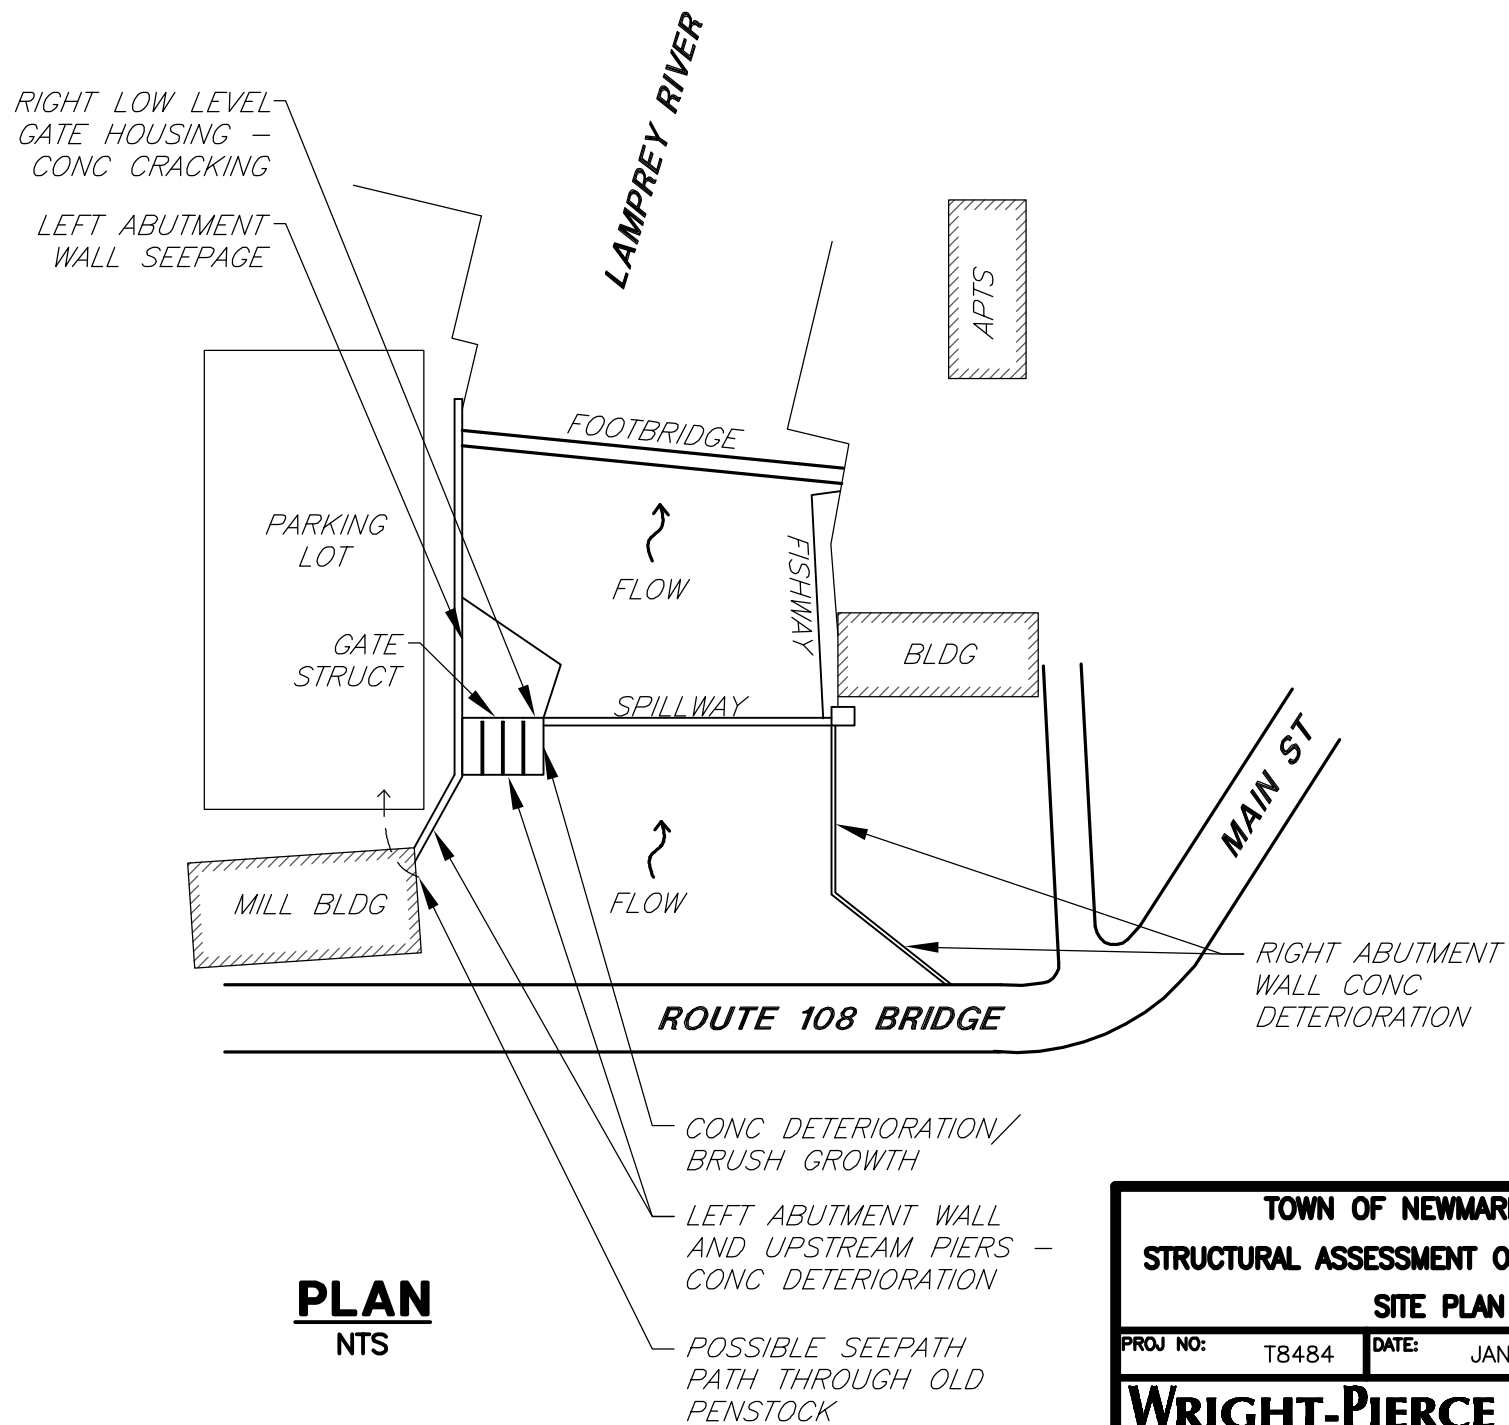
TOWN OF NEWMARKET, NH		
STRUCTURAL ASSESSMENT OF MACALLEN DAM		
SITE PLAN		
PROJ NO:	T8484	DATE: JAN 2010
WRIGHT-PIERCE  		FIGURE: 1
Engineering a Better Environment

The dam is a concrete and stone gravity type dam with a 68 foot long spillway (Figure 1). Previous inspection reports indicate that the height of the dam is approximately 27 feet although we were unable to confirm this dimension due to high water at the toe of the dam. (Photo 1) Engravings on the dam and gate structure indicate that the dam was constructed in 1887 (Photo 2) and the gate structure in 1925 (Photo 3). It is our understanding that the fish ladder was constructed sometime in the 1970's. The downstream face of the dam consists of stacked stone blocks and the top four feet (vertically) of the sloped upstream portion of the dam appears to have been faced with stone. The spillway consists of a 3 feet wide by 1 foot deep concrete cap. A corroded 15 inch wide steel channel section is bolted across the full width of the spillway crest (Photo 4). Plan views of the dam and affiliated structures are included in Appendix A. Photographs taken in July 2008 and November of 2009 are included in Appendix B. The Letter of Deficiency is included in Appendix C.

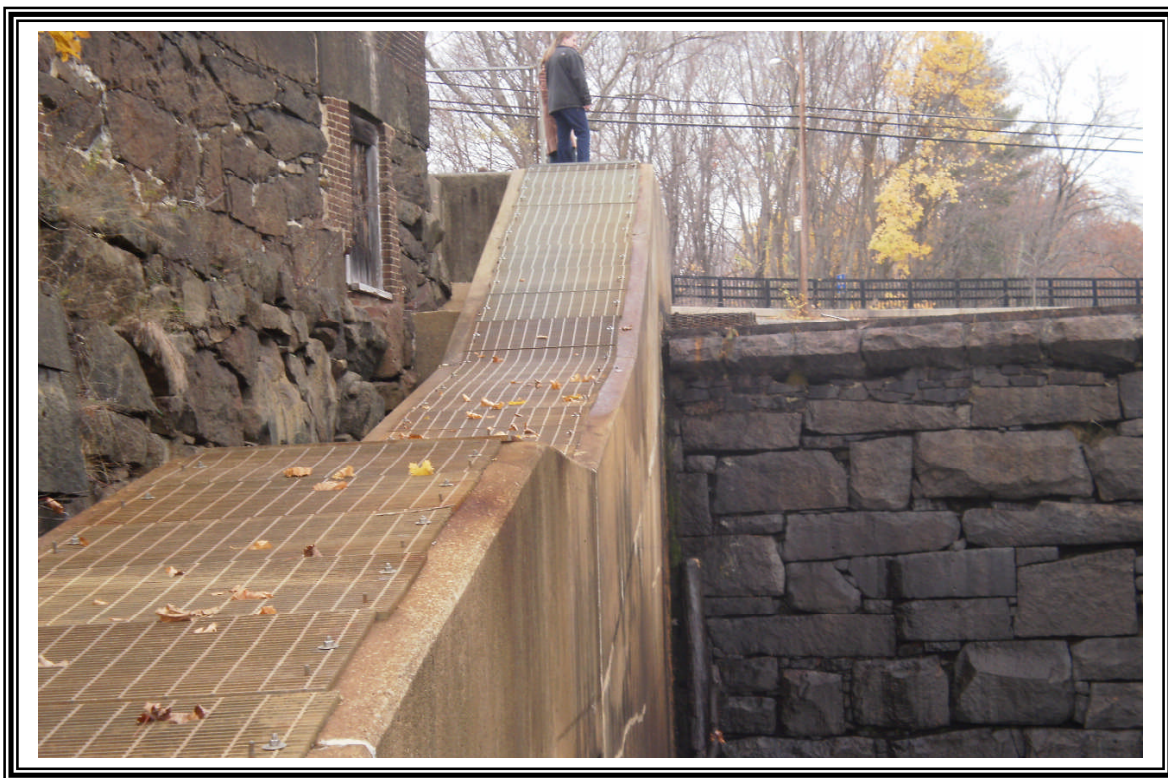
Photo 7

The downstream retaining wall on the west side of the dam is comprised of the concrete fish passage structure and the stacked stone foundation wall for the adjacent building (Photo 7). The fish passage structure appears to be in fair condition. There appears to be some cracks in the wall that have been repaired in the past and still show signs of efflorescence stains, which usually indicates past leakage through the crack. The stacked stone wall appears to be partially grouted and in fair condition. There is vegetation growing through some of the joints.

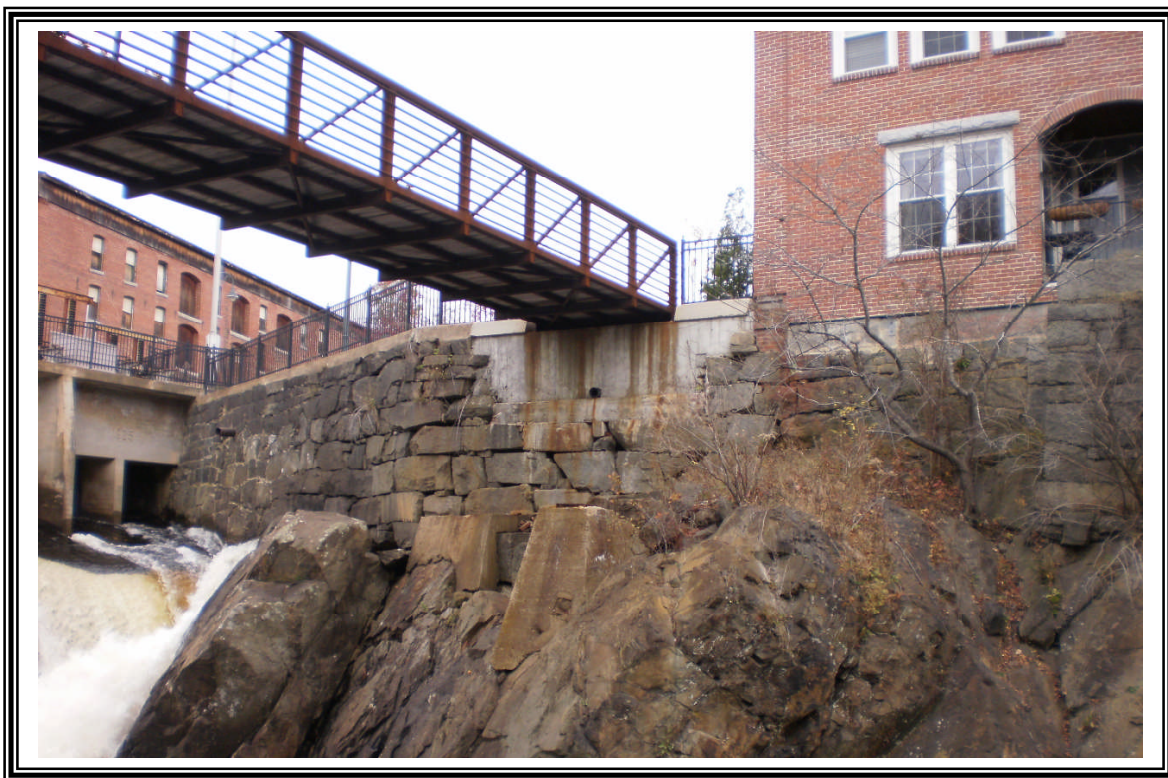
Photo 27

The downstream retaining wall on the east side of the dam is comprised of stacked stone blocks. It appears that a portion of the wall just north of the gate structure to the pedestrian bridge was built on a ledge outcrop (Photo 27). The wall appears to be partially grouted and in fair condition. There is vegetation growing through some of the joints. There is a drain pipe discharging about 5 feet from the top of the wall approximately 10 feet downstream from the gate structure. This may have served as a drain in the past.
