Macallen Dam Final Report - Dam Breach Analysis

Town of Newmarket

Macallen Dam - Newmarket, NH

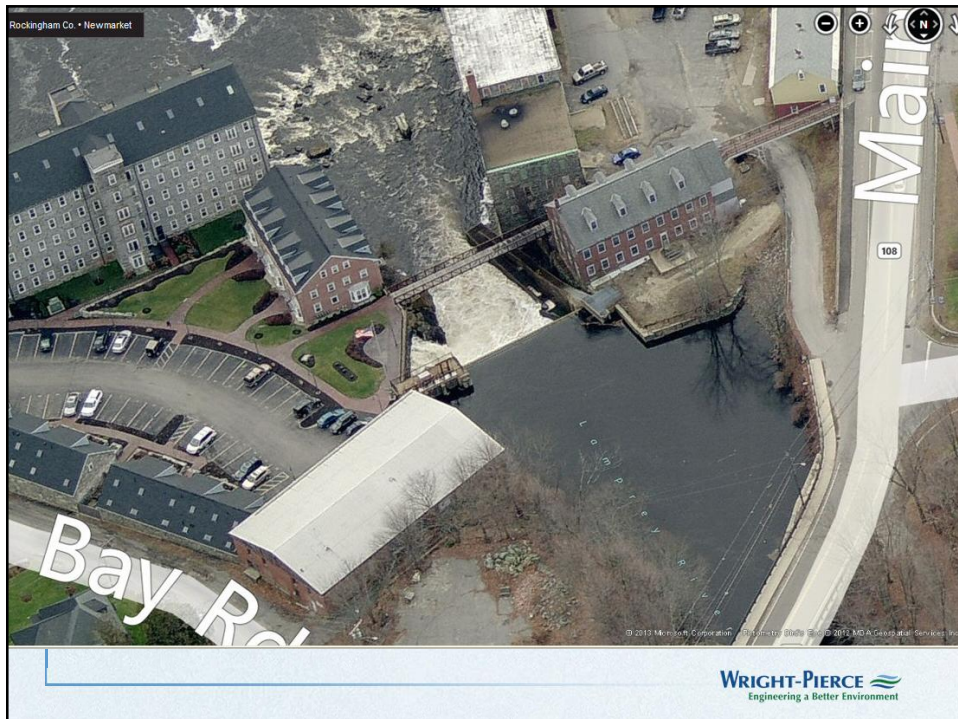
Another Alternative May Exist

- Overtopping
 - Allow water to flow around spillway
 - May need to armor overtopped area
 - Will require geotech and structural analysis
 - Impacts to existing paved area?
 - Impacts to existing buildings?
 - Analysis of weak points
 - Depends on depth, duration, and velocity
 - Depth = 2-3 feet
 - Duration = unknown
 - Velocity = 2 feet/sec
