FINAL REPORT - VOLUME 1

# Town of Newmarket

Facilities Master Plan

09.01.2023

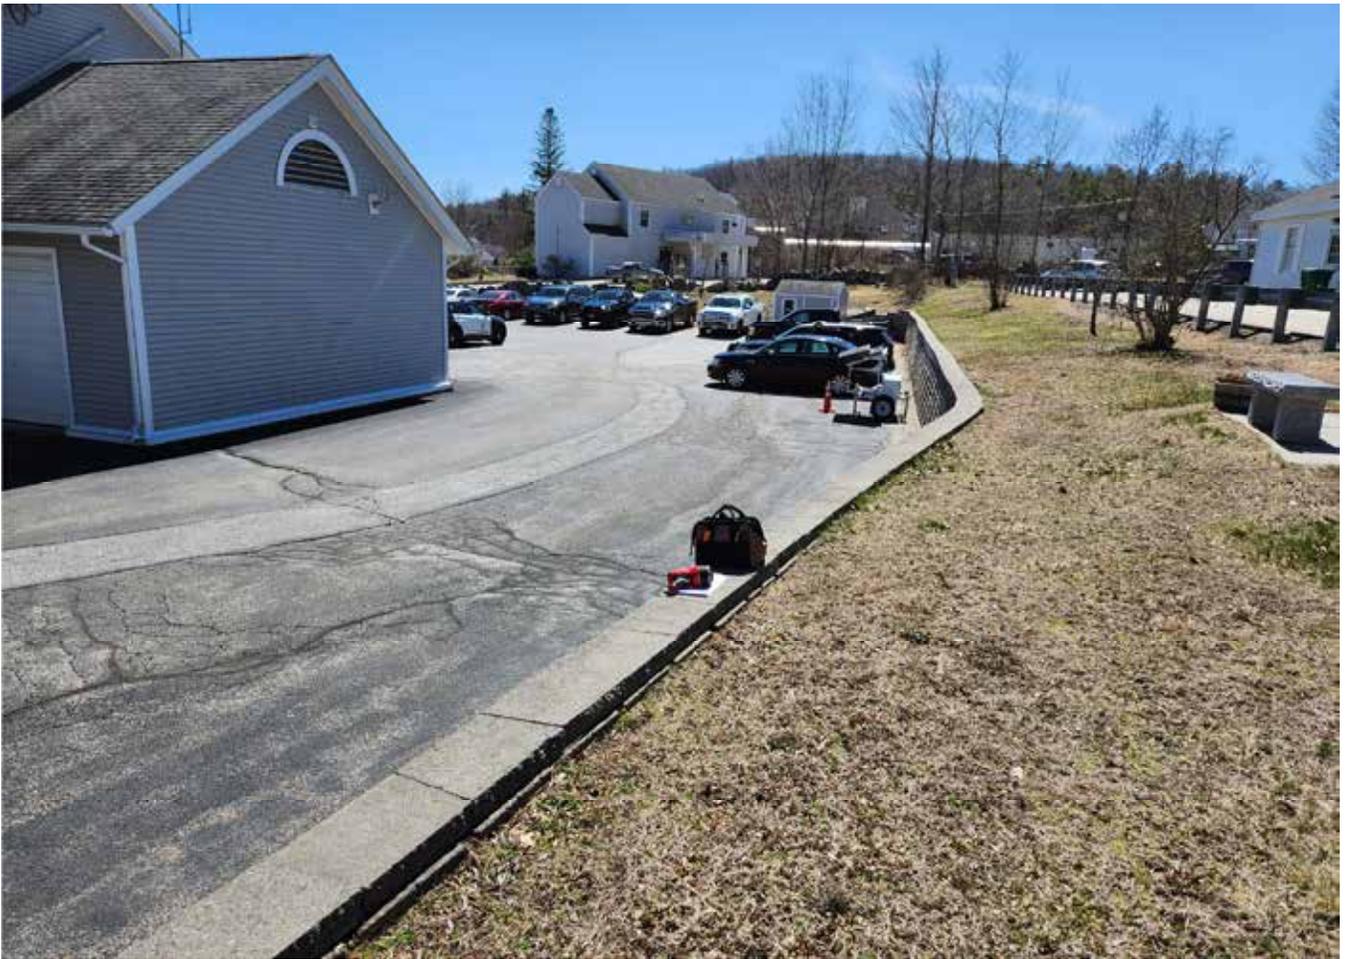
- 4) Retaining Walls
- a) Retaining walls are in disrepair. Some of the blocks are deteriorating from water and salt.
  - b) There is no fall protection on the upslope side of the retaining walls.

Retaining Wall with No Fall Protection

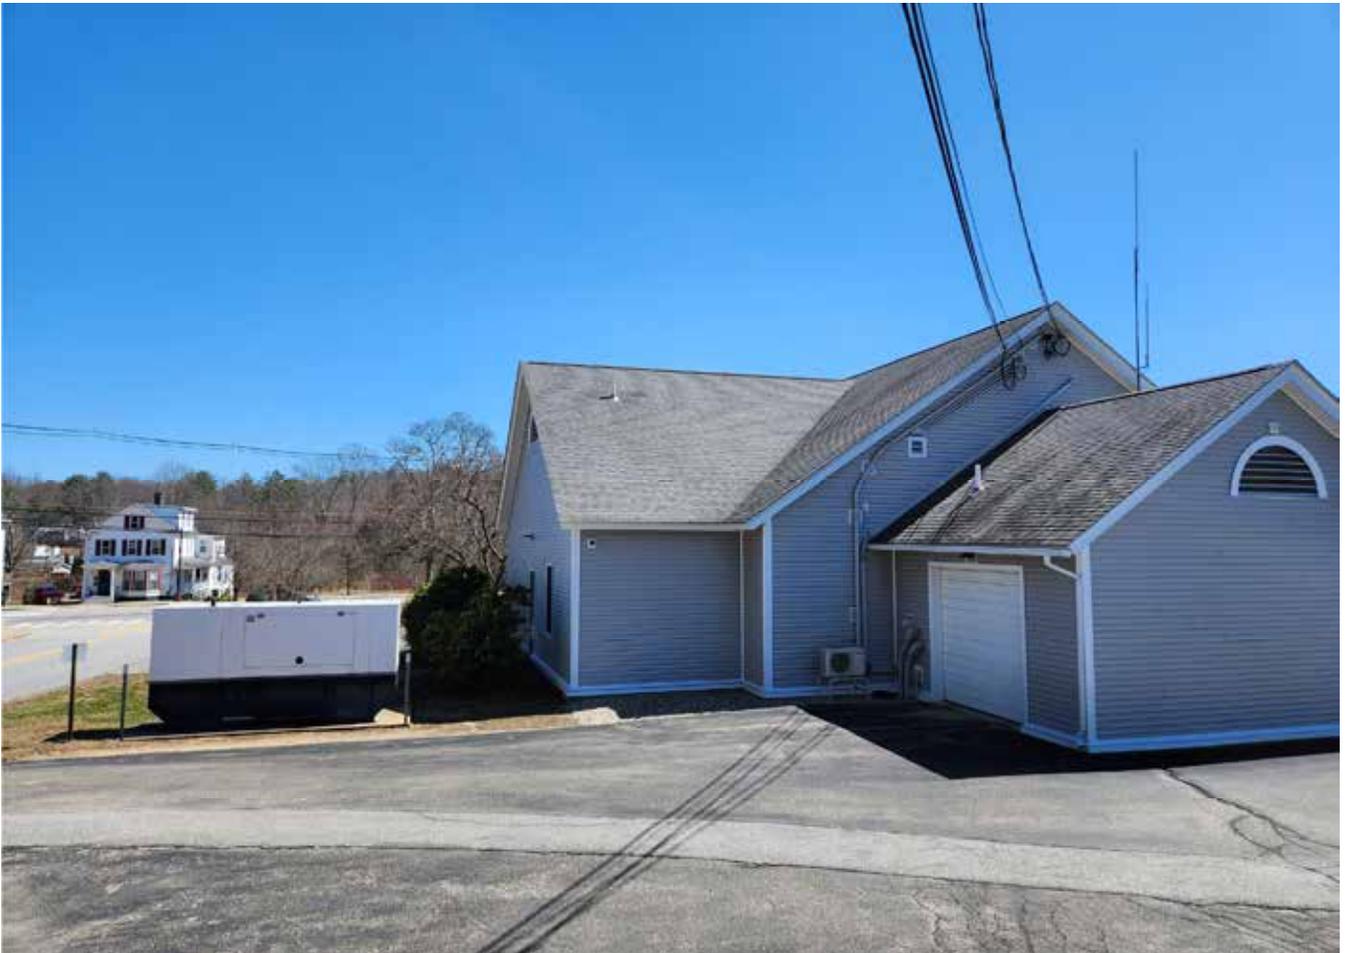
- a) Protect the gas lines from cars and plowing.
  - b) Protect the generator from cars and plowing to prevent damage.
  - c) Protect the air conditioning condensers and mini splits to prevent damage.

Generator and Mini Split without Protection

- 3) Add bollards to protect the gas lines entering the building from cars and plowing.
- 4) Add bollards at each end of the generator to prevent damage.

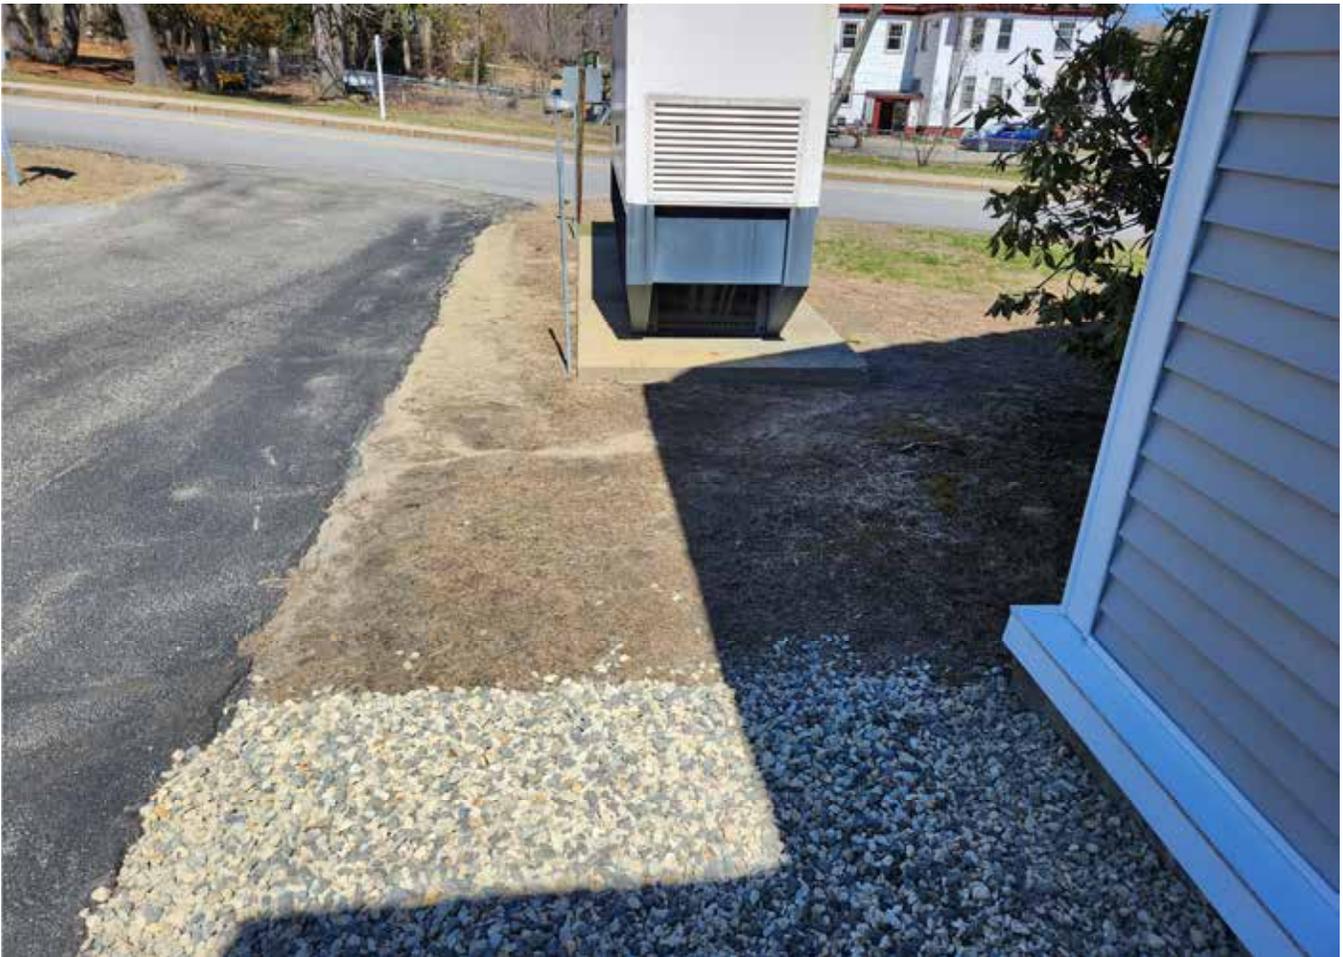
- c) There is an exterior 100kW pad-mounted generator with belly tank on the North side of the building. The generator is currently vulnerable to damage from vehicular traffic.

Generator without Protection

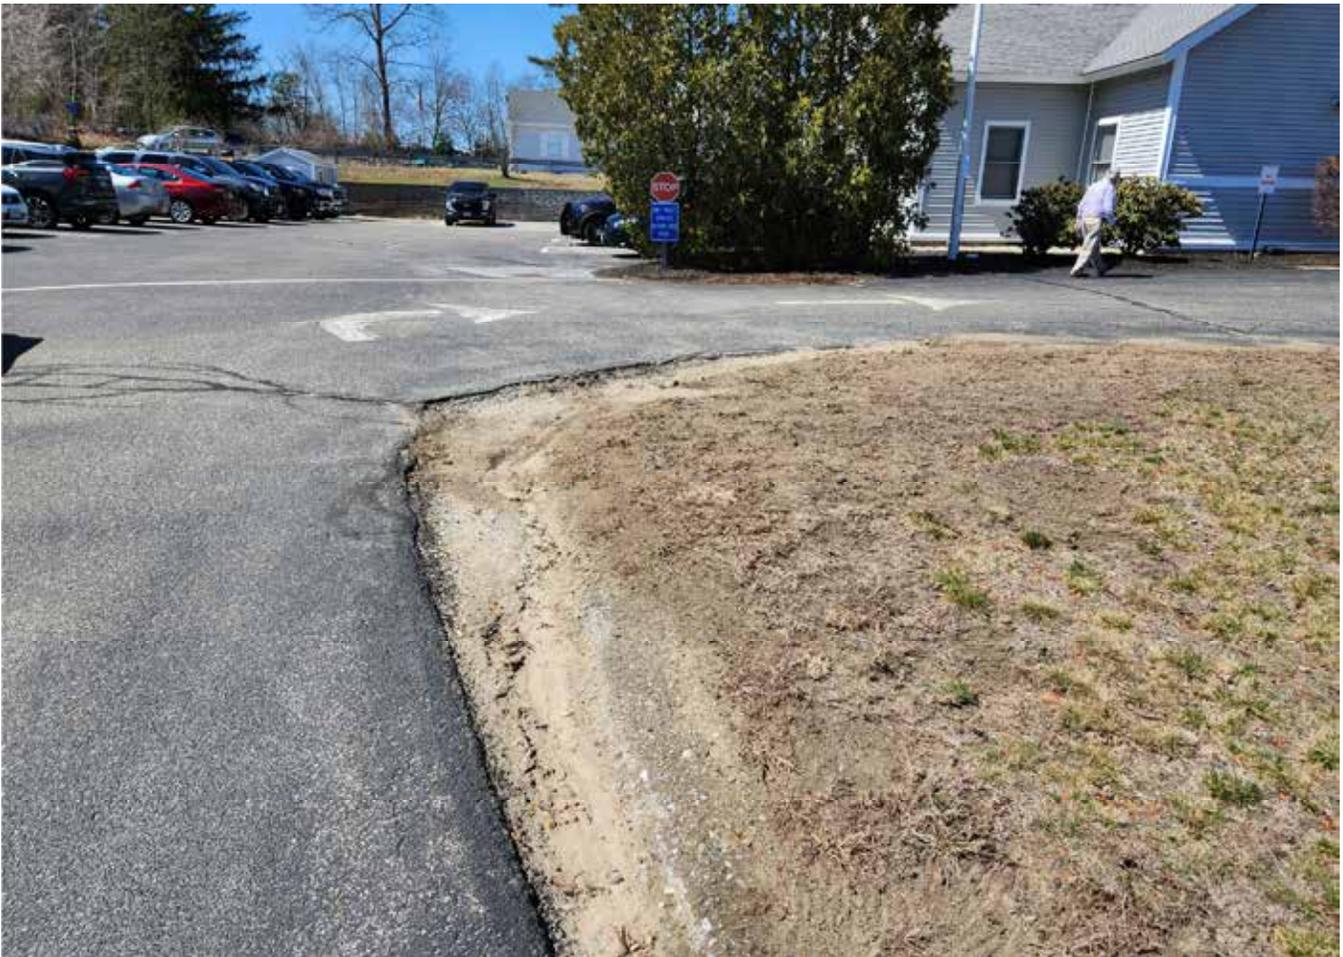
- 5) Erosion
- a) Along the edges of pavement in several locations there is erosion. It appears that the steep driveways have storm water running off at a speed that causes erosion. There are rills along the edge of pavement.

Erosion at the Main Street Driveway

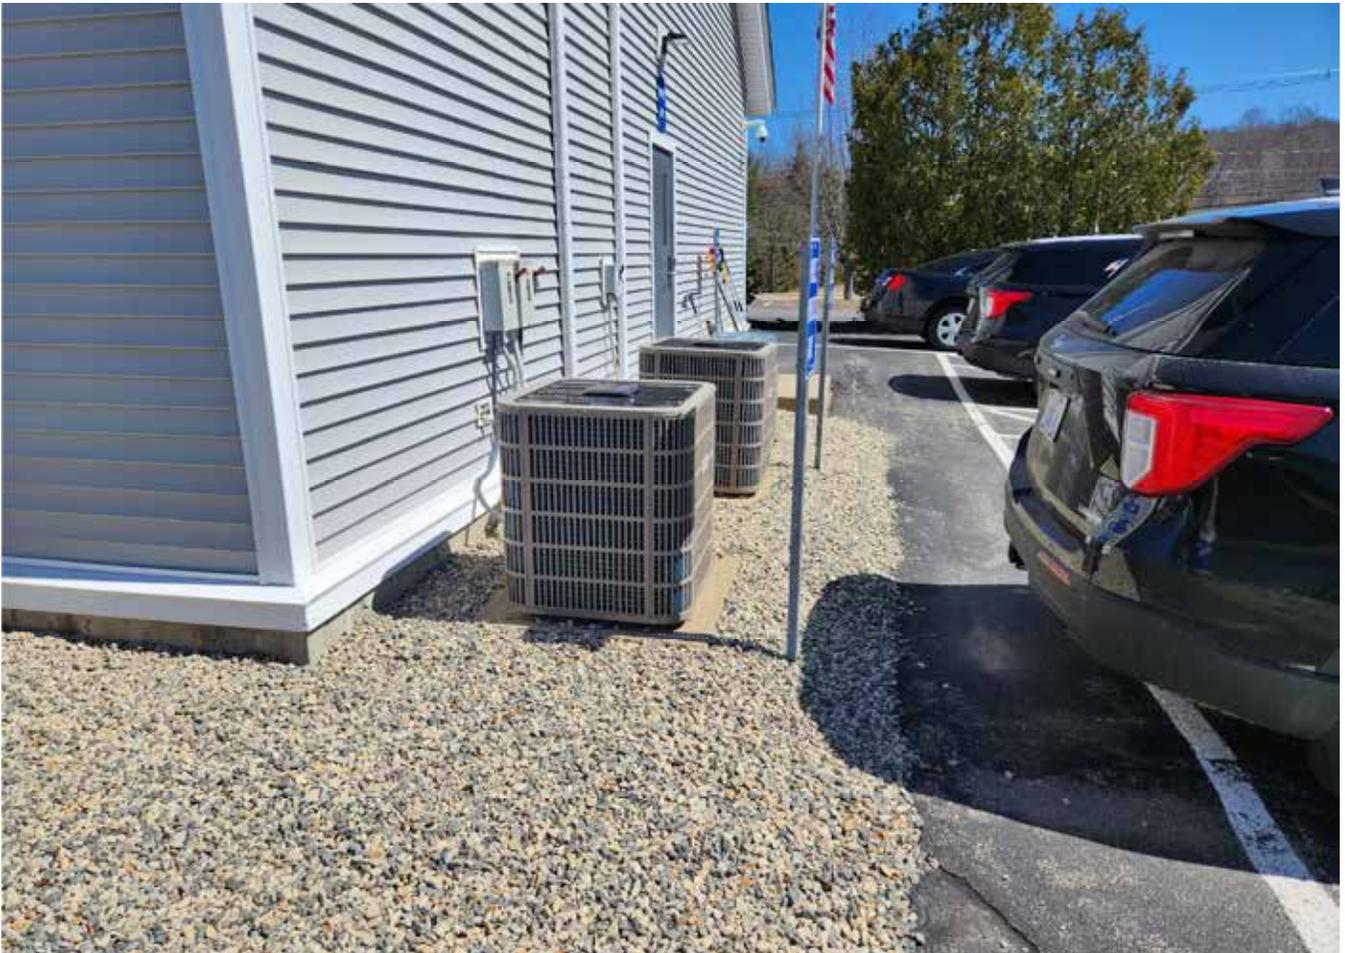
Unprotected Compressors

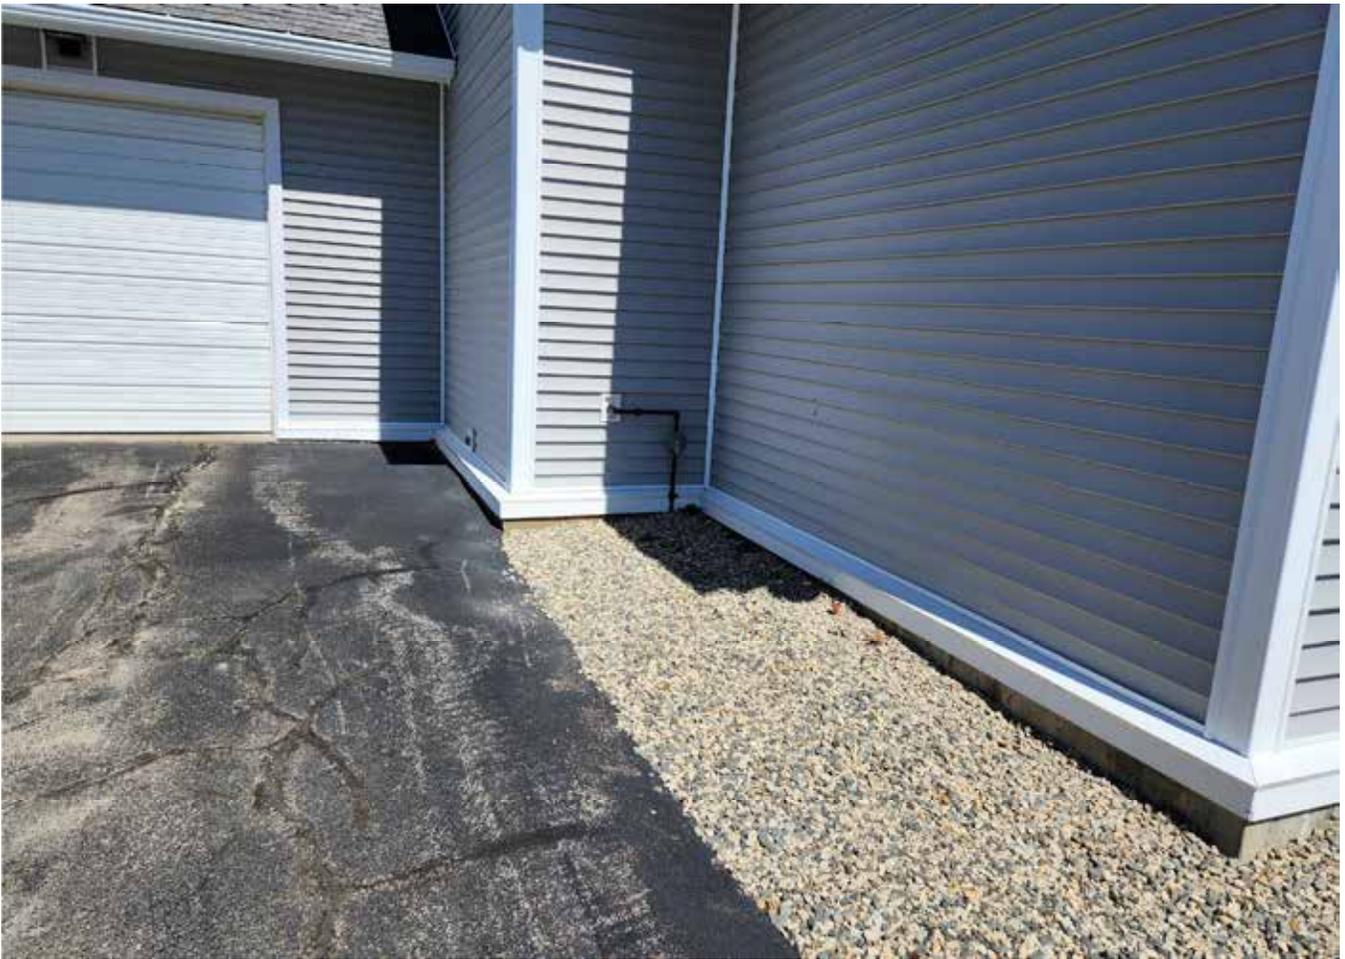
Unprotected Gas Line

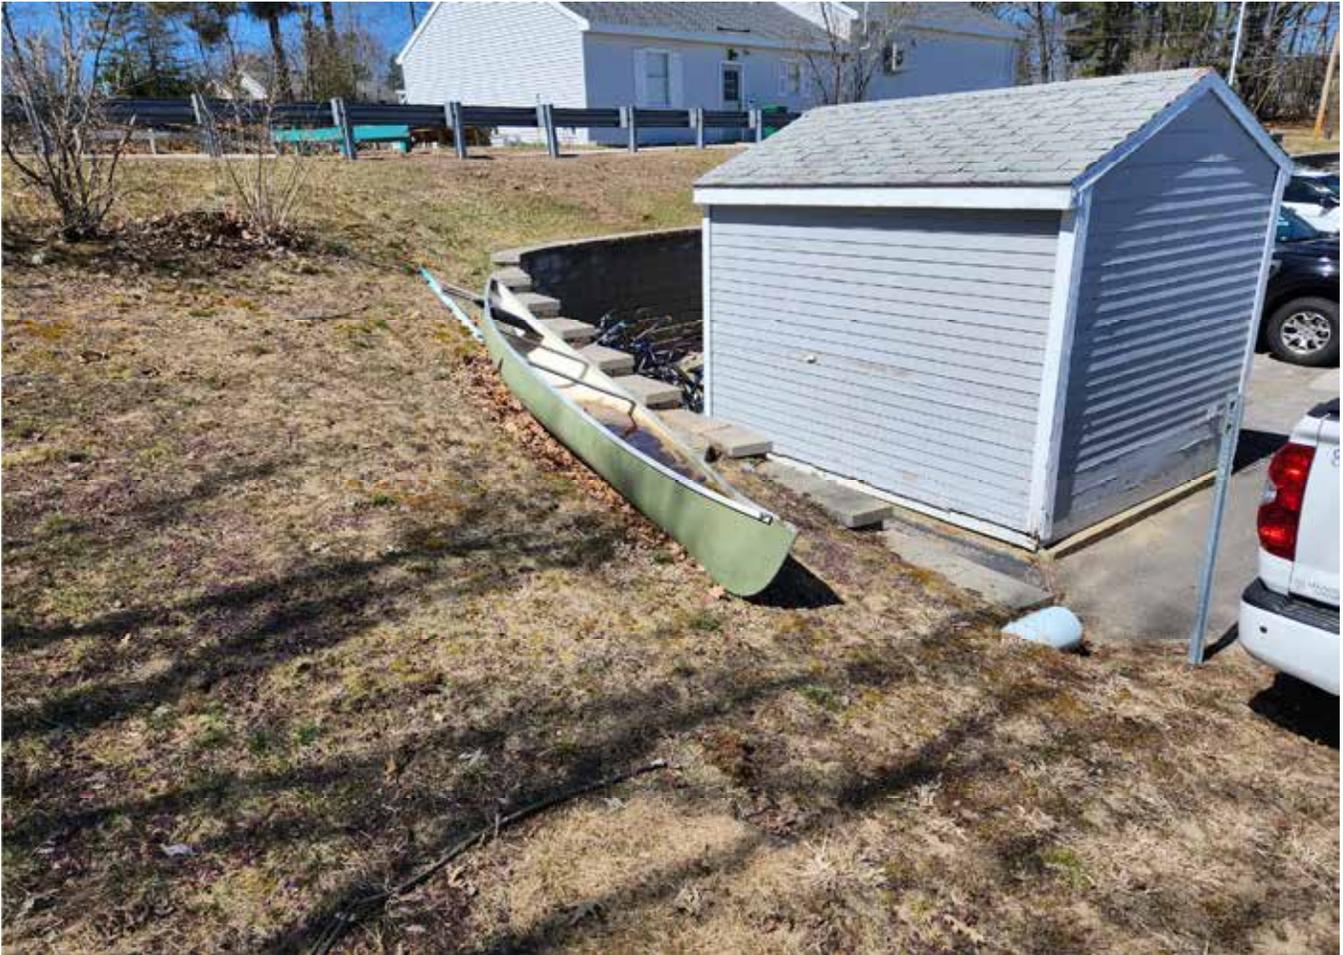
- b) There are at least 2 patch jobs on the pavement. The first is around the catch basin at the Southeast corner of the building. It appears that there has been settling around the catch basin.
  - c) The rear of the lot has had a catch basin added because of poor original grading or settling that caused ponding. Under the shed looks like it has been shimmed to get the water to flow into the new catch basin.
- 8) Drainage
- a) There does not appear to be any nutrient removal on-site for stormwater.
  - b) There does not appear to be any detention or retention of stormwater for this site.
  - c) There have been issues with water in the rear of the police parking lot. A catch basin has been added.
  - d) There is an eight-inch pvc pipe that appears to flow water from the Sunshine Center which is just West of the site.

8" PVC Drain Line Headed Towards Sunshine Center

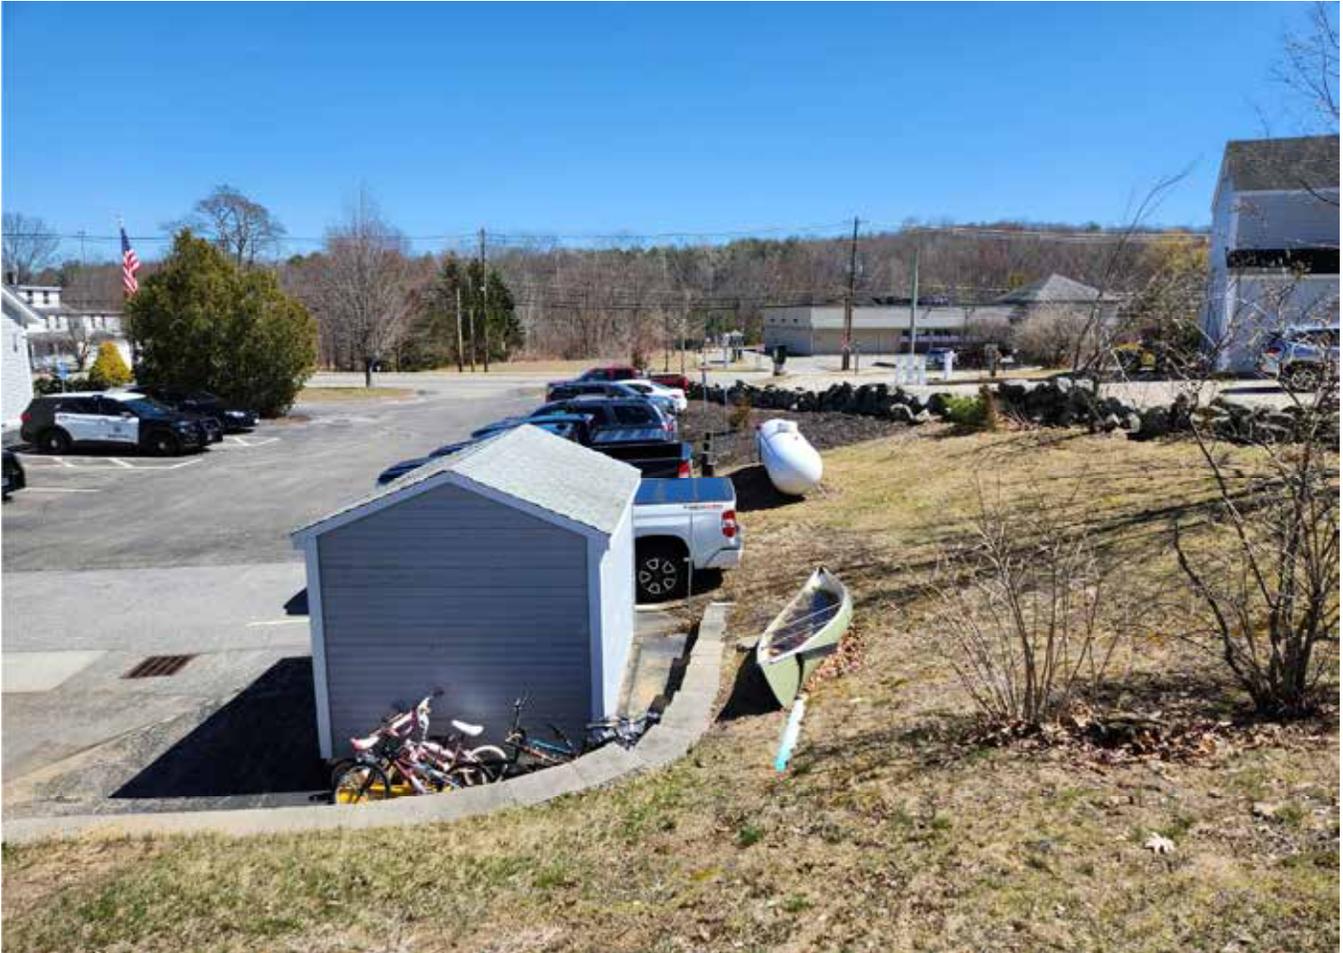
Propane Tank -Retaining Wall-Regraded Pavement -Catch Basin

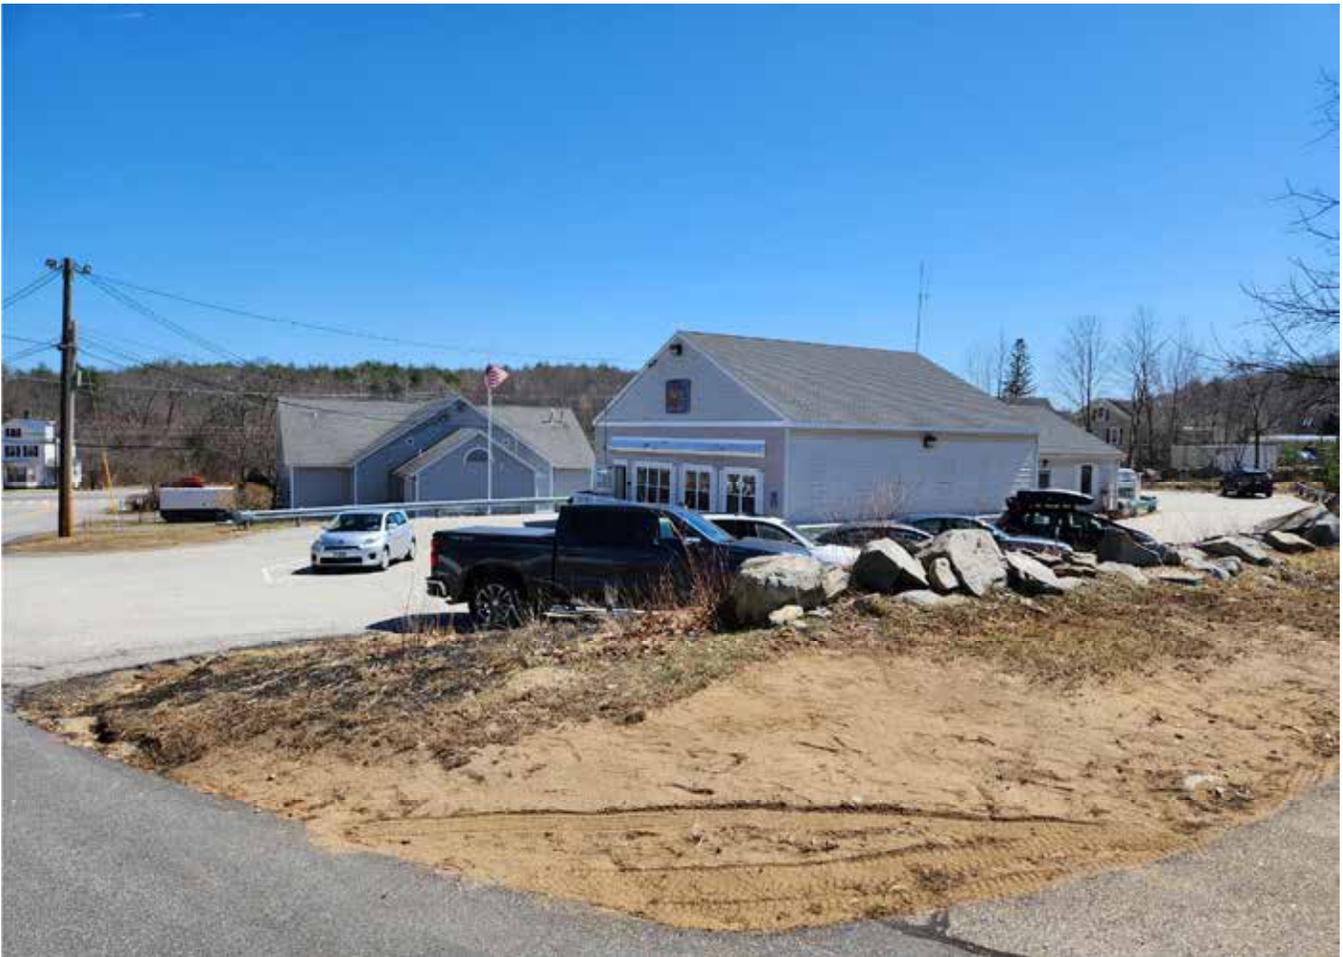
View from above Sunshine Center & Police Station -Erosion at Entrance

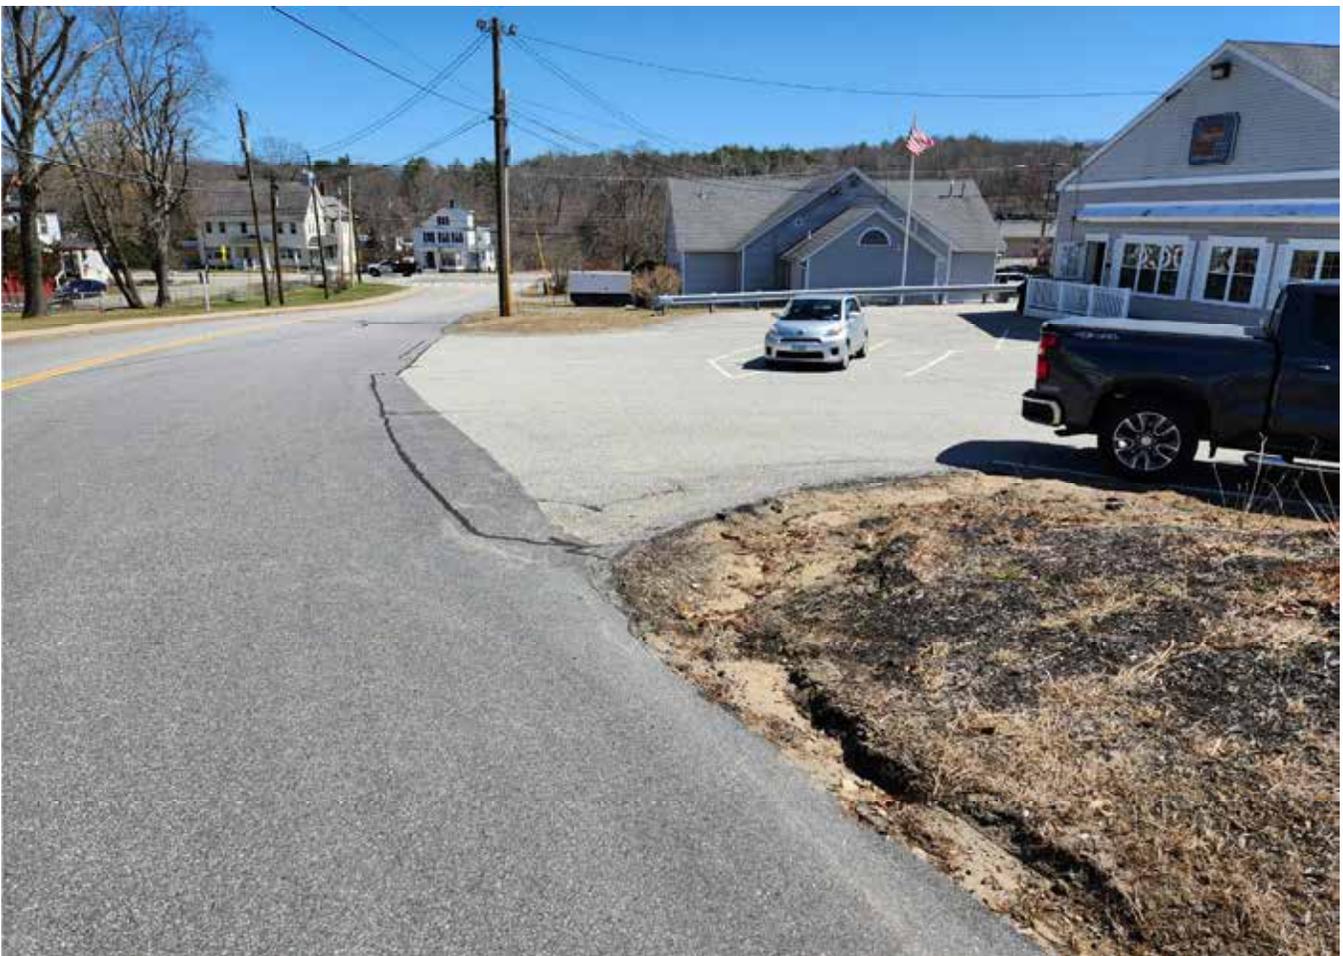
Erosion at Entrance

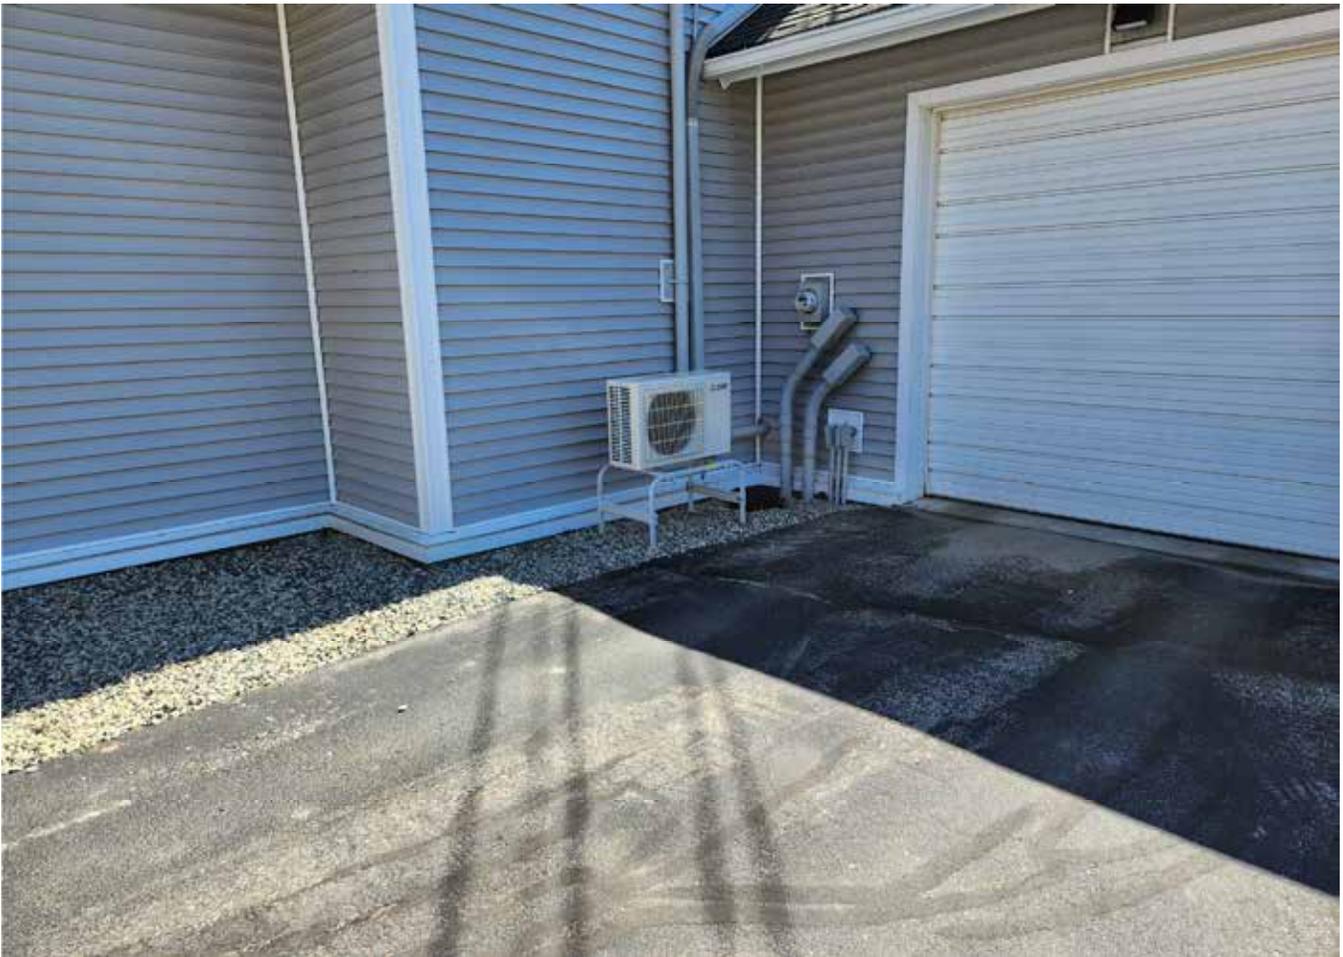
Mini Split without Protection

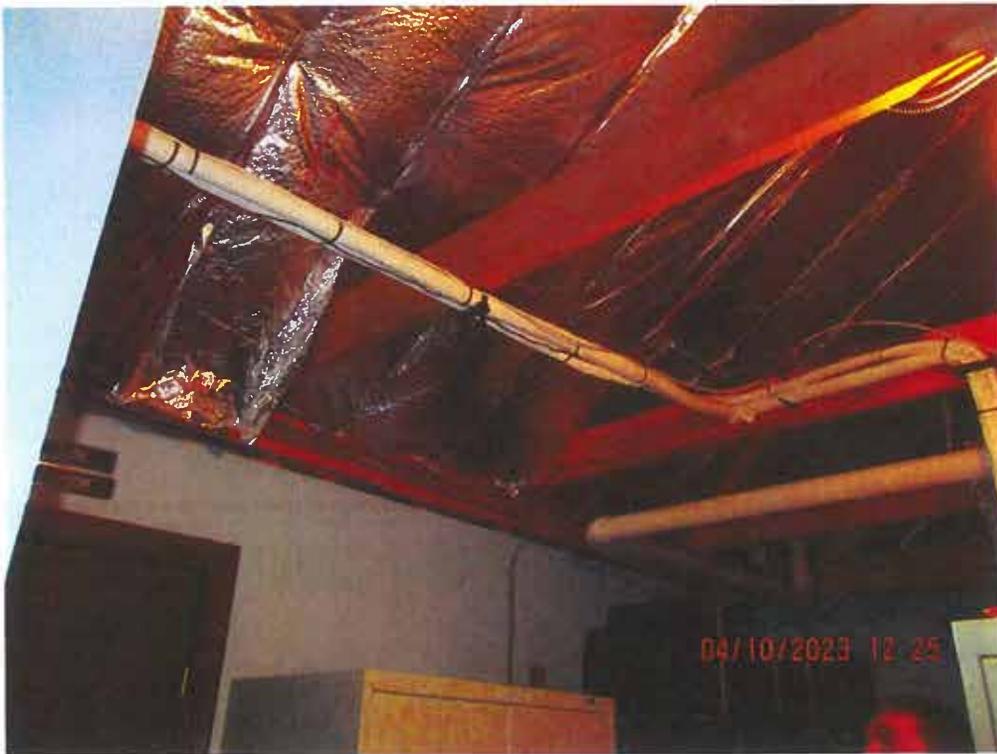
**Police Station – Insulation does not meet energy code**

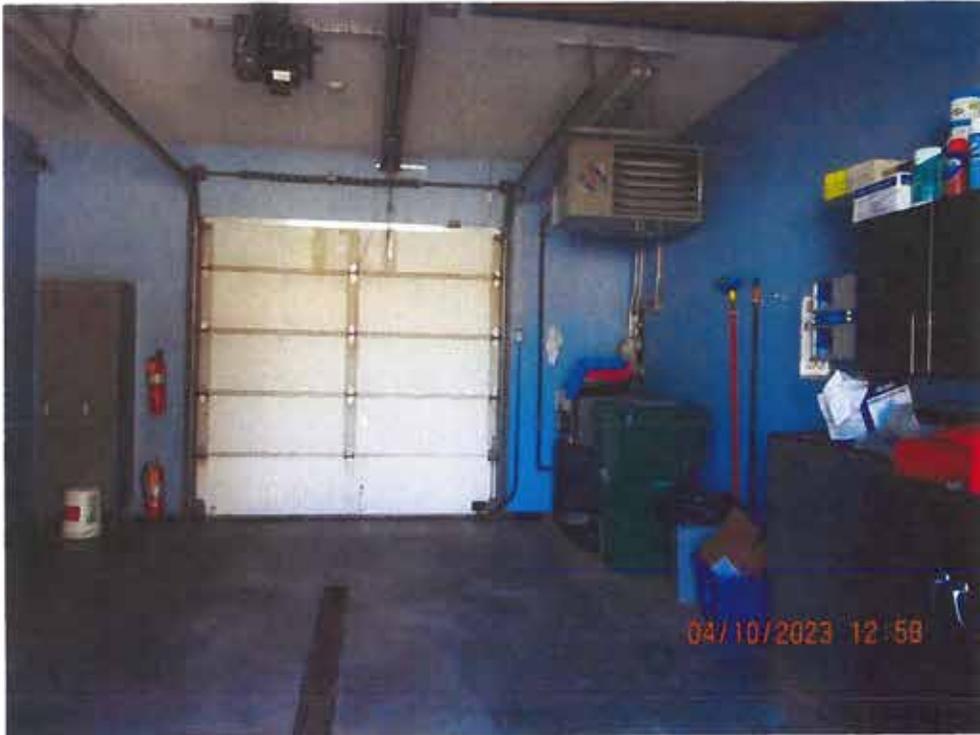
There is an attached garage, AKA a sally port measuring approximately 18x25 and has two overhead doors. A masonry wall separates the garage from the main structure. No framing is exposed nor accessible to determine framing conditions. A trench drain is located in the middle floor.

**Police Station – Sally port**

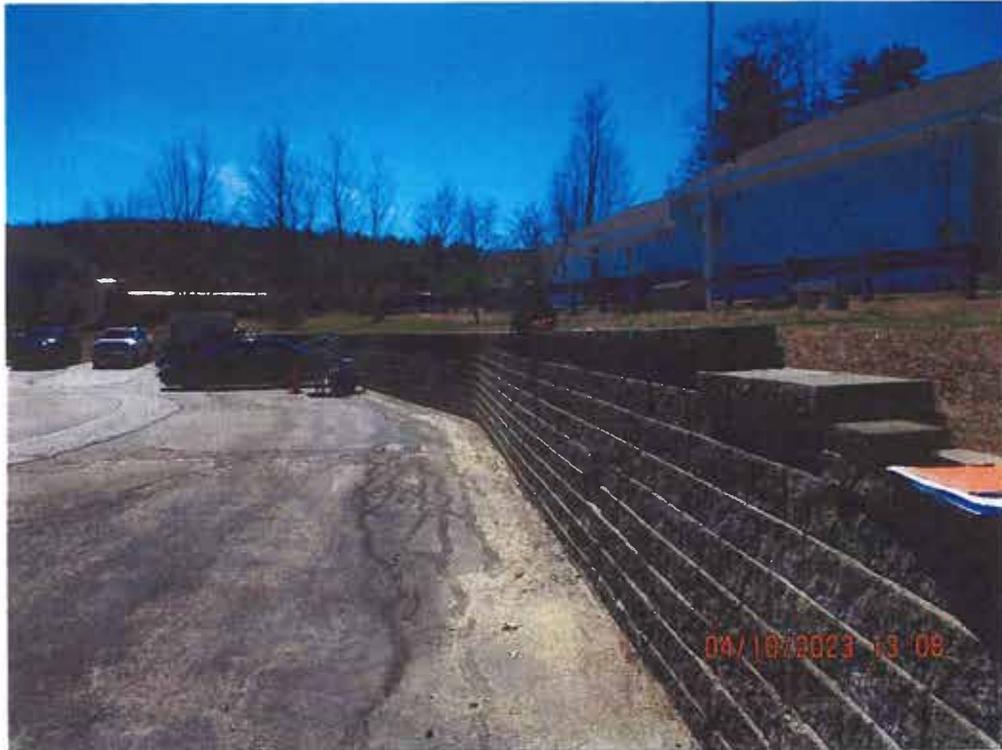
**Police Station – retaining wall exhibit signs of lateral movement**

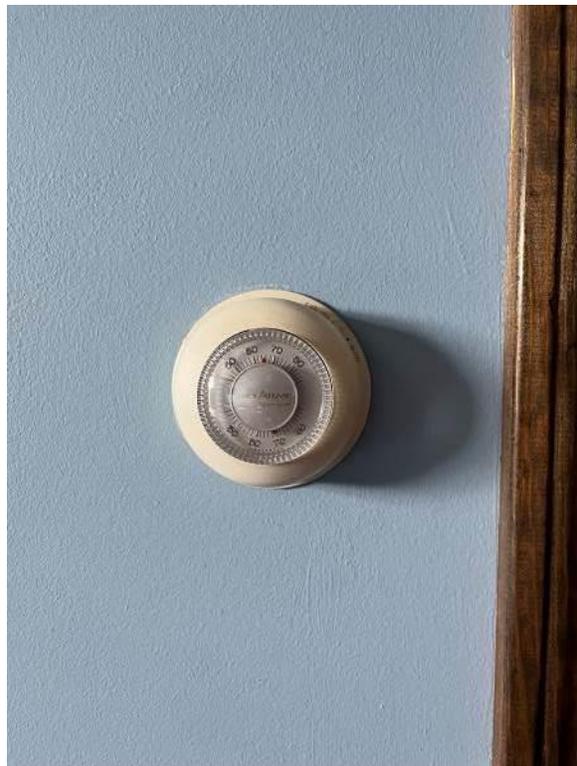
Thermostat (no longer used)

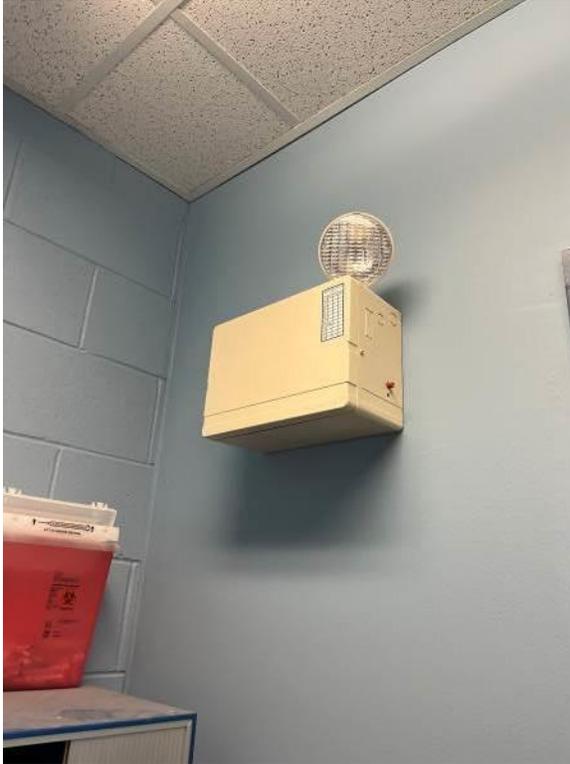
Emergency lighting (note that entire building is on generator)

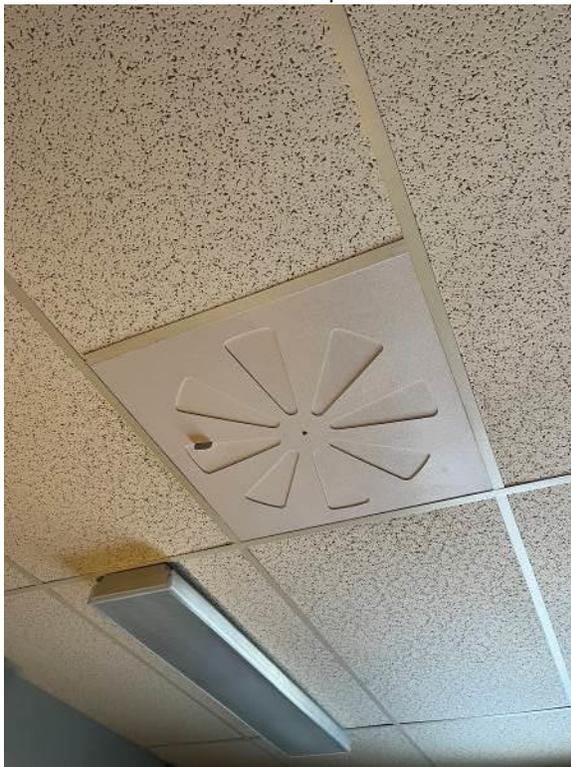
Aftermarket adjustable diffuser due to occupant complaints

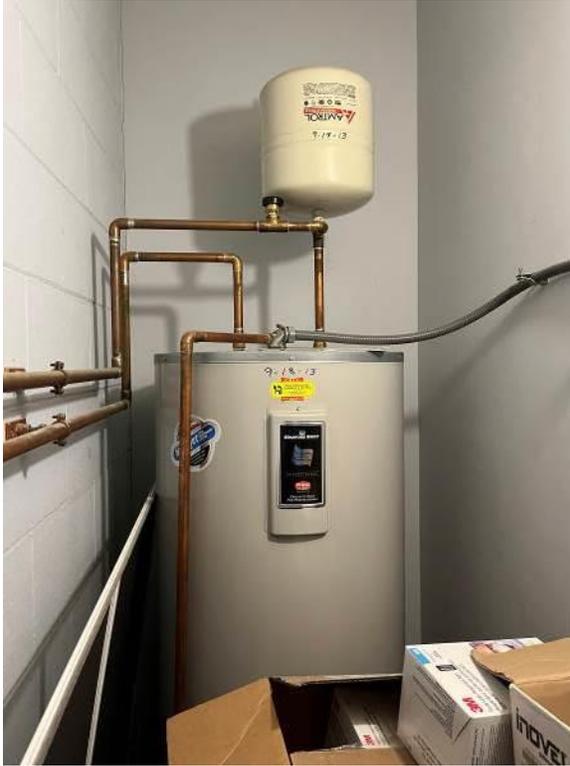
The building hot water demand is supplied from an electric water heater (Bradford Model M280R6DS) located in the mechanical room with approximately 80-gallon capacity. The water heater was installed in 2013 and appears to be in good condition.

Electric tank-type water heater with expansion tank above

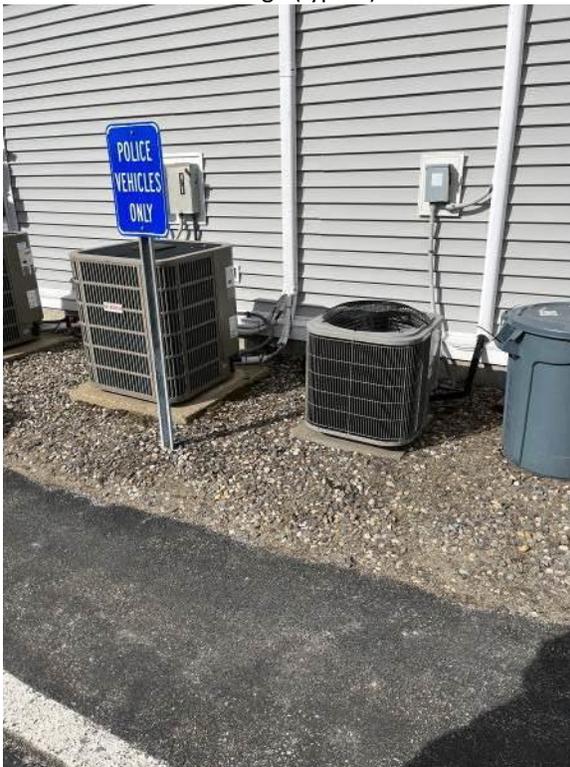
Exterior condensing units

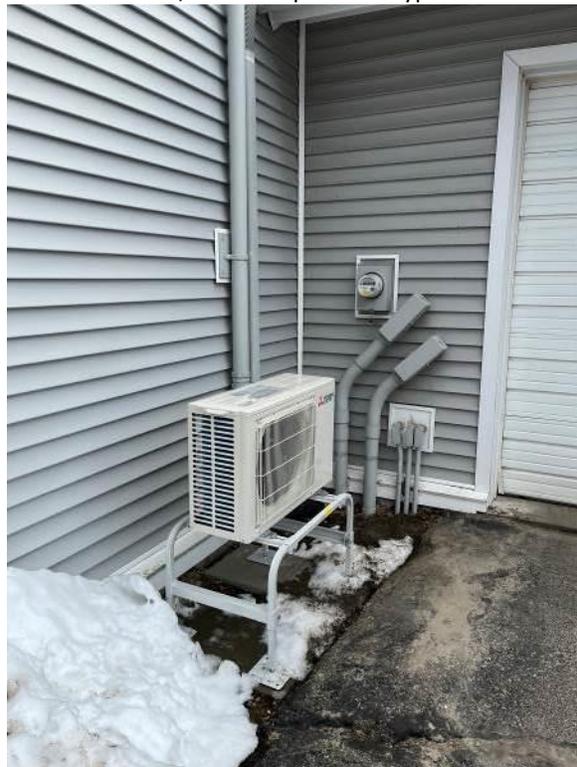
Exterior heat pump for 2<sup>nd</sup> floor office, refer to narrative for zoning information

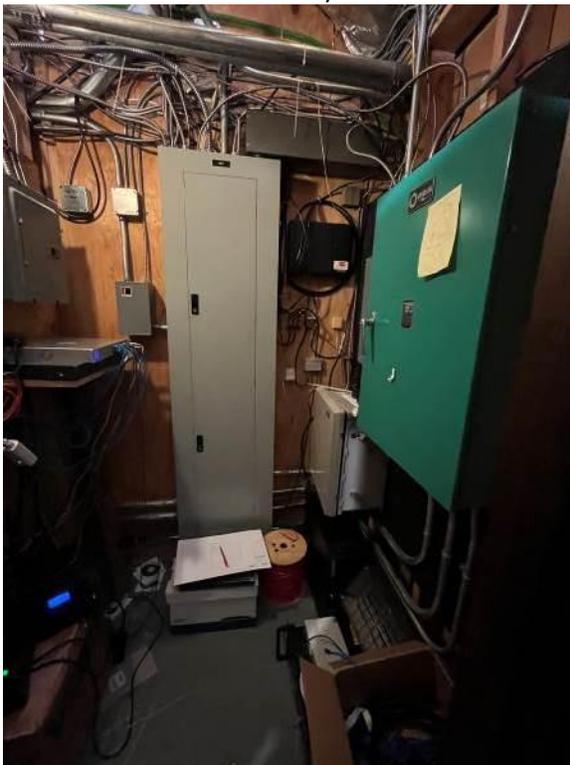
Main Distribution Panelboard on 2<sup>nd</sup> floor and defunct automatic transfer switch from previous, smaller generator

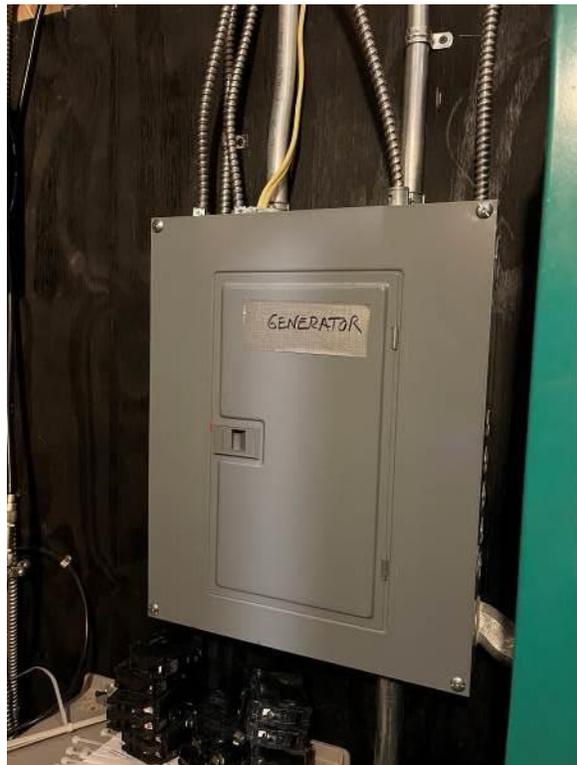
Load center (labeled as Generator, however entire building is now on generator)

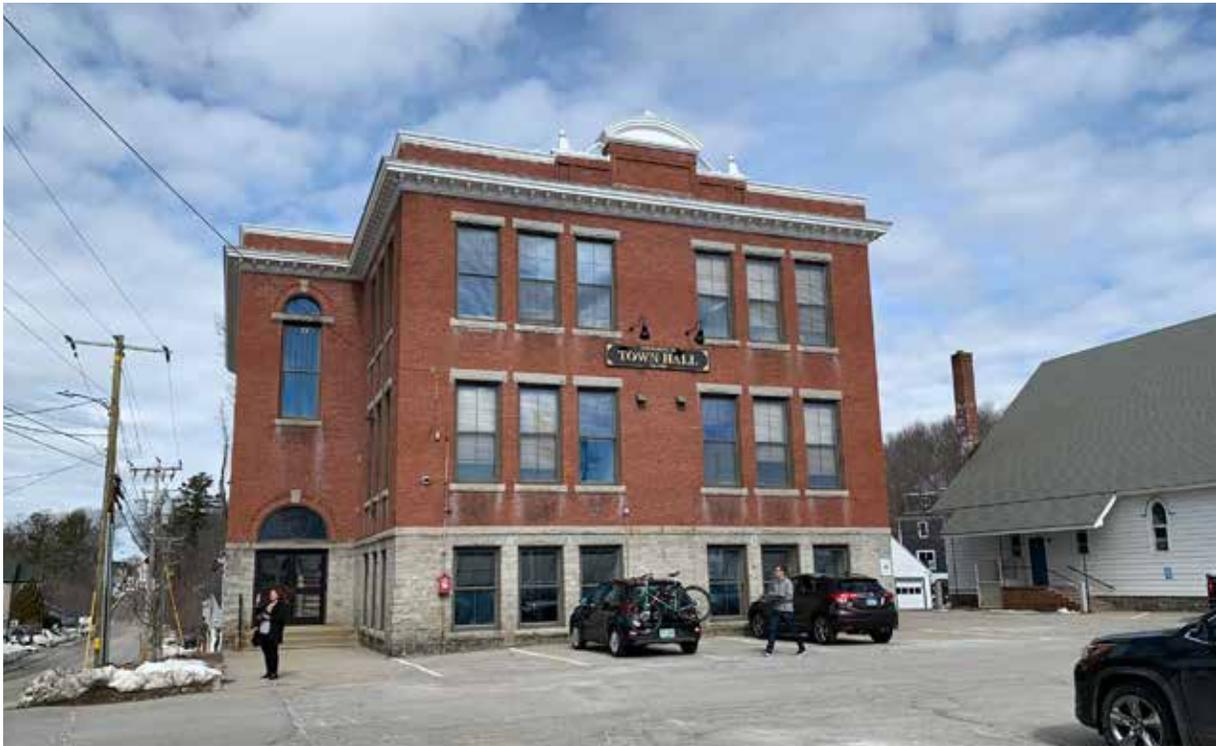
EXISTING BUILDING EXTERIOR

Existing brick masonry appears to be in good condition given its age. In conversation with the Town Buildings and Grounds Supervisor, Placework understands that a comprehensive repointing campaign took place in the last 15 years. There is consistent white staining under each corner of nearly all exterior windows; this may be caused by runoff from the original painted wood windows, however further investigation will be required to confirm. Additionally, there are localized areas of black staining on the clay masonry.

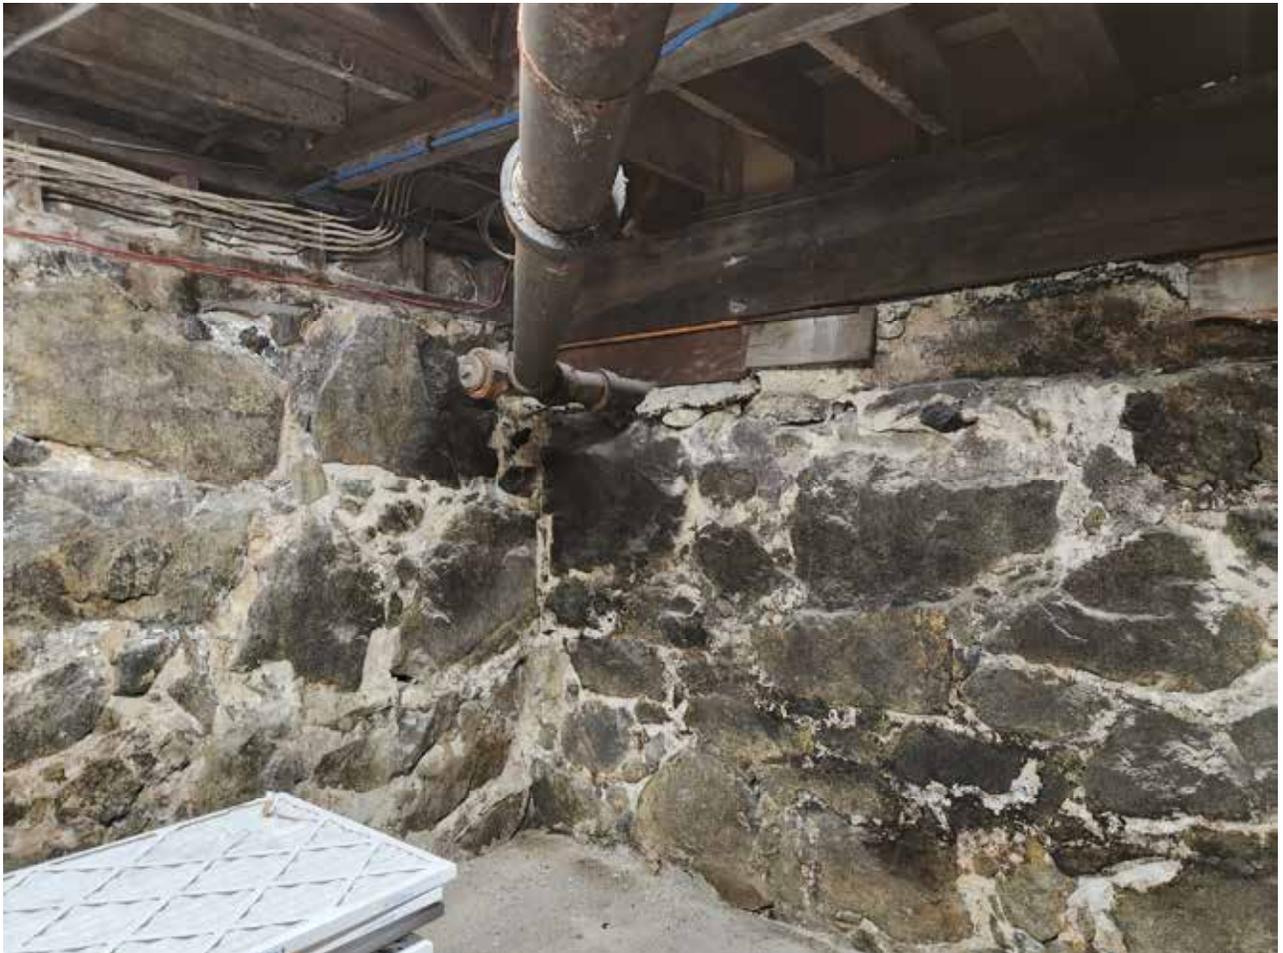
Rusted Sewer Pipe
