FINAL REPORT - VOLUME 1

# Town of Newmarket

Facilities Master Plan

09.01.2023

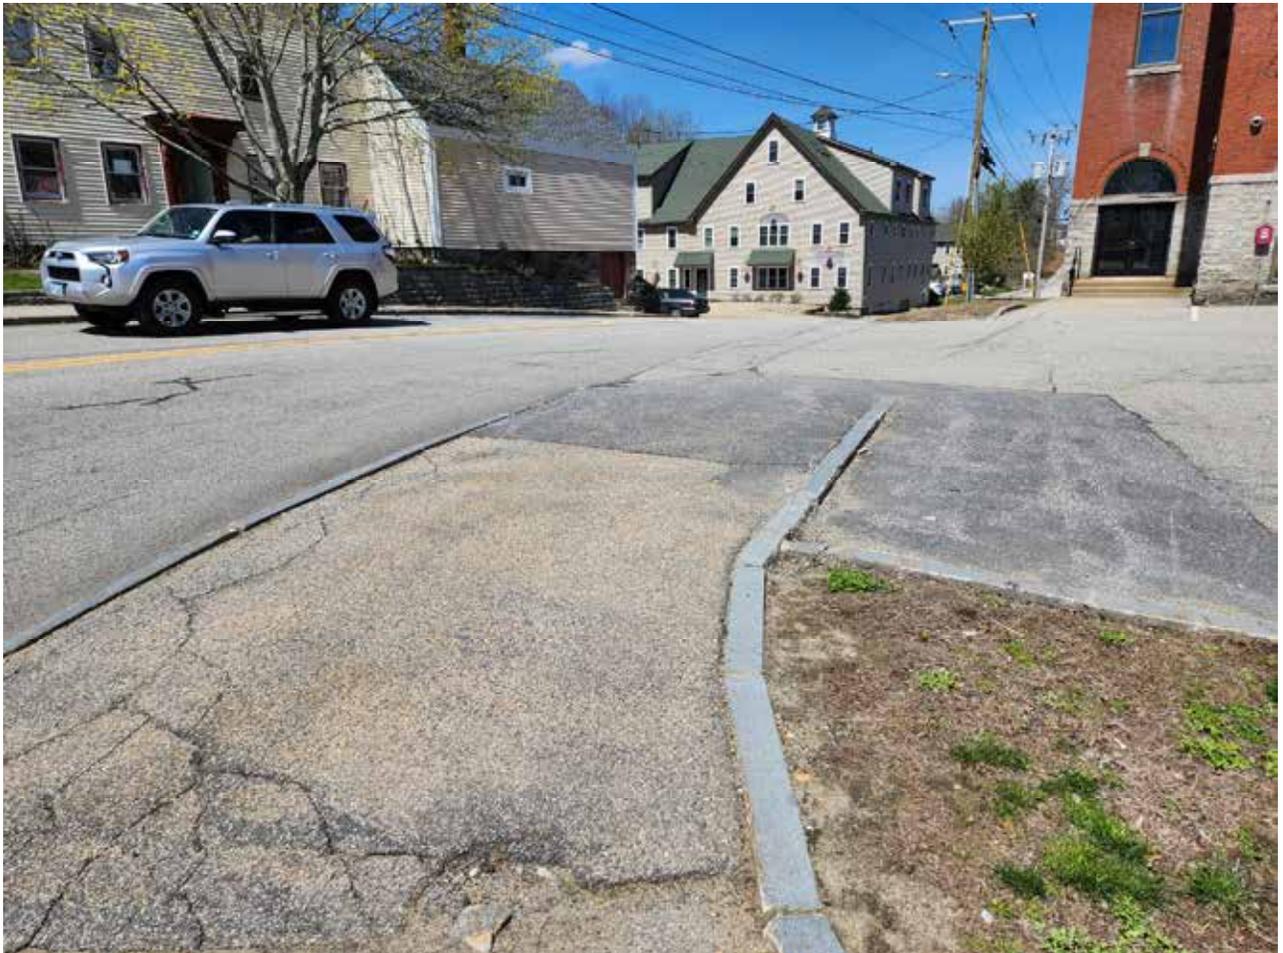
No Curb Protection for Pedestrians

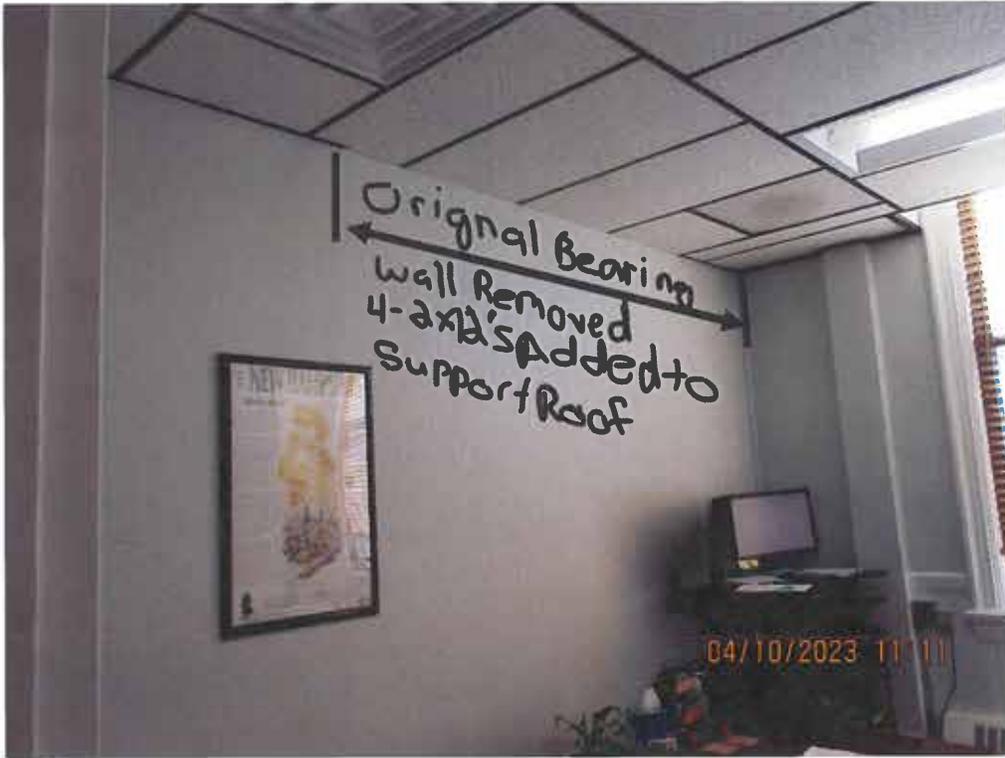
Third floor portion of bearing wall removed. New partition wall terminates at ceiling grid

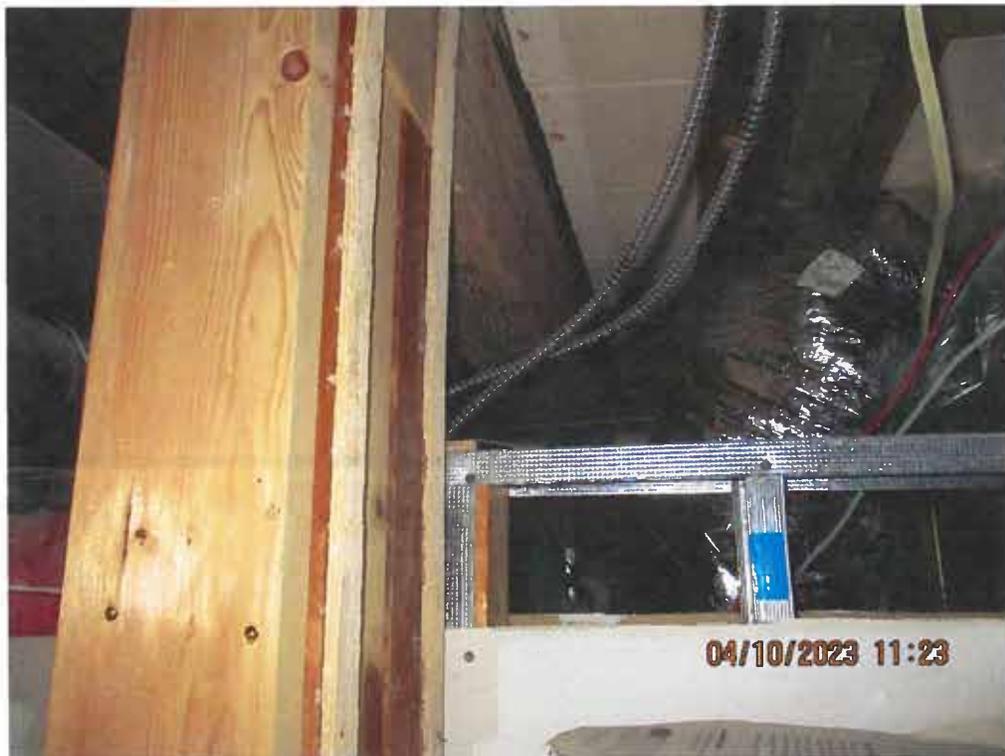
Tax Office 2 – Third floor reinforcing to allow opening in bearing wall on second floor

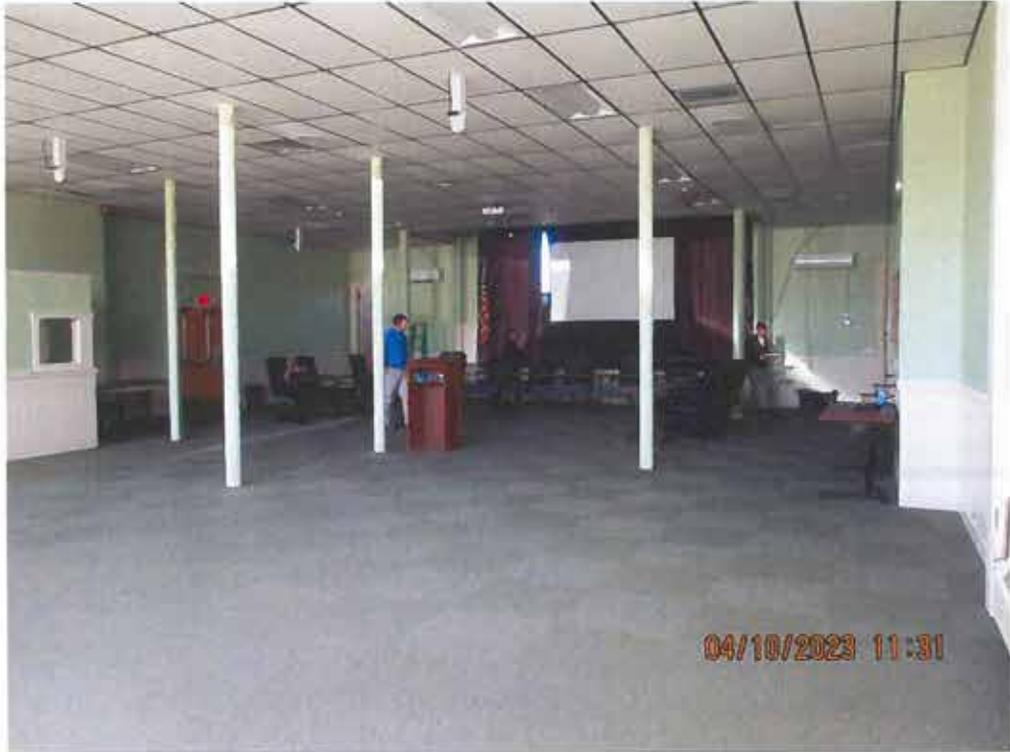
First level – posts align with above bearing walls

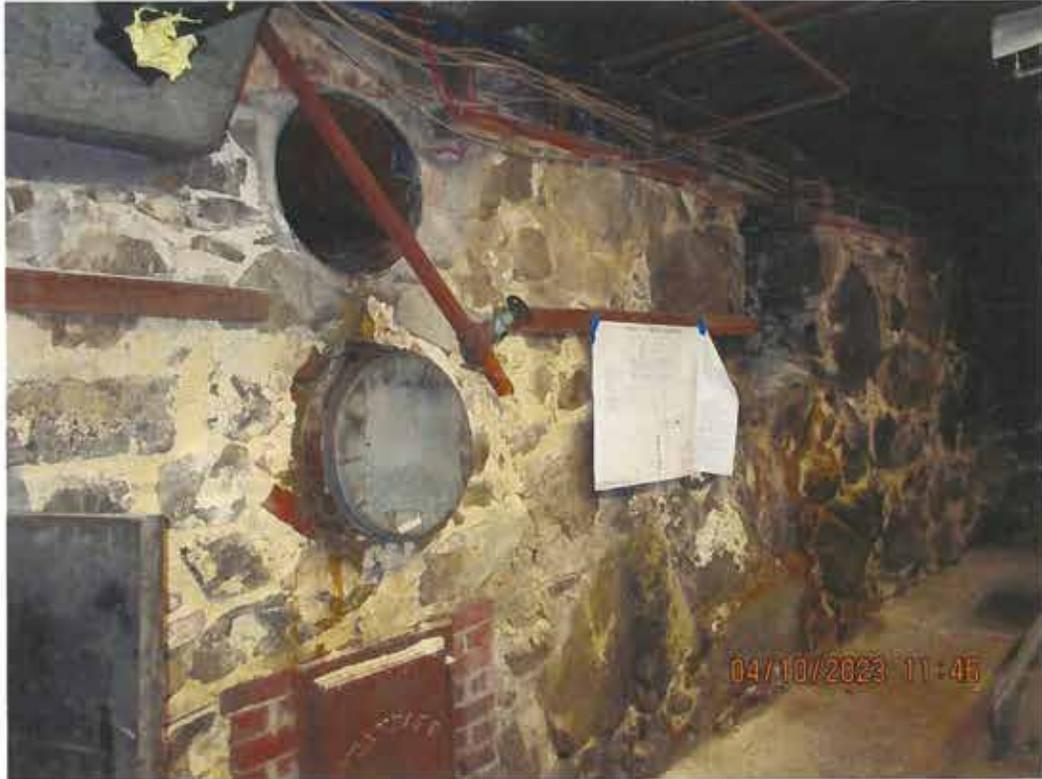
Chimney openings

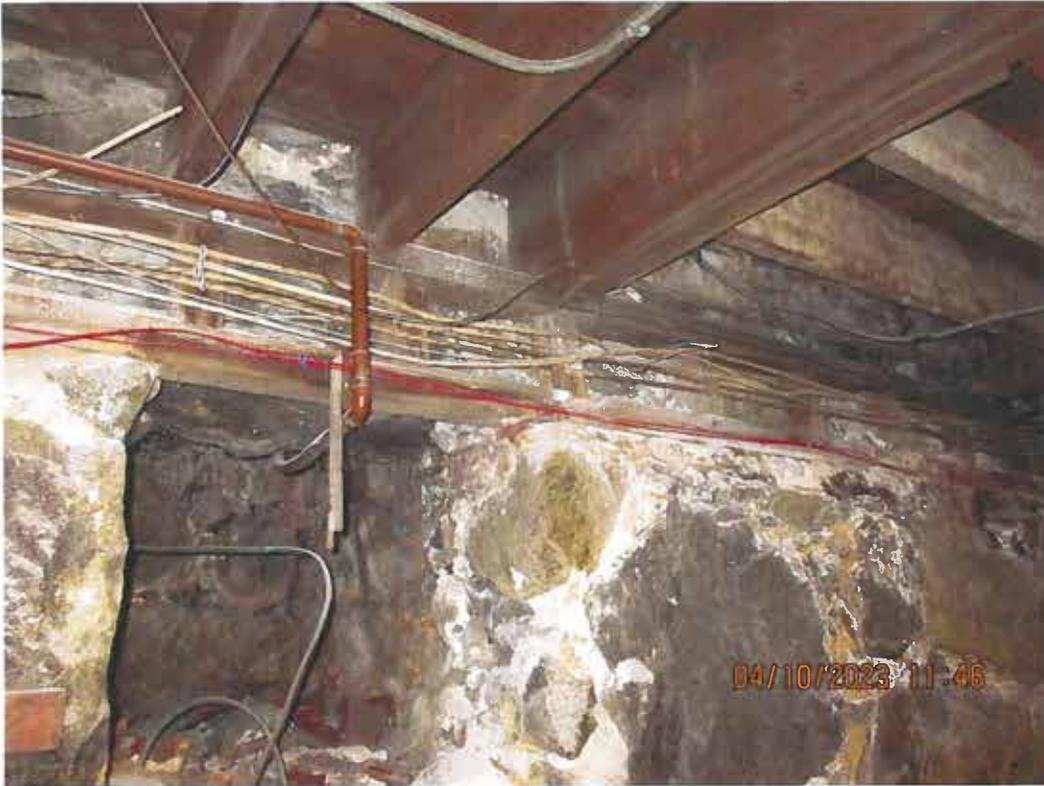
First floor wood floor framing rests on stone shelf. Wall framing continues to roof along with cut stone brick veneer.

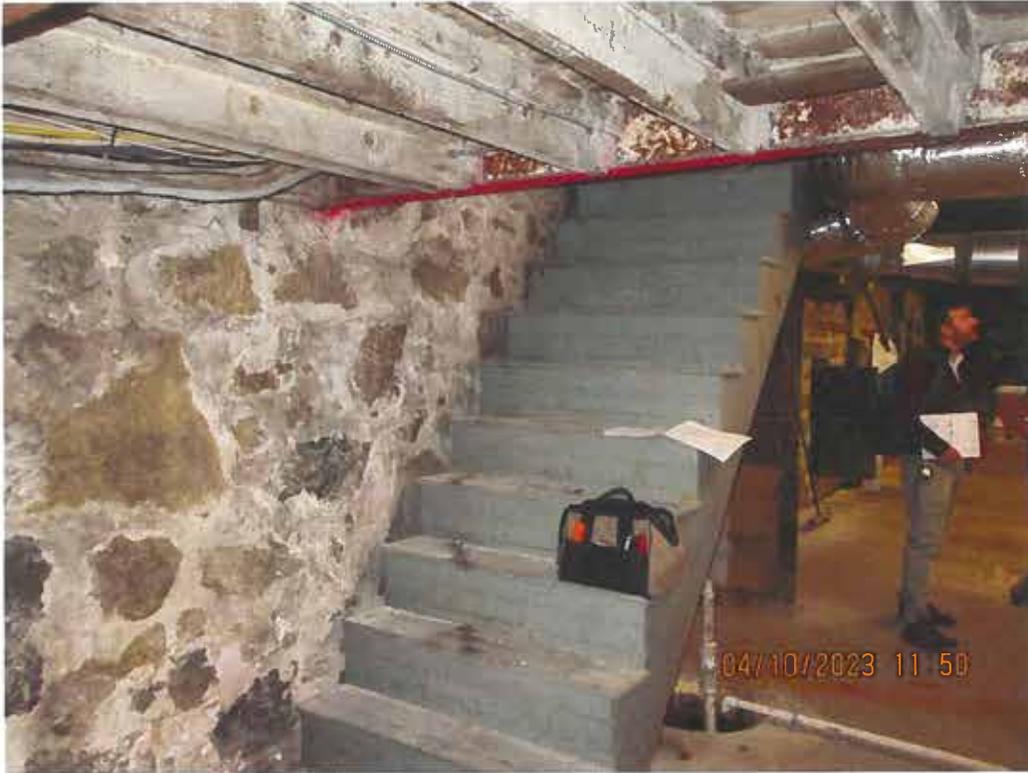
**Abandoned stair**

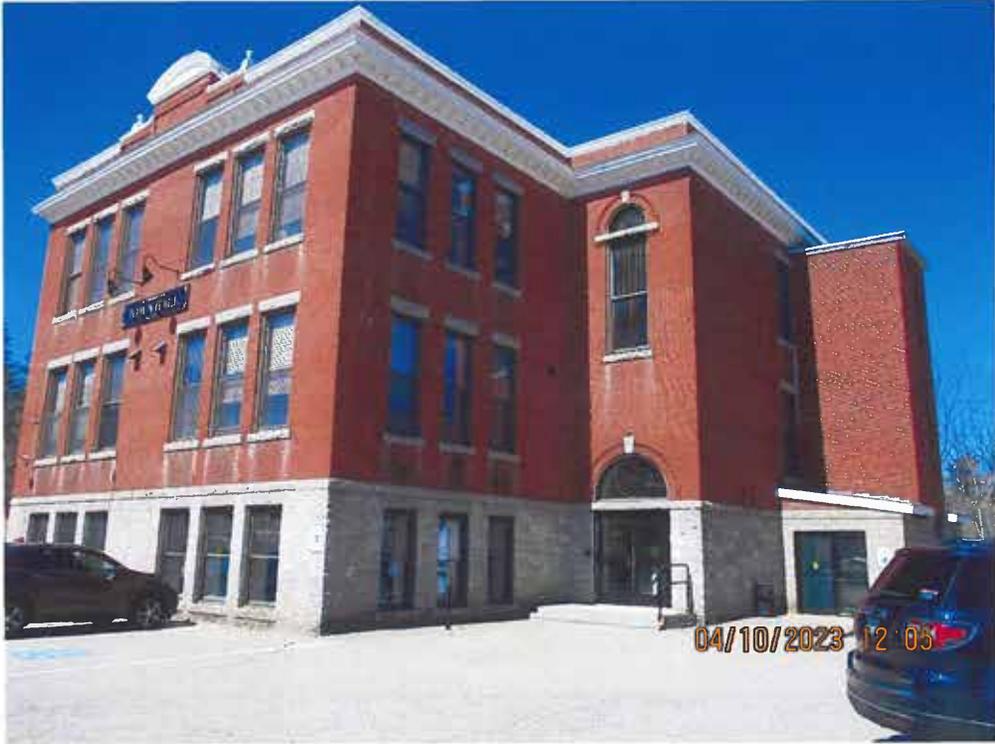
Masonry in good condition throughout

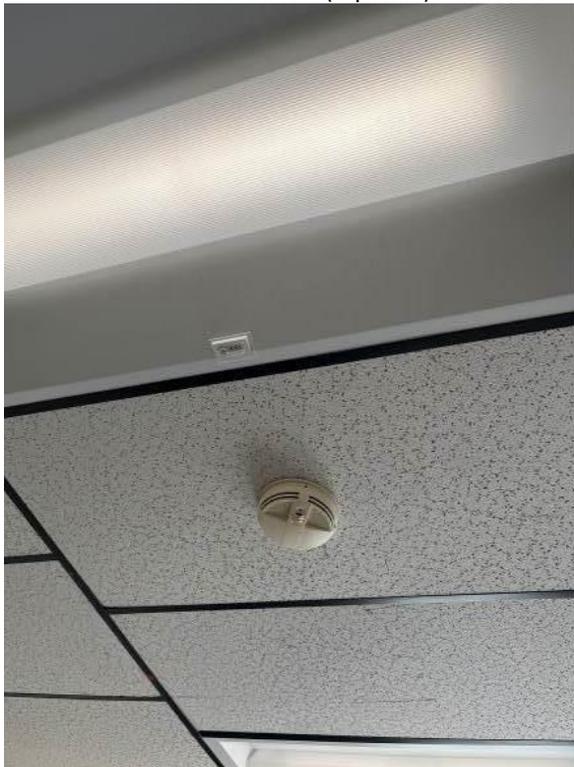
Line voltage smoke detector (not possible to determine whether these have any interconnection to the system fire alarm)

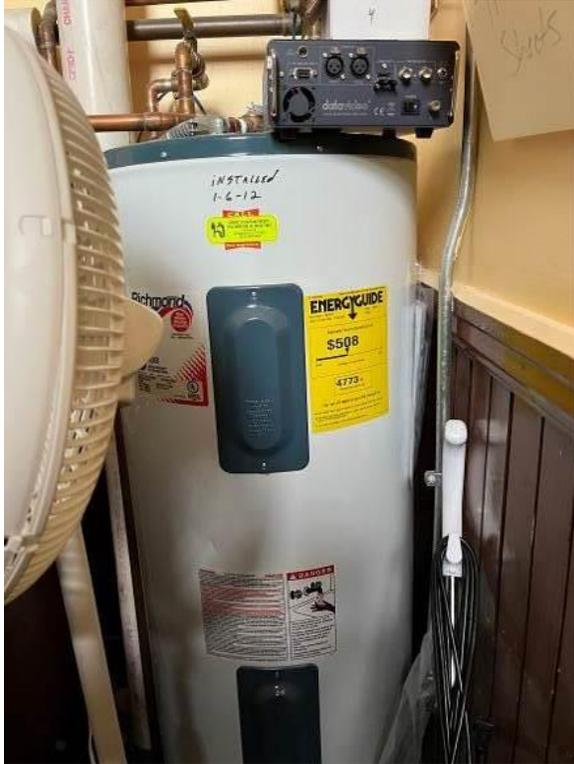
Hot water is generated from an electric water heater (Manufacturer: Richmond) located in the IT room off of the Meeting Space with approximately 50-gallon capacity. The water heater was installed in 2012 and appears to be in good condition.

Electric tank-style water heater in IT/Storage Room in basement

The electric water heater is currently located in the IT Room. IT Rooms generally produce large heat loads that the HVAC system must account for with cooling. The use of a heat pump water heater in this space will inherently cool down the room since it extracts the heat out of the air in order to heat the water in the tank. Heat pump water heaters are also 3 to 4 times more energy efficient than an electric water heater. It is recommended that the electric water heater be replaced with a heat pump water heater, either now or when the electric water heater breaks.

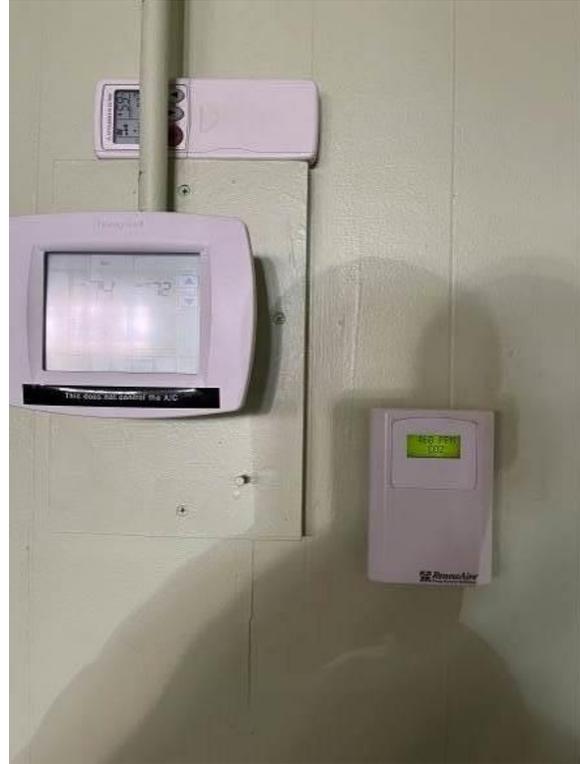
Thermostat for Meeting Space controls on right (thermostat on left no longer used)

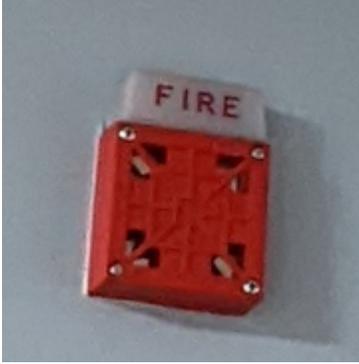
Item	Location	Findings	Code Ref.	Applies to Existing
4.	Fire Alarm Notification, General	<p>Many of the horn/strobes observed are aging and are not ANSI/UL 1971 compliant, meaning that the strobe portion of the appliance does not provide adequate visible notification. The strobes shown in the First Floor restrooms, for example, are newer generation appliances that do comply with ANSI/UL 1971. See below for example of non-compliant strobe.</p>

<p>As part of future fire alarm work in the building, these devices should be replaced.</p>	NHBC §907.5.2.3	No

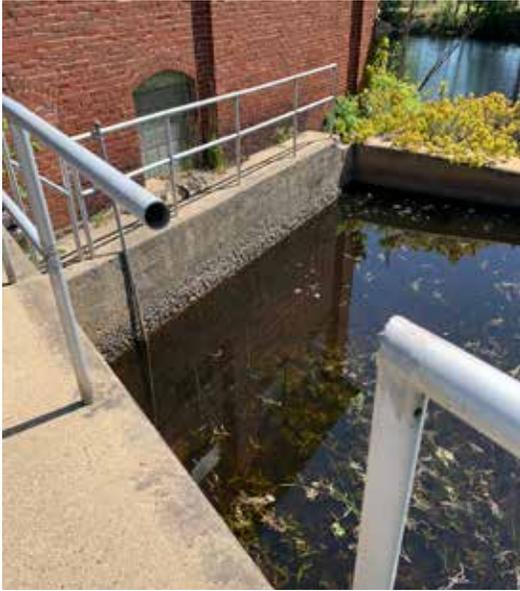
The existing building is unique in that it sits near the Piscassic River due to its historic use. There is an existing dam immediately adjacent to the building, which appears to be integral to the building's foundation. The Town Environmental Services Director noted during the site visit that despite the extreme proximity to the river, there has been minimal incidental flooding in the building basement during his tenure of over 25 years, which includes several widespread flood events in the Town as a whole. The 1990 upgrade included apparent structural reinforcement of the foundation wall immediately adjacent to the river. Additionally, there appears to be some continuity between the existing dam crossing the Piscassic River to the foundation wall of the existing building. This requires further specialized investigation from a dam specialist to determine any implications for the building foundation, as well as any considerations related to ownership and responsibility for the existing dam.

PHOTOS SHOWING DAM - BUILDING INTERFACE

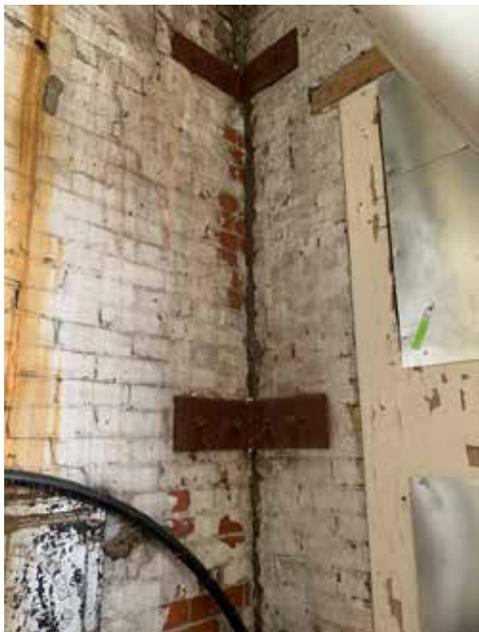
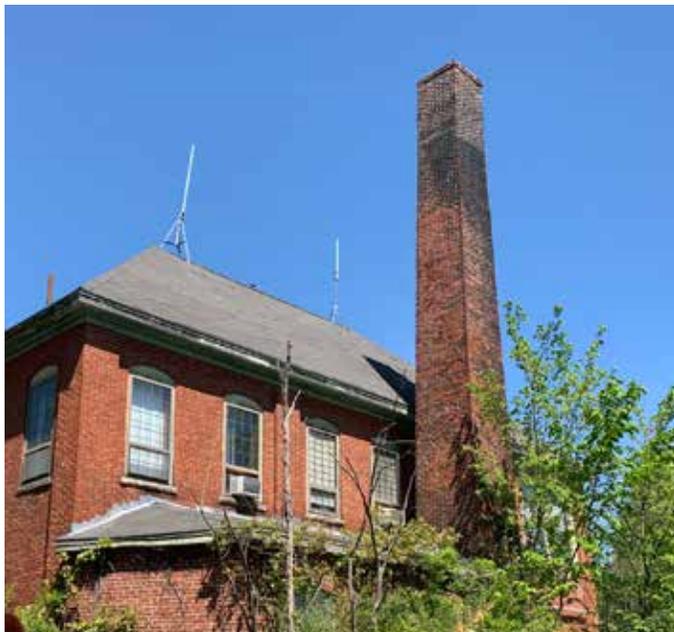
The existing building structure consists of a combination of multiwythe masonry, cast-in-place (CIP) concrete and contemporary style dimensional lumber framing at newer portions of the building. The oldest portions of the building appear to be in good condition given their age, and the original foundation nearest the river appears to have been reinforced at the time of the most recent (1990) renovation. There appears to be localized masonry damage and remediation at the base of the existing chimney, as well as deterioration at the top.

REMEDATION AND GENERAL CONDITIONS AT EXISTING CHIMNEY

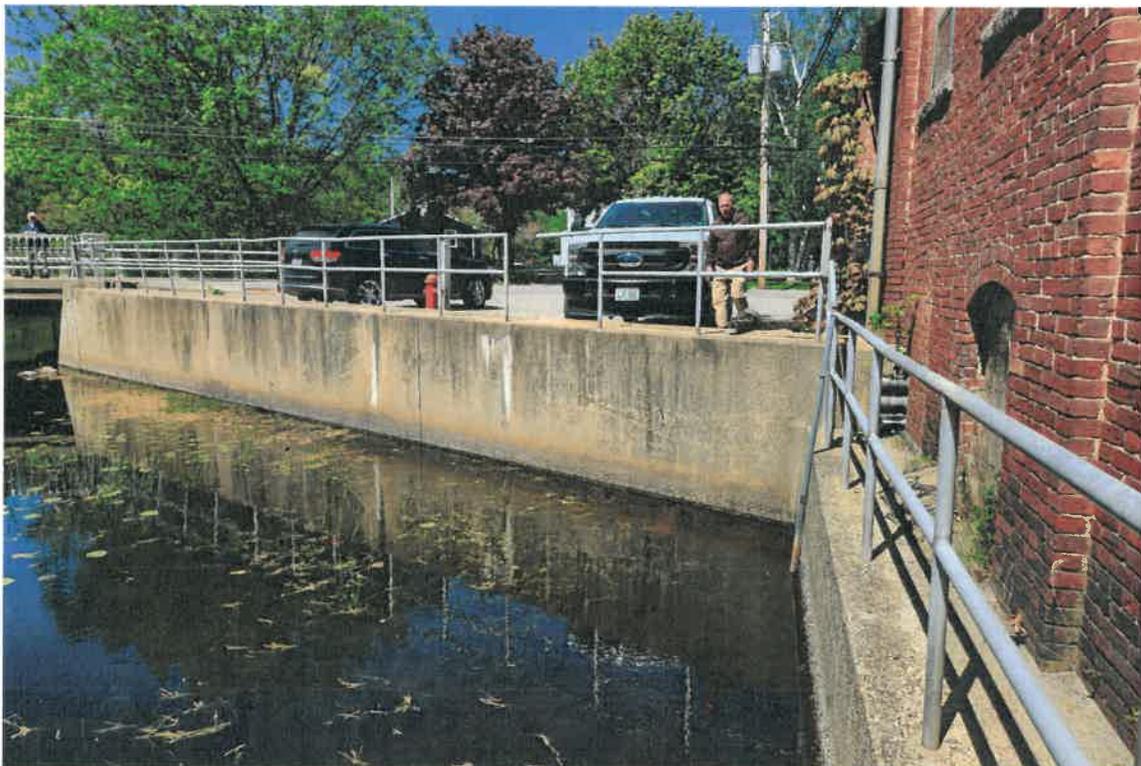
Integrated foundation/retaining wall/headwall/bridge abutment

The team was not able to determine the extent to which the building's foundation is integrated with the adjoining dam structure. This should be further evaluated. Additionally, depending on the scope, future renovations may require review of the existing building's lateral force resisting system (LFRS). Upgrading the LFRS would likely require detailed engineering and structural mitigation and should be considered during future design and planning.

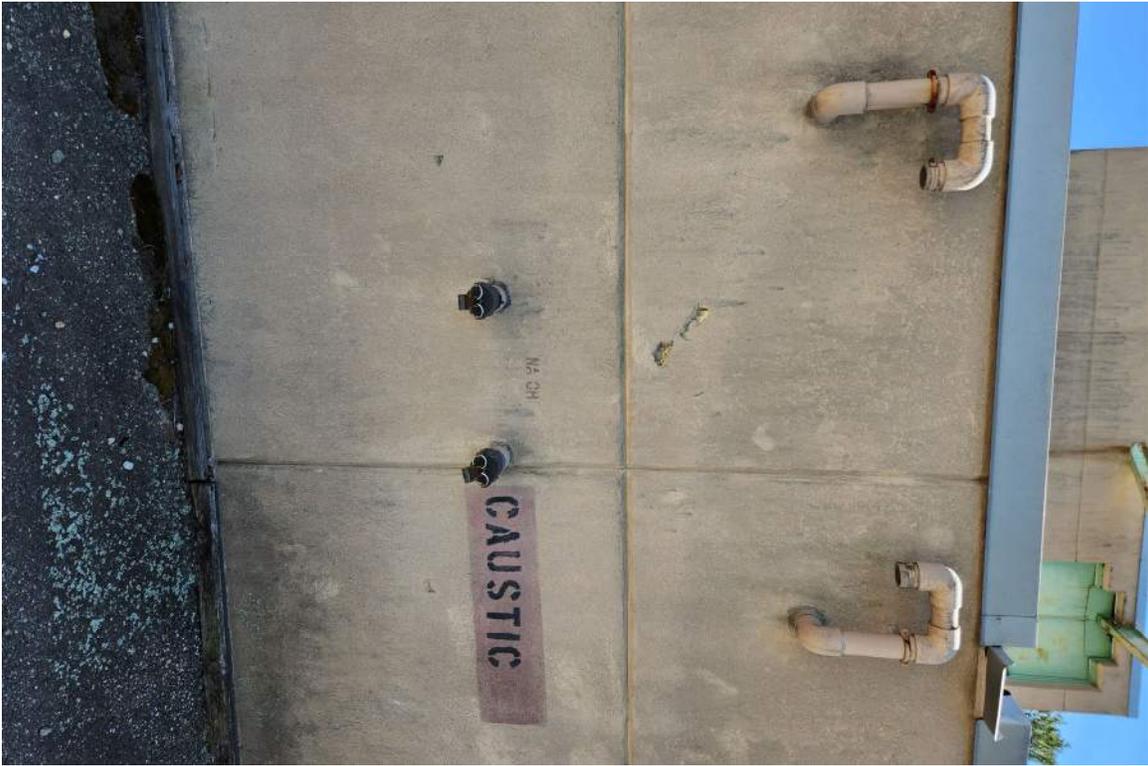
Chemical fill and vent pipes outside the building.

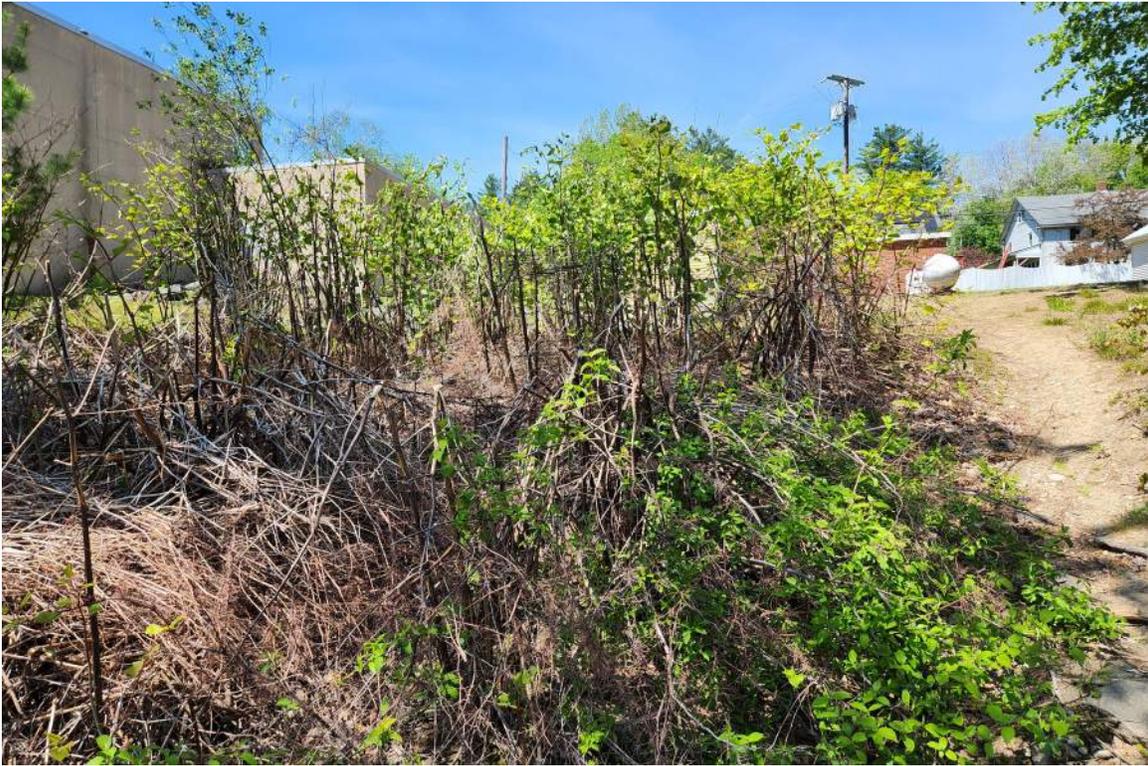
Stormwater outfall channel taken from the river. Silted channel with invasive plants.

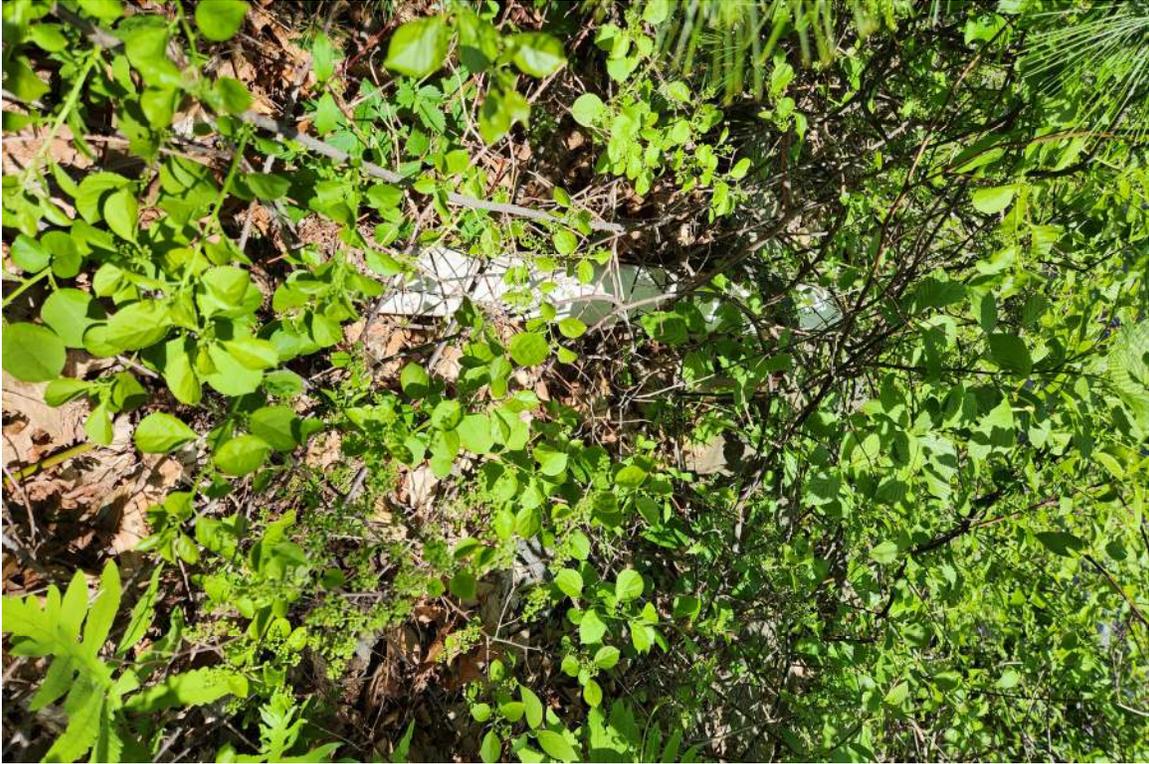
PVC pipe (possibly foundation drain) with outflow onto the bank of the river.

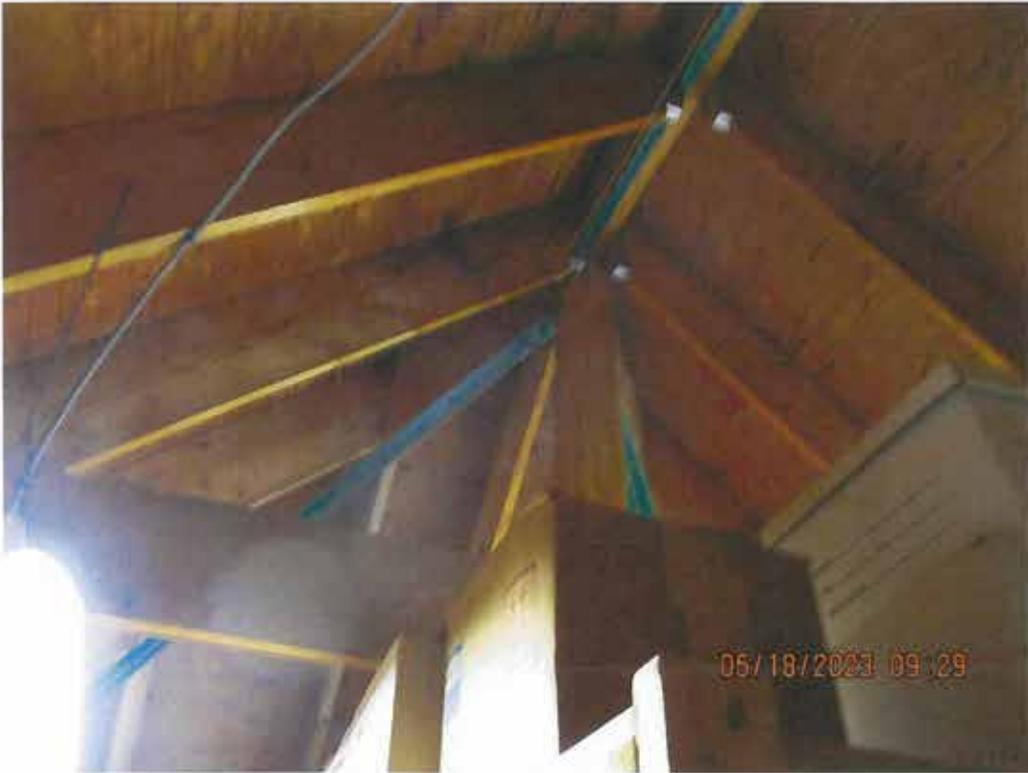
- In the attic space, the wood framed hip roof exhibited no sags, no water damage, and no weathering deterioration.  
In the 1990 area, laminated veneer lumber was utilized for the hip rafters.

Ridge & hip roof utilized engineered lumber

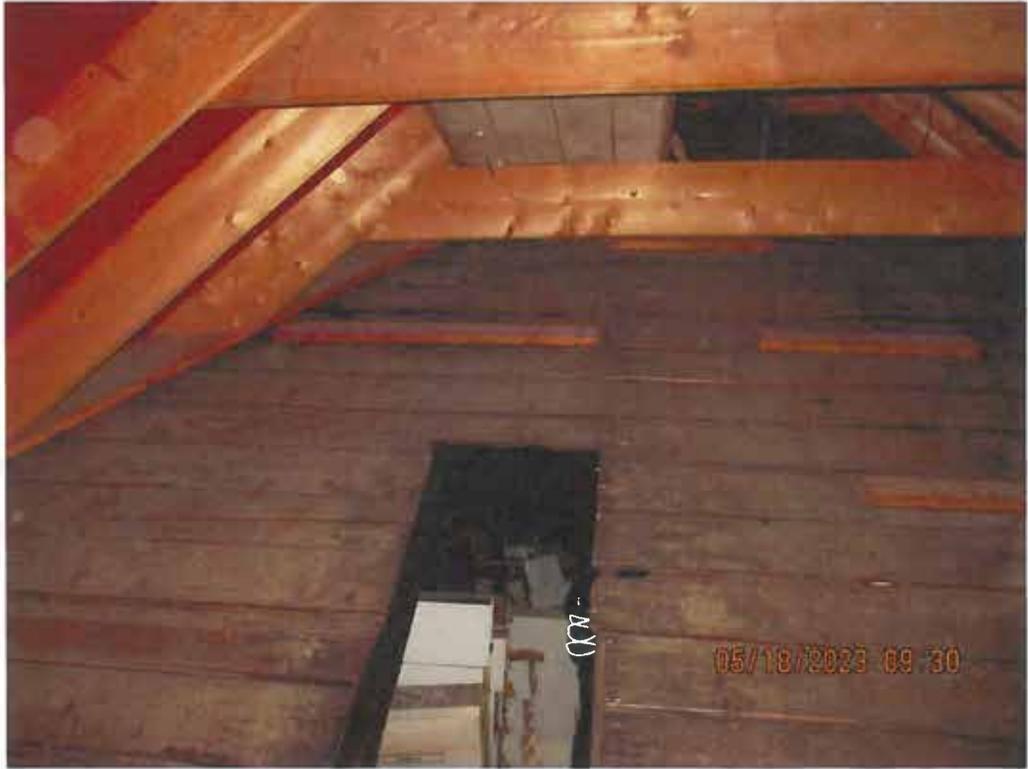
Newer roof adjoining original roof

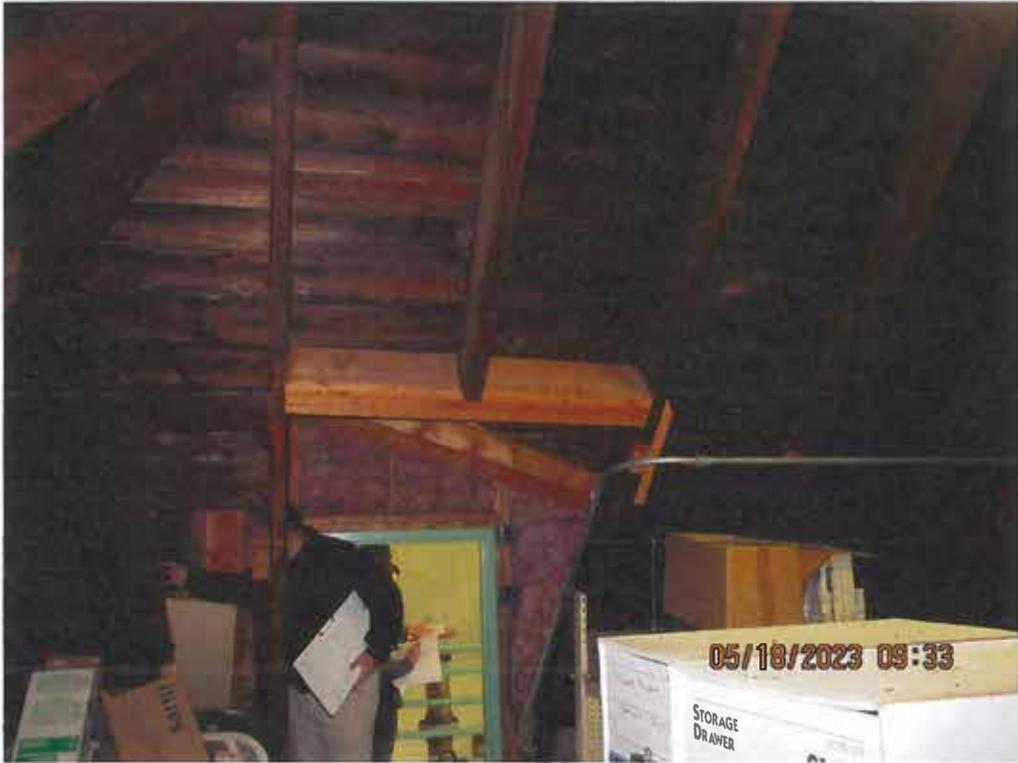
- The attic space created by the hip roof design lacks adequate ventilation. Good ventilation extends the life of the roof shingles.
- During the 1990 expansion, the original hip roof system was compromised when a rafter was cut without reinforcing the adjacent rafters.
- Water damage was found at the first-floor ceiling near the area connecting the 1894 structure to the 1924 structure.
- The exposed structural steel in the pipe gallery room exhibits heavy mill scale near the column base.
- In the chemical storage room, the structural steel beams supporting the roof exhibit corrosion causing the shotcrete to fail.
- In the boiler room, the base of the chimney exhibits vertical and step cracks. At the junction of the chimney and east boiler room wall, a separation crack occurs. Reinforcing plates have been installed to prevent further movement.

Rafter cut without reinforcing adjacent rafter

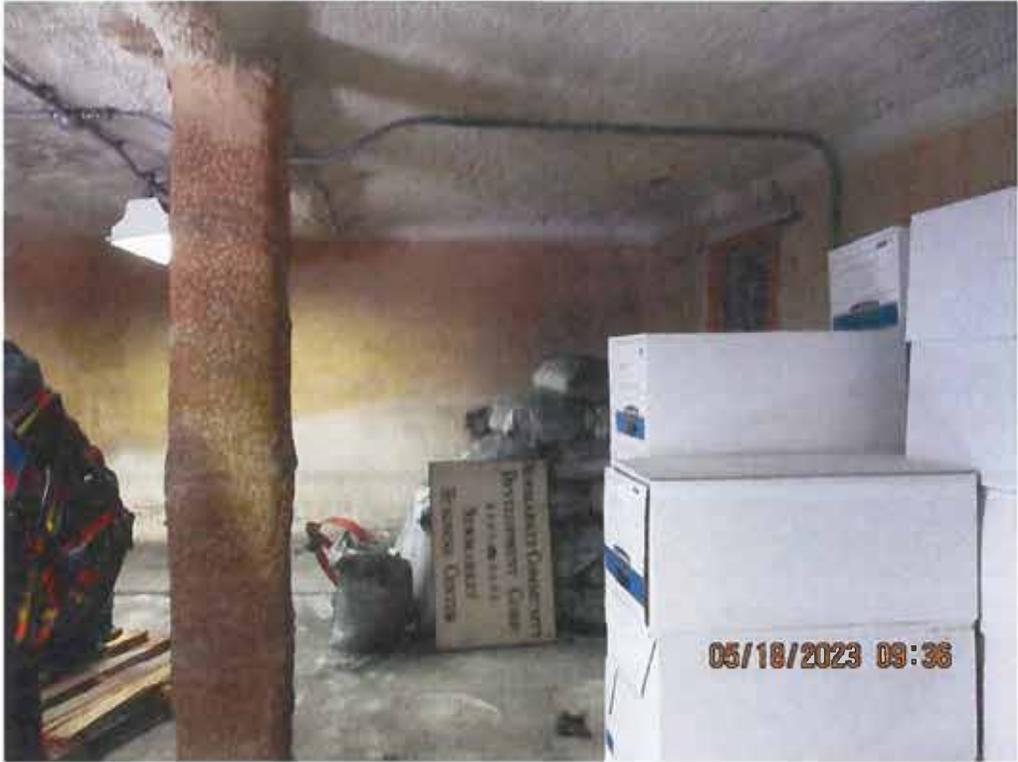
- In the 1924 PAC storage room, all walls and ceiling exhibited concrete shotcrete surfaces. The writer suspects the repair was performed during the 1990 expansion due to the original concrete wall degradation or as future protection of structural concrete.

PAC Storage room has shotcrete coating throughout

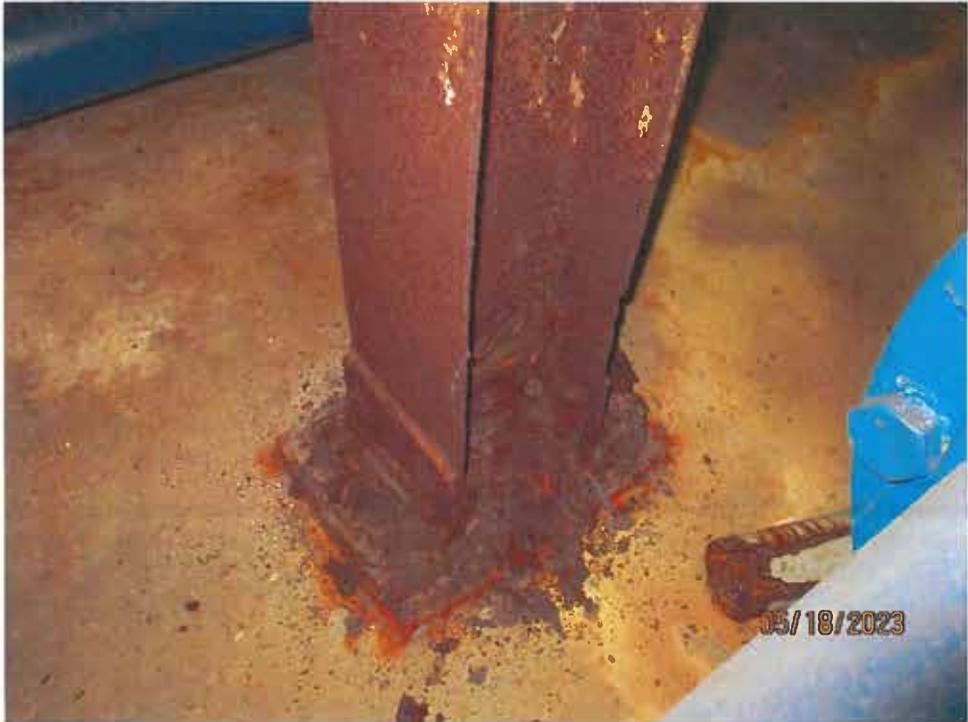
Pipe gallery – heavy mill scale on structural steel columns

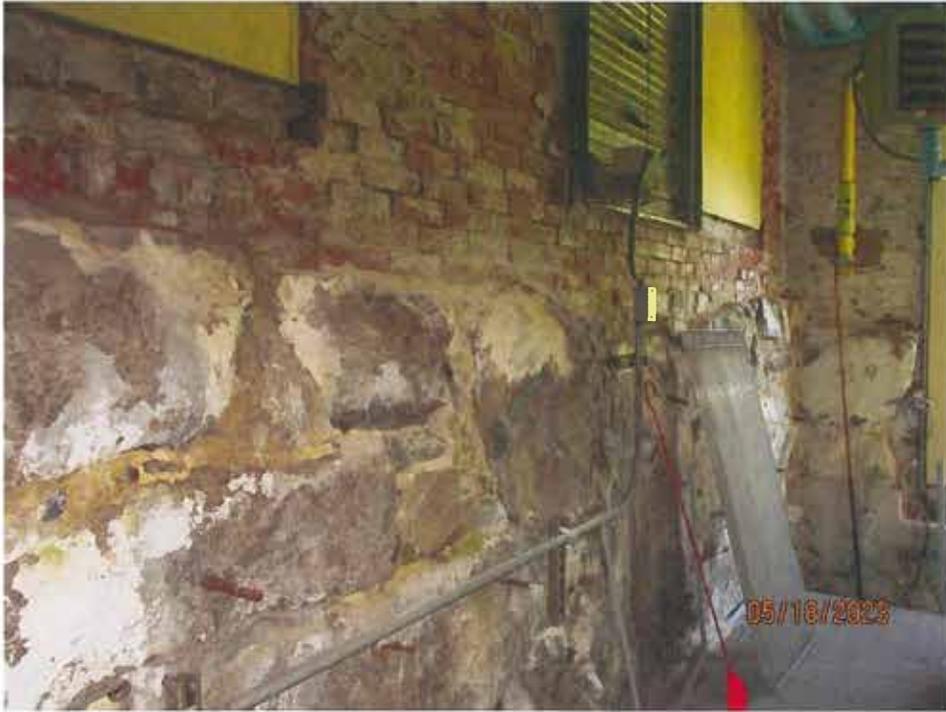
1894 Multi – wythe masonry wall in sound condition

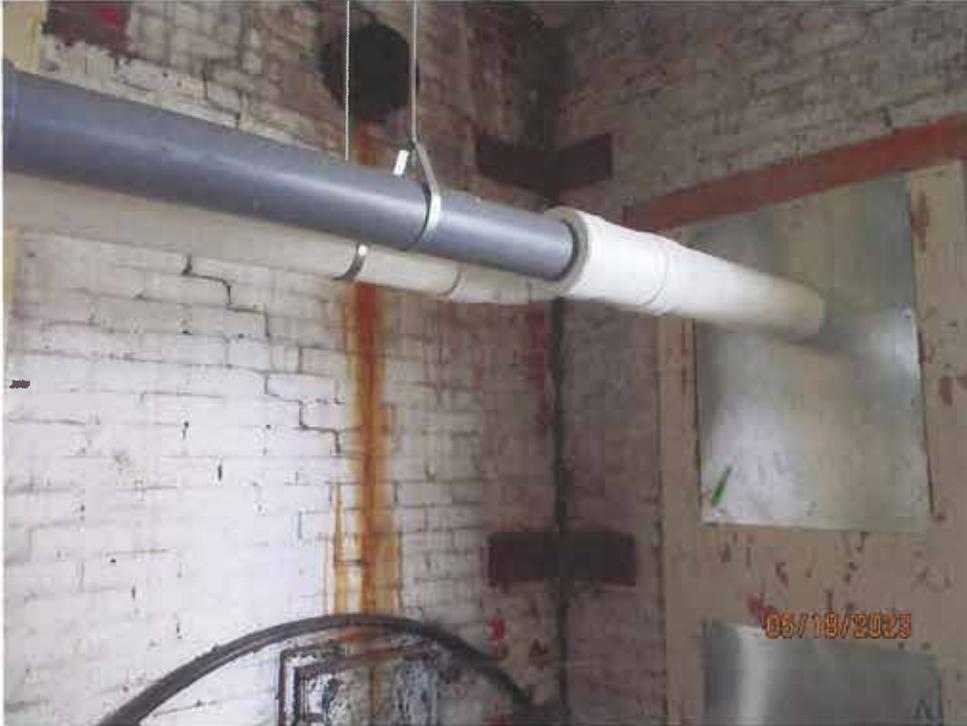
**Masonry cracks near chimney base due to settlement or wind**

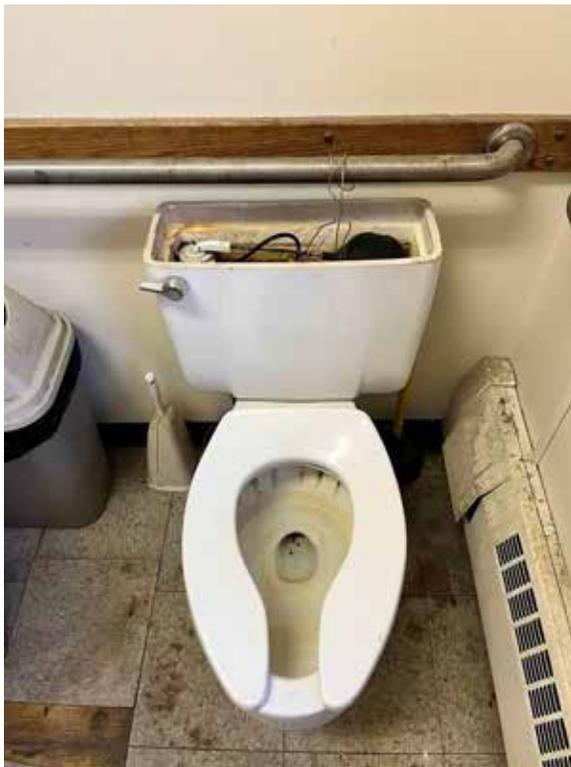
Water Closet

The plumbing fixtures throughout the buildings appear to be in poor to fair condition.

The fixtures in the building do not appear to be in good condition. It is recommended that the fixtures be replaced with new low-flow fixtures.

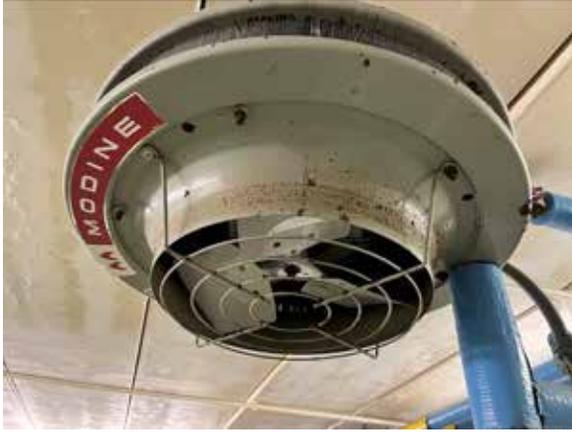
Vertical Blow Unit Heater

The unit heaters consist of horizontal and vertical blow manufactured by Modine. The unit heaters serve as the only source of heating for the spaces. The unit heaters appear in fair condition.

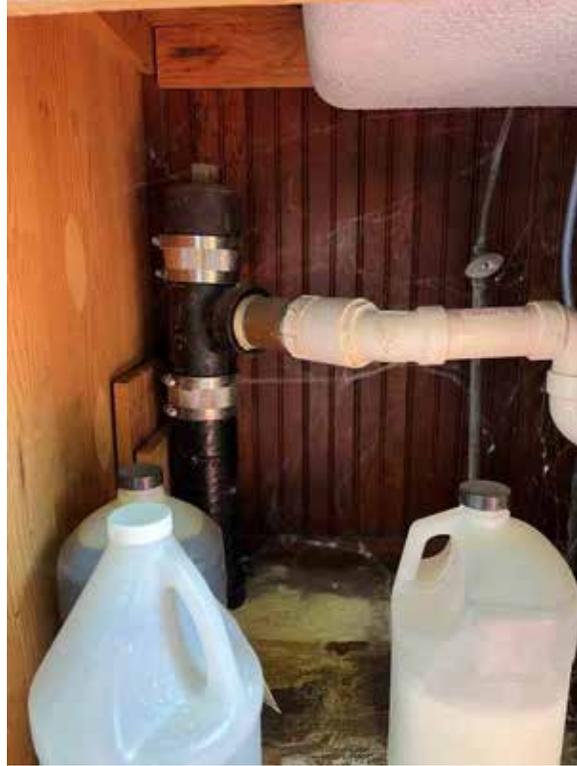
There were several plumbing fixtures that appeared to be unvented; including the sink in the Laboratory, the mop sink in the Janitor's Closet, and the floor drains. It is recommended that these fixtures are re-plumbed in order to provide the proper venting required by the 2018 International Plumbing Code.

Unvented Sink Piping

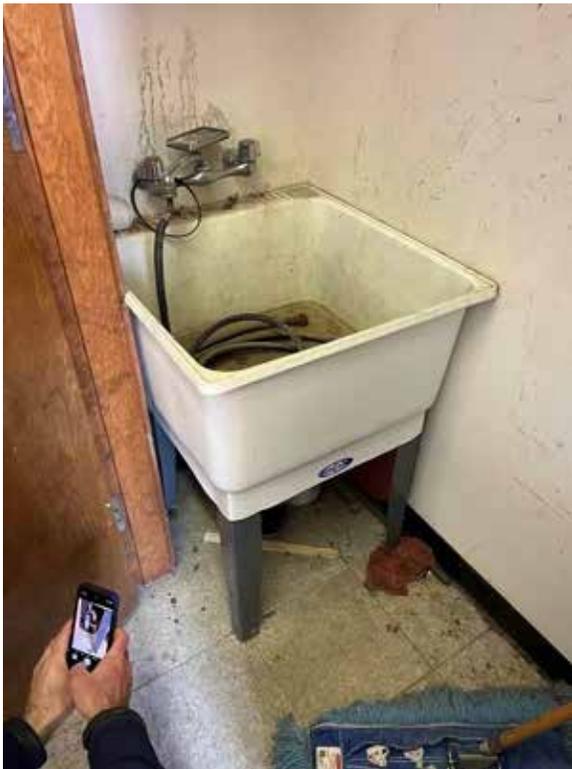
Mop Sink in Janitor's Closet

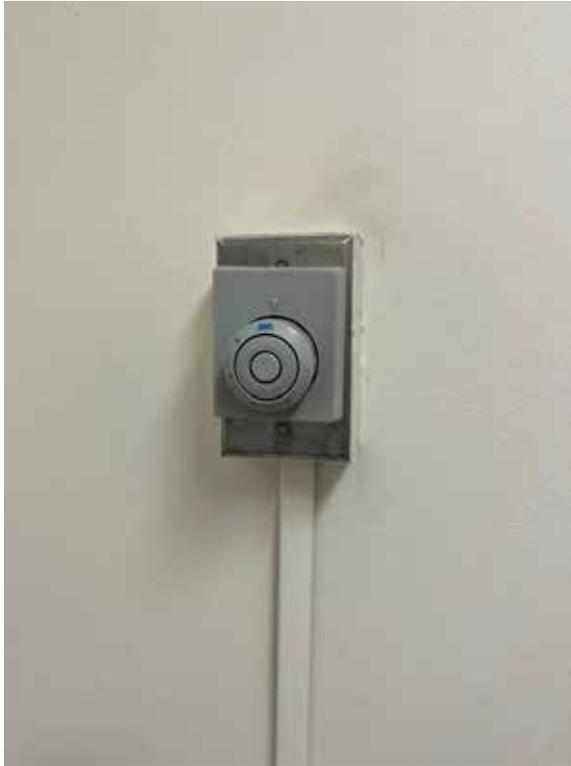
Wall Mounted Thermostat

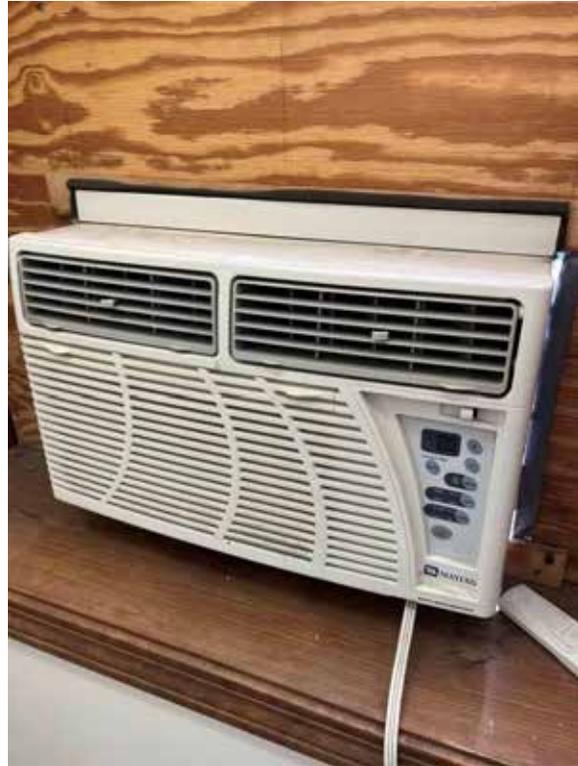
Window AC Unit

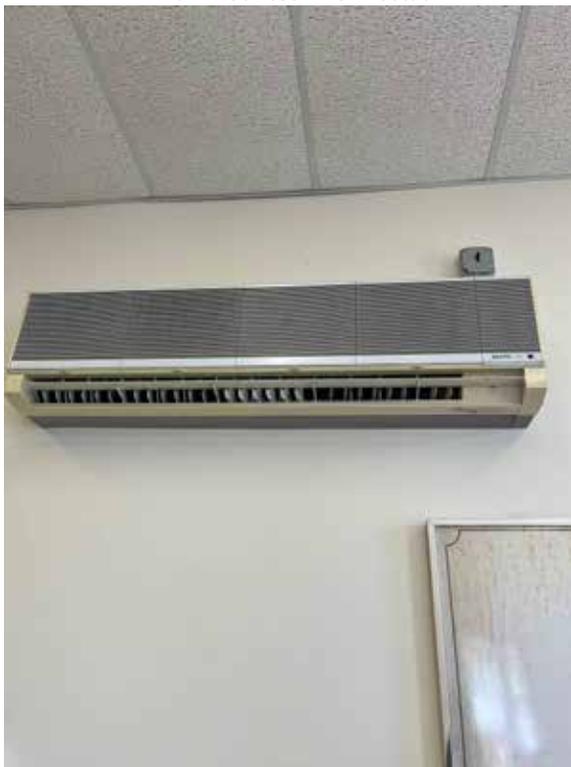
Wall Mounted Ductless Air Handling Unit

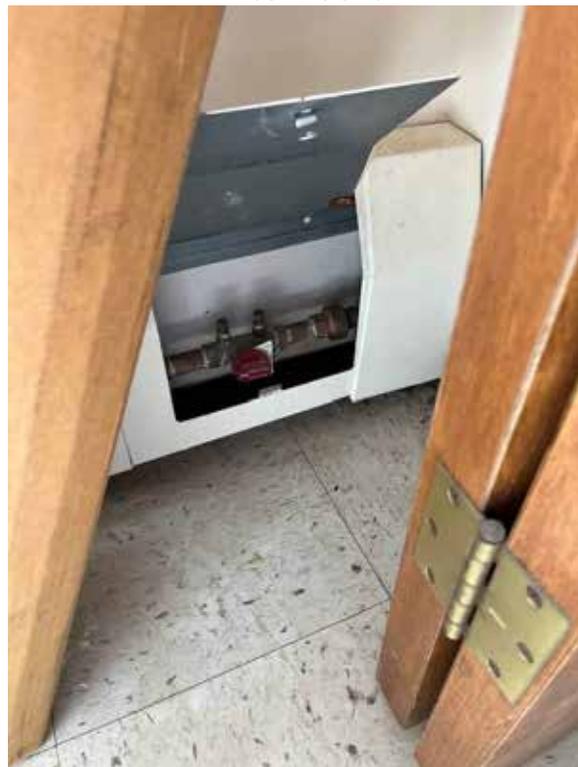
Radiator Control Valve
