FINAL REPORT - VOLUME 1

# Town of Newmarket

Facilities Master Plan

09.01.2023

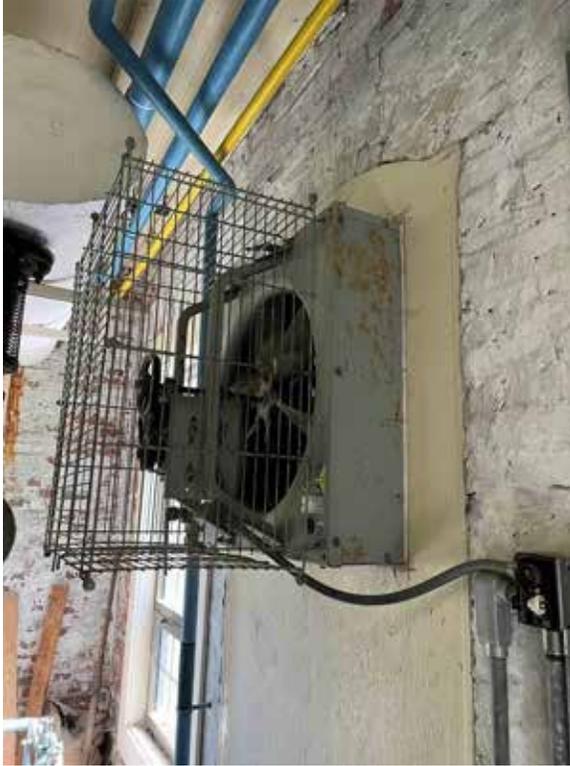
Wall Mounted Exhaust Fan

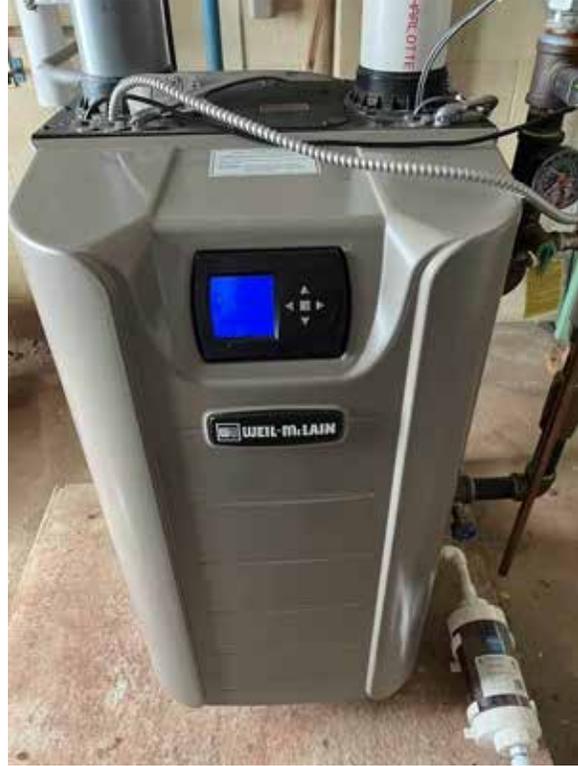
Gas-Fired Condensing Boiler

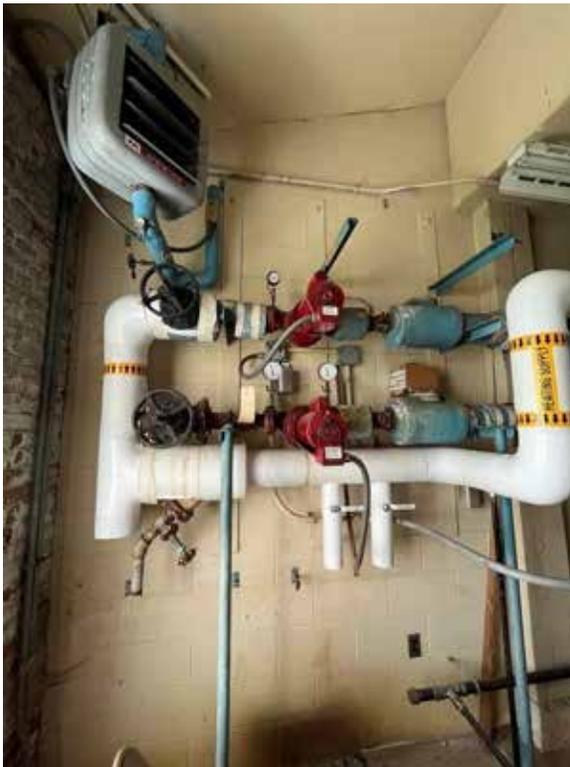
Hydronic Pump Piping

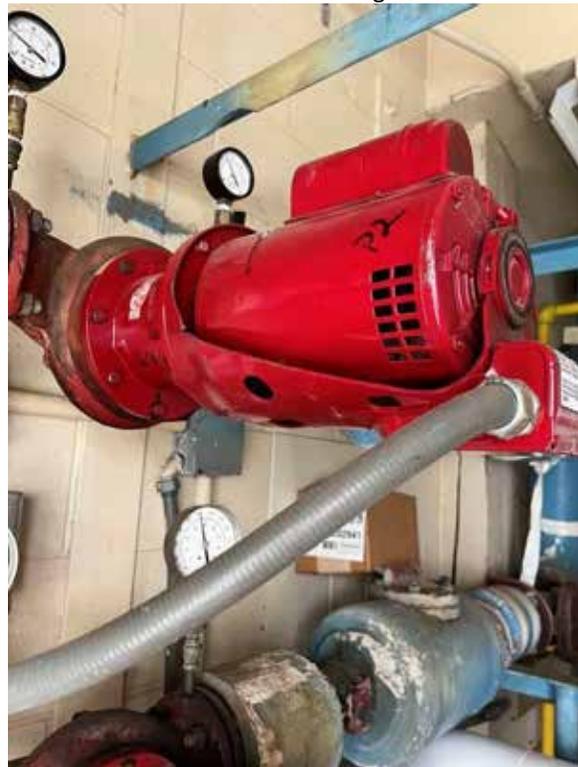
Hydronic Hot Water Pump

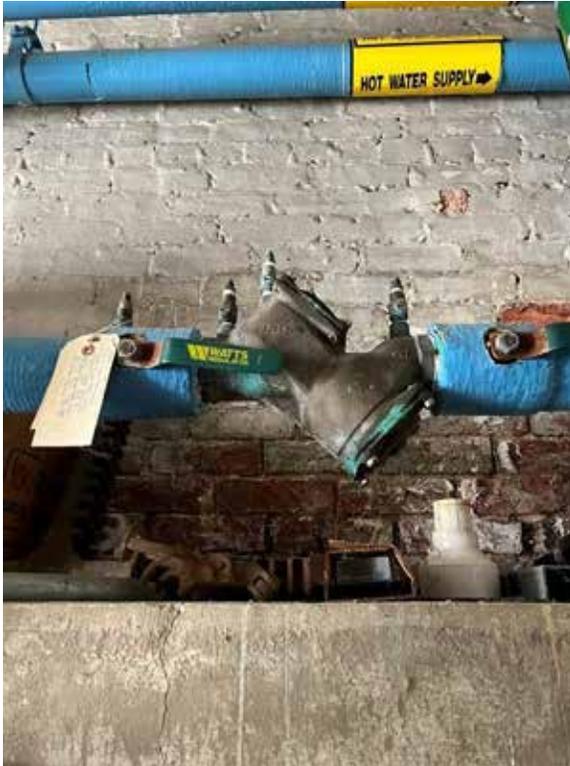
Domestic Water Backflow Device

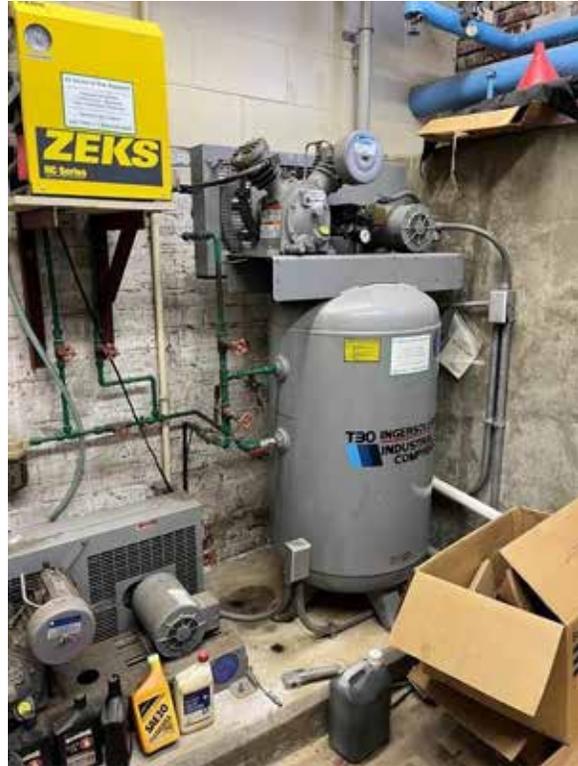
Compressed Air Station

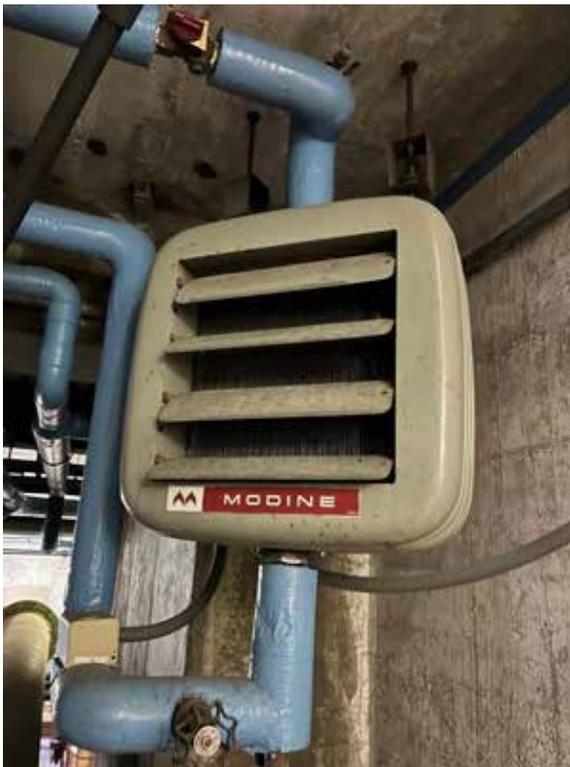
Horizontal Blow Unit Heater

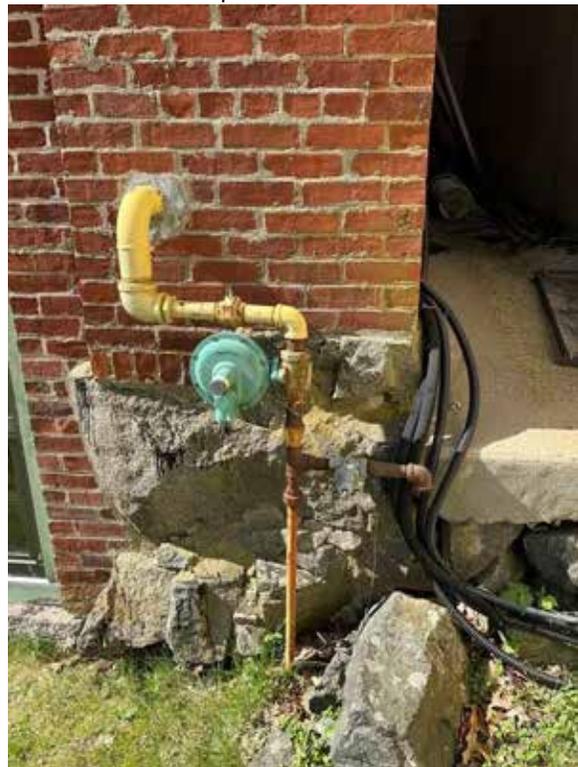
Natural Gas Main Entrance

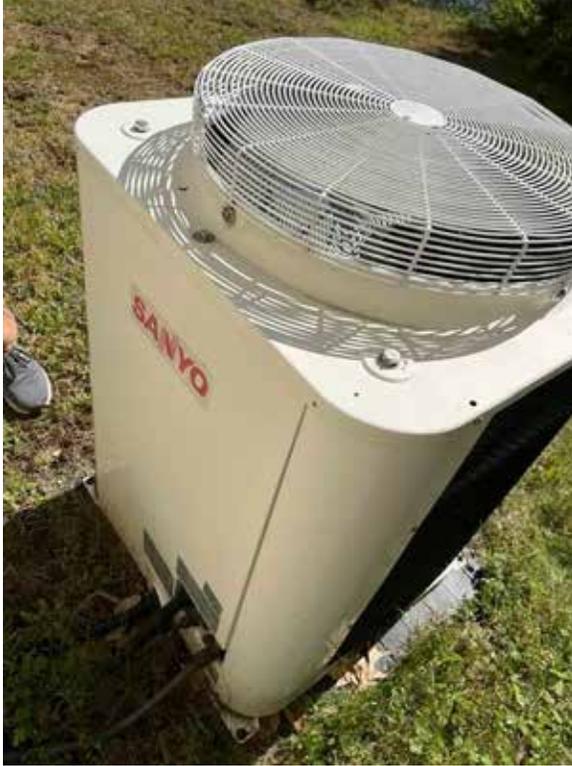
Exterior Condensing Unit

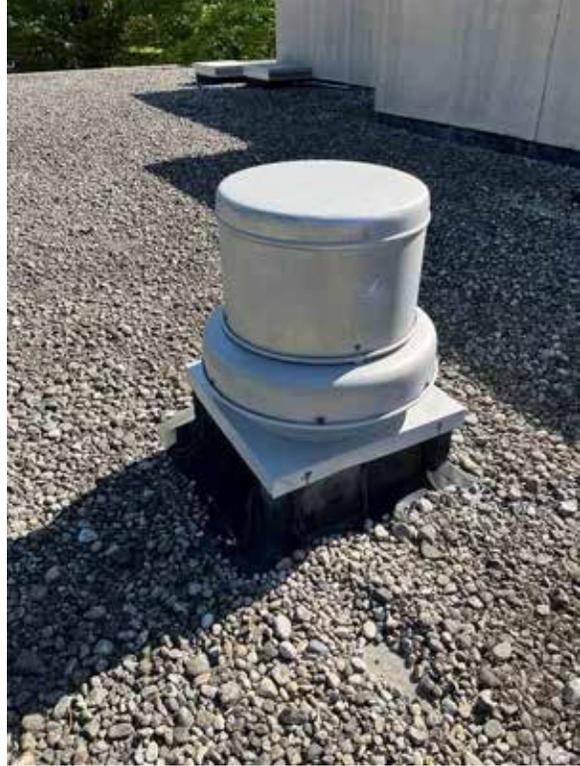
Roof Mounted Exhaust Fan

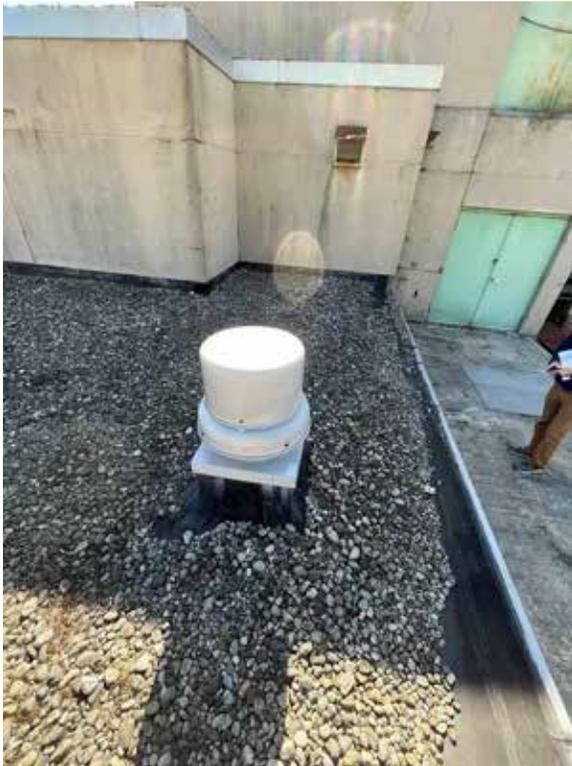
Roof Mounted Exhaust Fan

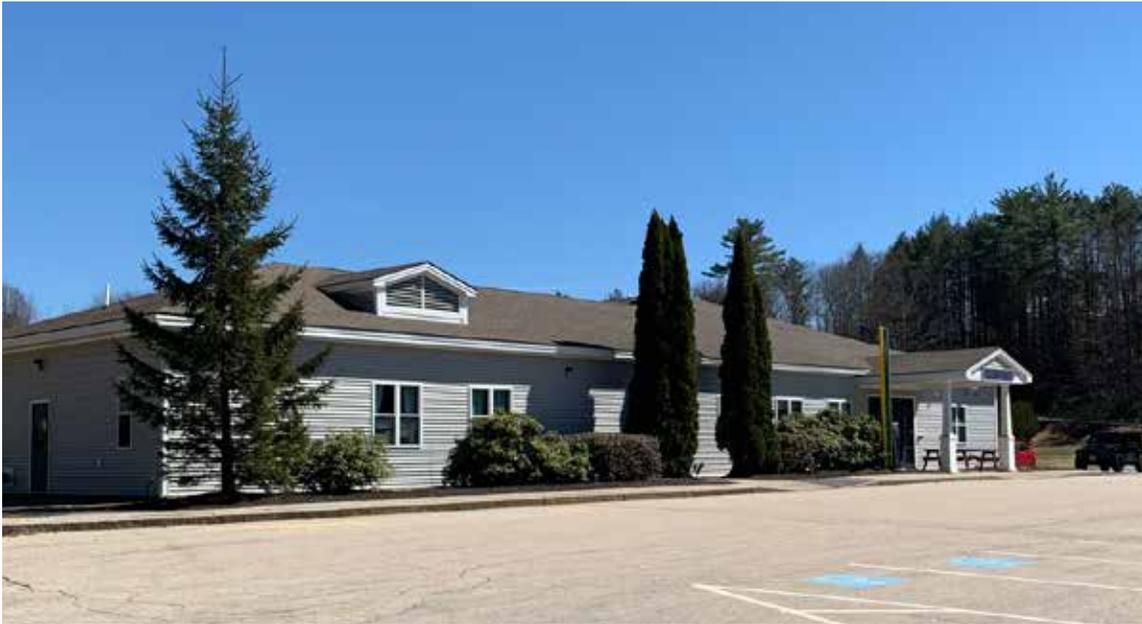
## Community Center

Generally, the Community Center Facility appears to be serving the function for which it was designed. Similar to the Police Department, finishes, lighting, and furnishings are largely original and dated, however generally functional. There are issues with water intrusion along the foundation perimeter; during the site assessment it appeared that roof drainage may be collecting at the base of the wall and backflowing toward the building. Recommend diverting roof drainage to drain away from the building.
